Report C 1997:36

**Incident involving Aircraft N-263US
12 November 1996 at Örebro Airport,
T county, Sweden**

Case L-108/96

1997-10-29

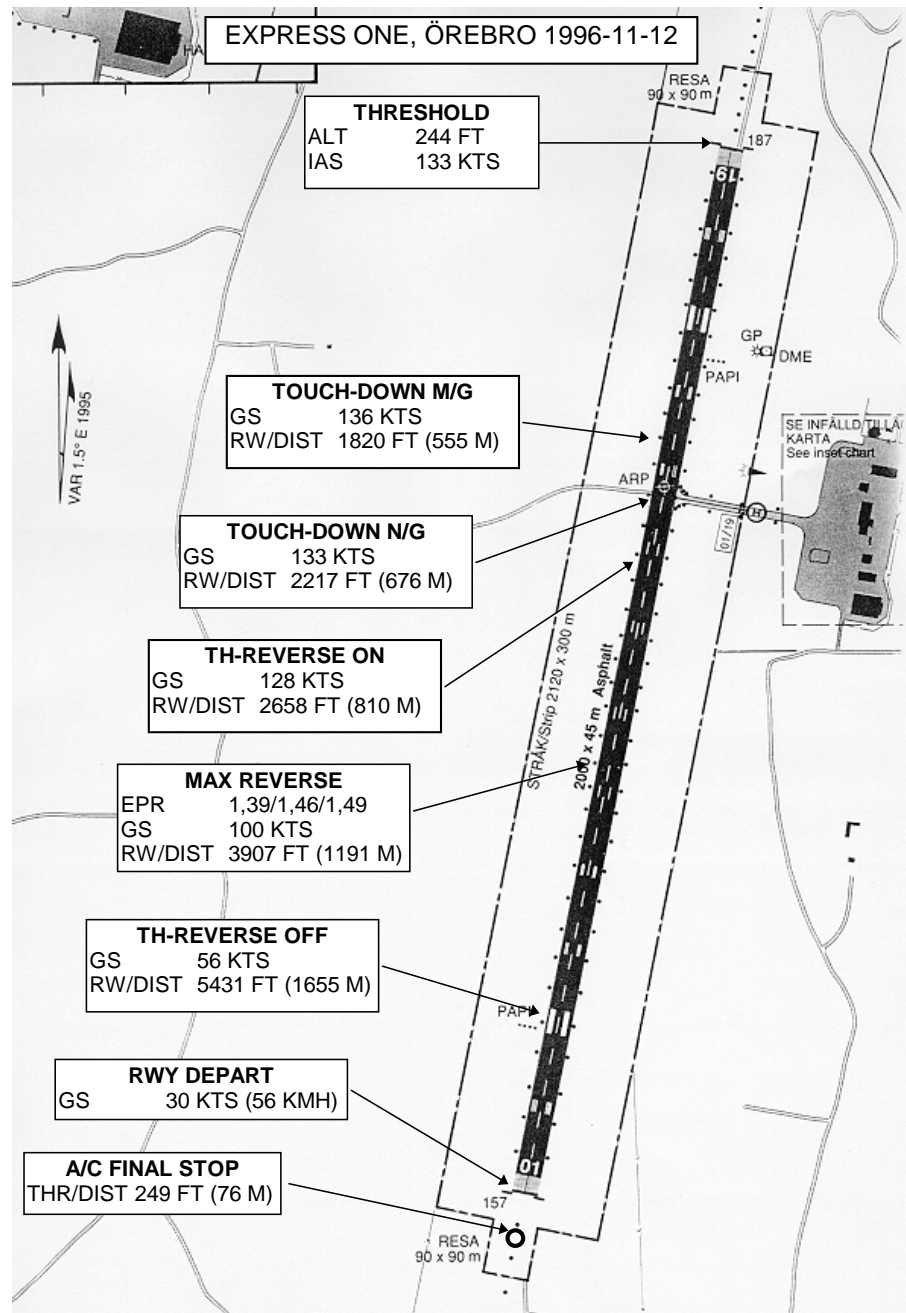
In drawing below essential positions along the runway have been pointed out.

The crew chose runway 19 with 8 knots tailwind which was reasonable considering the lack of ILS on the opposite runway. The ILS approach seemed normal according to the flight recorder and the Board's appraisal. The touchdown, however, was 250 m beyond the normal touchdown zone. The tailwind may have contributed to this.

The captain used reversing and wheel braking normally down to a ground speed of 56 kts (103 km/h) at which speed he unreversed only 345 m remained of the runway length. The captain has stated that braking was normal until the speed had been reduced to taxiing speed and that he thereafter intended to continue to the runway end to turn around there. The ground speed when the aircraft skidded off the runway was 30 kts (56 km/h), however, which indicates that the captain underestimated the ground speed and unreversed the engines and released the brakes too early. Contributing to this misjudgement may have been a visual perception of low ground speed due to the snowflakes moving in the same direction due to the tailwind.

When the captain was to perform the final braking before the 180° turn at the end of the runway, the ground speed was thus too high in relation to the actual runway friction. The main wheels lost their grip and the aircraft skidded uncontrollably over the runway and additionally 76 m into the overrun area.

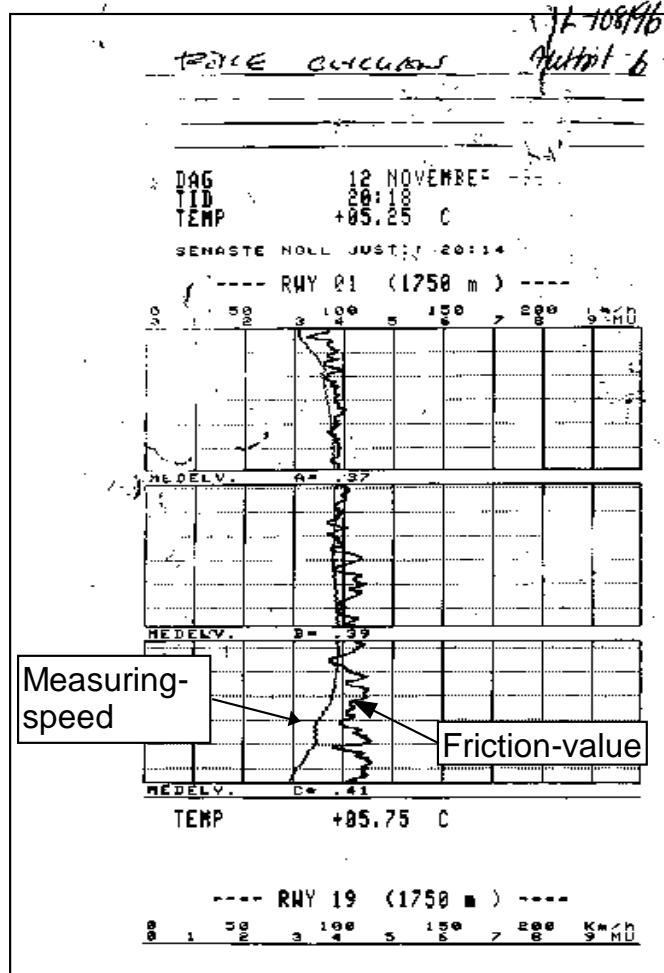
Recording slip of test before the incident (one direction)

Runway friction at Örebro airport is measured with a Skiddometer Friction Tester, BV11, towed behind a car. The last measurement before the landing in question was performed during a snowfall and was completed 21 minutes before the landing. The test run was performed in one direction, along runway 19, 5 - 8 m from the centreline. The run followed in the tracks of the snowplough vehicles at a speed slightly below 95 km/h.

The following friction values were reported to the tower: 0.37, 0.39, 0.41 corresponding to braking action "good to medium", "good to medium" and "good". The test equipment computer was wrongly programmed and gave the result as being obtained on runway 01.

The friction report given to the aircraft was based on a test performed 21 minutes before the landing, near the centreline and along a section that had just been swept. As the heavy snowfall persisted during the continued cleaning, which was terminated just before the landing, the real friction values must have been lower than those reported. This was also confirmed 8 minutes after the landing when it was found that the friction values had deteriorated by 0.01 on the first third and by 0.05 on the last two thirds of the active runway.

Also, the test before the landing was performed only in one direction and at an average speed below the recommended 95 km/h, which rendered the test result less reliable.

Runway friction values shall be given starting with the first third of the runway with the lowest designation. The air traffic controller thus understood the reported values given to him as being for runway 01 - not 19 - and forwarded this to the aircraft. It is difficult to judge if this circumstance had any influence on the course of events.

- to draw up requirements on maintenance and calibration of friction measuring equipment similar to those specified for measuring equipment and tools used in the maintenance of aircraft and air material, and
- to consider the need for the person who has performed the friction test to sign the recording slip.
