## *Interim statement* *SRL 2015:02e*

**Serious incident close to Visby Airport on 30 November 2014 involving the aeroplane SE-MDB of the model ATR-72-212A, operated by Braathens Regional AB.**

File no. L-148/14

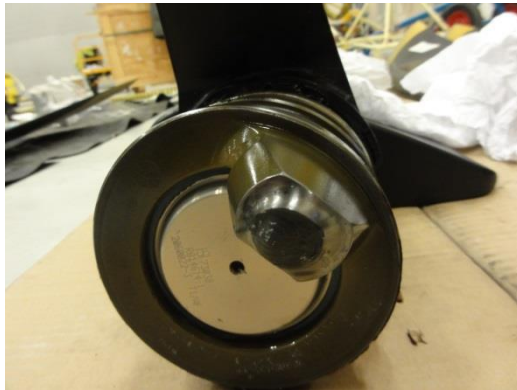
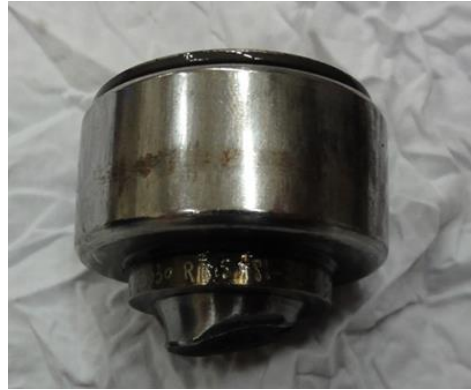
An inspection of the right hand power plant revealed severe damage inside the propeller hub. One trunnion bearing had failed and the actuator plates were bent. The compressor housing was fractured and there was damage on the engine mounts. Furthermore the drive shaft for the AC-wild generator was broken.

Figure 1 and 2. The failed trunnion pin.

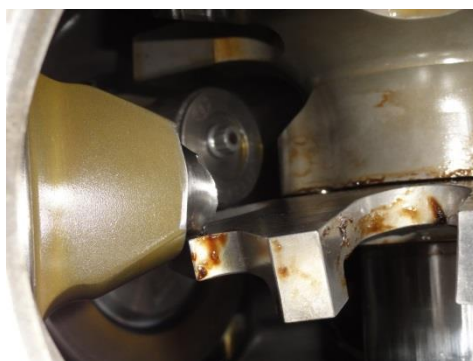
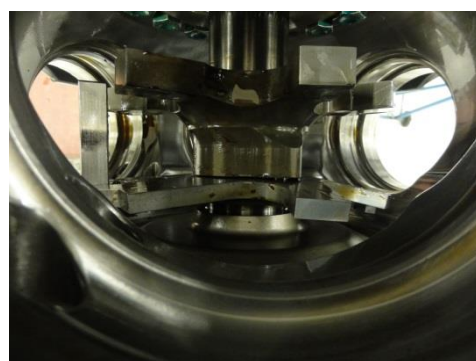
Figure 3 and 4. The bent actuator plate.
