**ACCIDENT**

<b>Aircraft Type and Registration:</b>	Saab-Scania SF340B, G-LGNL	
<b>No &amp; Type of Engines:</b>	2 General Electric CT7-9B turboprop engines	
<b>Year of Manufacture:</b>	1991 (Serial no: 340B-246)	
<b>Date &amp; Time (UTC):</b>	2 January 2015 at 0833 hrs	
<b>Location:</b>	Stornoway Airport, Isle of Lewis	
<b>Type of Flight:</b>	Commercial Air Transport (Passenger)	
<b>Persons on Board:</b>	Crew - 3	Passengers - 26
<b>Injuries:</b>	Crew - None	Passengers - None
<b>Nature of Damage:</b>	Extensive damage to the nose landing gear, powerplants and underside of the aircraft	
<b>Commander's Licence:</b>	Air Transport Pilot's Licence	
<b>Commander's Age:</b>	46 years	
<b>Commander's Flying Experience:</b>	3,880 hours (of which 3,599 were on type) Last 90 days - 98 hours Last 28 days - 28 hours	
<b>Information Source:</b>	AAIB Field Investigation

**Synopsis**

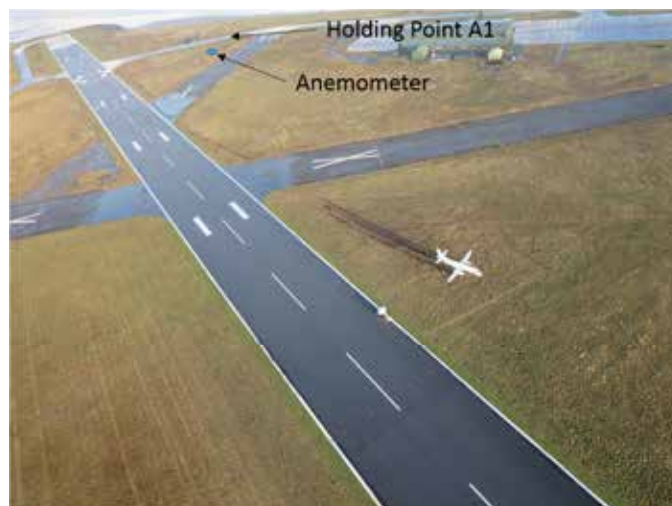
**Figure 1**

Marks from all six tyres were visible on the runway from about 200 m after the taxiway where the aircraft entered Runway 18. These tracks diverged to the left and then departed the paved surface after another 100 m. The tracks remained visible on the unpaved surface beside the runway until the point where the aircraft came to rest, a further 250 m, but were not visible for the period when the aircraft crossed a disused paved runway (Figure 1).

General view of accident site

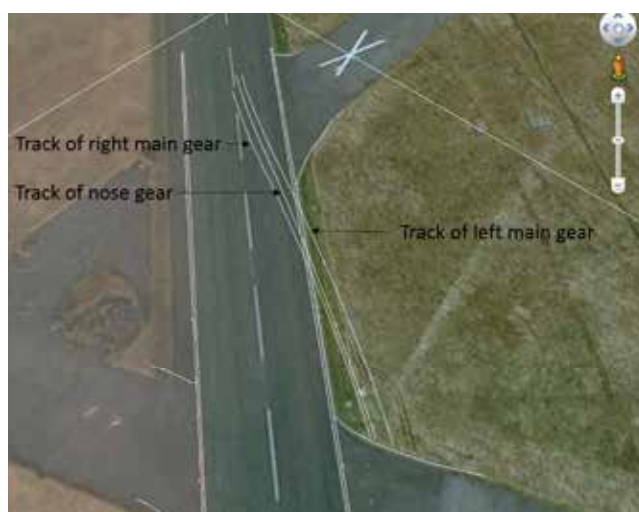
**Figure 2**

The rubber marks left by the tyres indicated that the tyres were not rolling straight ahead and, as the aircraft approached the side of the runway, the geometry of the marks indicated that the aircraft was progressively yawing to the right of its direction of travel (Figure 2). Calculations indicated that this yaw angle reached a maximum of approximately  $14^\circ$  just after the aircraft entered the grass beside the runway and it remained fairly constant until the aircraft reached the disused runway. There were no tyre marks across the disused runway but when they reappeared in the grass on the far side the aircraft was no longer yawed. Shortly after this point the ground markings indicated where the nose landing gear collapsed.

Tracks of the aircraft landing gear (Police Scotland)

As the aircraft moved towards the edge of the runway, the pilot applied right rudder in an attempt to return to the runway centreline. Figure 2 shows that, with the aircraft still on the runway, the nose of the aircraft began to turn right in response to the rudder input but the main landing gear maintained their track towards the runway edge. The track of the nose landing gear moved towards that of the right landing gear, indicating that the aircraft was skidding left as it departed the paved surface.

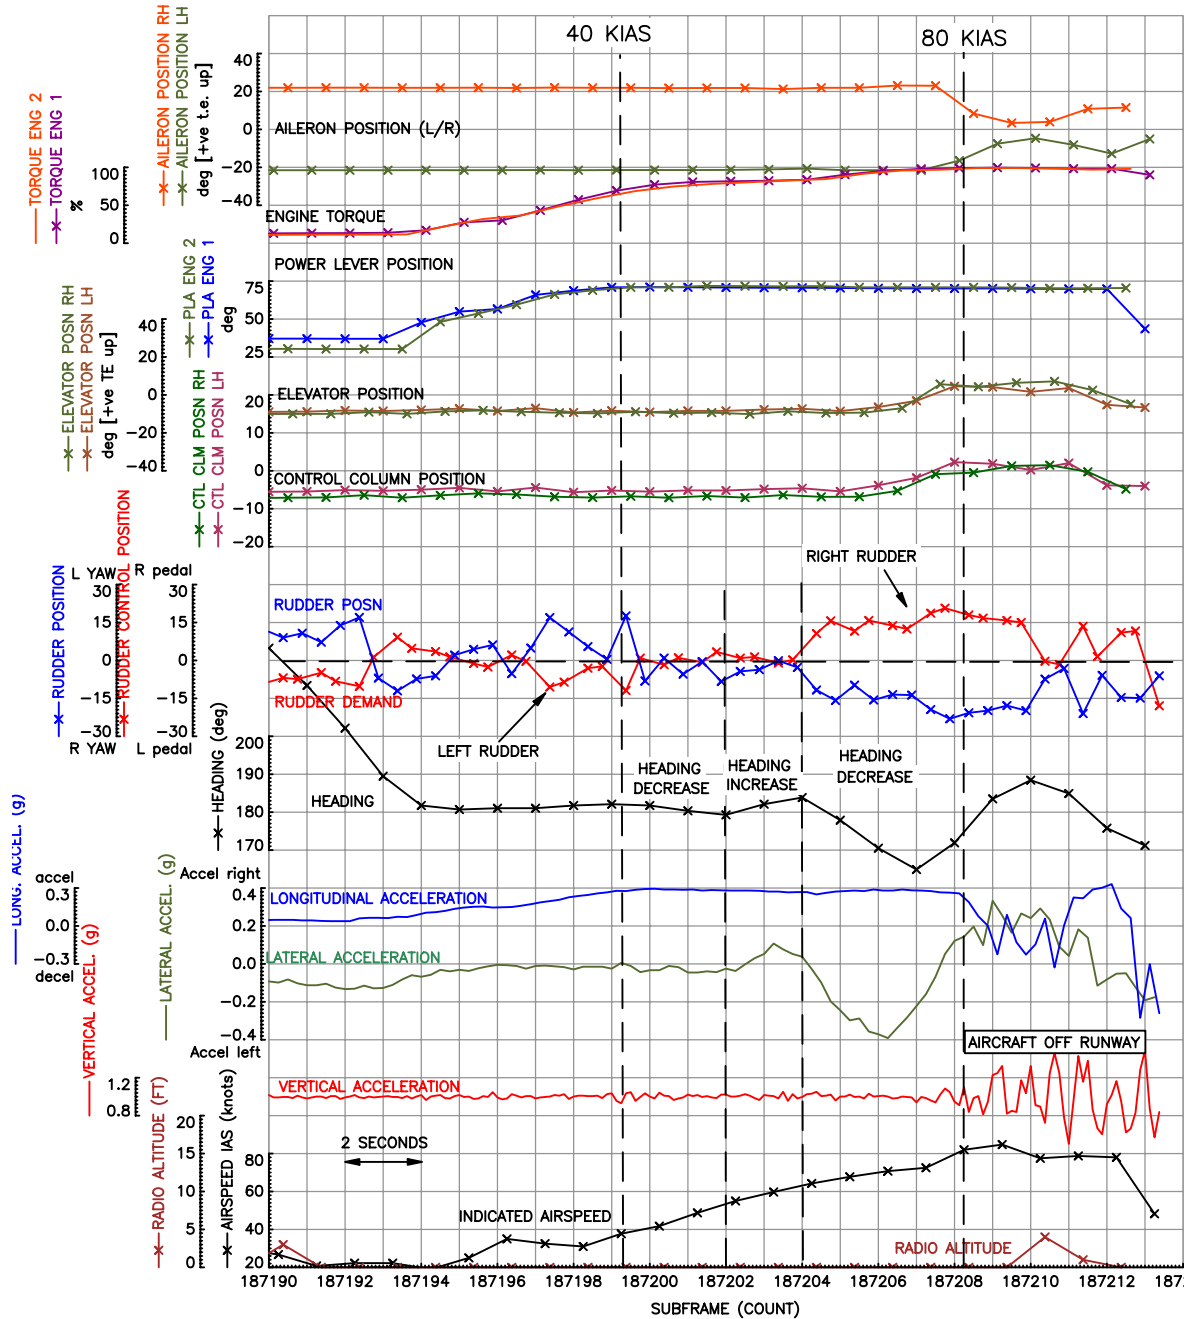
**Figure 3**  
G-LGNL FDR data<sup>7</sup>

<sup>7</sup> Note: Rudder pedal position and rudder surface position are in the opposite sense.

During the attempted takeoff, the rudder was central from 40 kt and remained so until approximately 65 kt. Between approximately 52 and 65 kt, the aircraft turned right slightly before it turned left sharply at approximately 65 kt (Figure 3). Given that the rudder was central, this change of direction might have been caused by one, or a combination of the following factors:

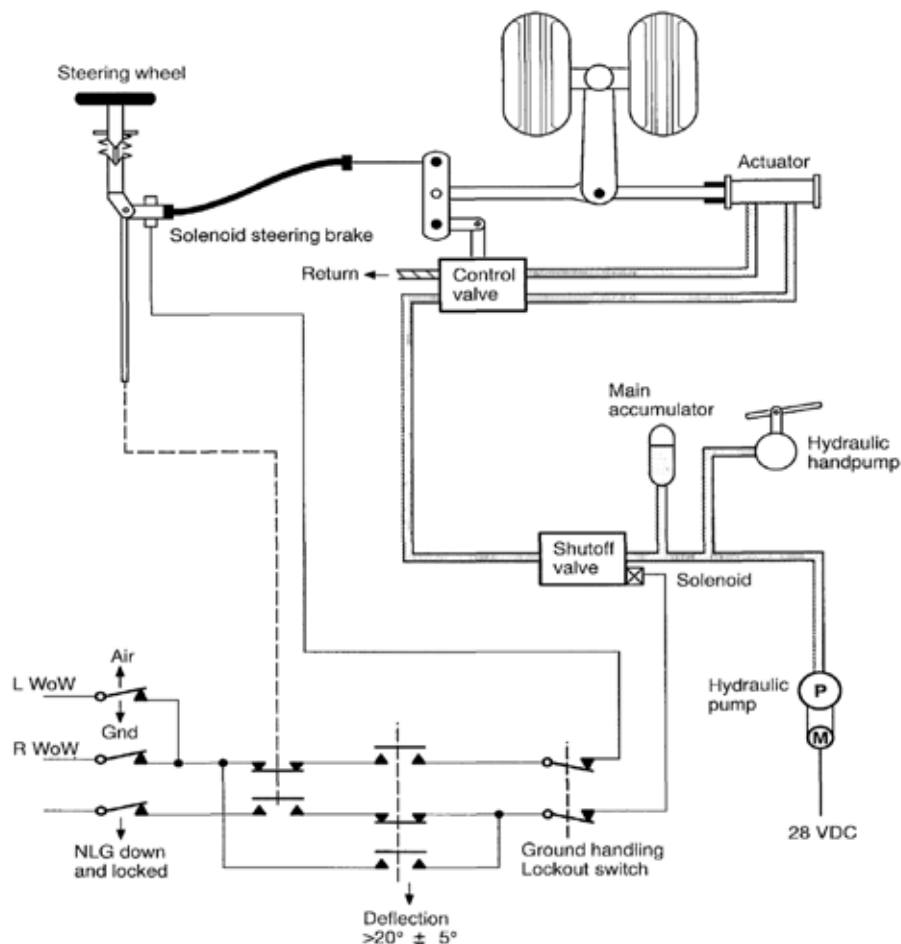
**Figure 4**

Due to damage sustained, it was not possible to conduct a detailed check of the steering system and its rigging. However, a visual examination of the system did not reveal any pre-existing defects.
