- Summary Report -

AAIS Case N°: AIFN/0009/2011

Fumes in Passenger Cabin

Operator: Emirates
Type: Boeing 777-300ER,
Registration: A6-ECE
Place of Occurrence: Near Stockholm
State of Occurrence: Sweden
Date of Occurrence: 14 February 2011

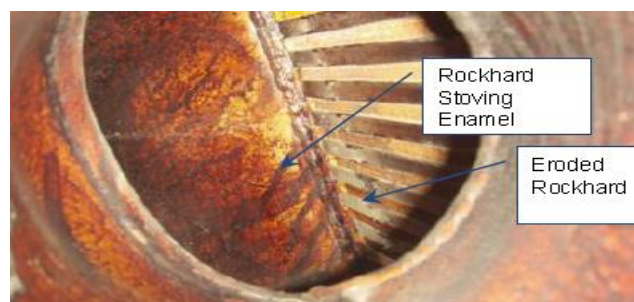
Figure 3. Condenser/Reheater Internal View

The Condenser/Reheater exhibited a wet spot in the Reheater hot inlet. An attempt was made to gather any residual fluid by pouring it out but nothing was collected. The wet spot appeared to be a water spot. In an effort to gather any foreign material that may have been present in the core, water was poured through the core and a sample collected for analysis.

The reddish/brown compound witnessed on the interior walls of the Condenser/Reheater was actually a Rockhard Stoving Enamel that is applied as a corrosion preventative. This coating is applied both during original production, and as required at subsequent shop visits. After maintenance, and cleaning and baking in an oven to drive off residual moisture, this compound is sprayed into the unit and dripping and running occurs normally prior to oven curing of the material, following the application step.

Even though several areas were found where some Rockhard material had been eroded from the core inlet, most of the material was found to be intact. Erosion of this material would not lead to a sulphurous smell. See figure 3. It is likely that liquid water, present on the interior walls of the Condenser/Reheater, was mistaken for liquid Rockhard, when in fact the water only coated the Rockhard, which was intact.
