SERIOUS INCIDENT

Aircraft Type and Registration:	Saab-Scania SF340B, G-LGNM	
No & Type of Engines:	2 General Electric CO GE CT7-9B turboprop engines	
Year of Manufacture:	1990 (Serial no: 340B-187)	
Date & Time (UTC):	3 October 2014 at 0930 hrs	
Location:	En route from Aberdeen to Sumburgh	
Type of Flight:	Commercial Air Transport (Passenger)	
Persons on Board:	Crew - 3	Passengers - 25
Injuries:	Crew - None	Passengers - None
Nature of Damage:	None	
Commander's Licence:	Airline Transport Pilot's Licence	
Commander's Age:	51 years	
Commander's Flying Experience:	9,168 hours (of which 6,283 were on type) Last 90 days - 87 hours Last 28 days - 37 hours	
Co-pilot's Flying Experience:	2,340 hours (of which 928 were on type) Last 90 days - 105 hours Last 28 days - 44 hours	
Information Source:	AAIB Field Investigation

Synopsis

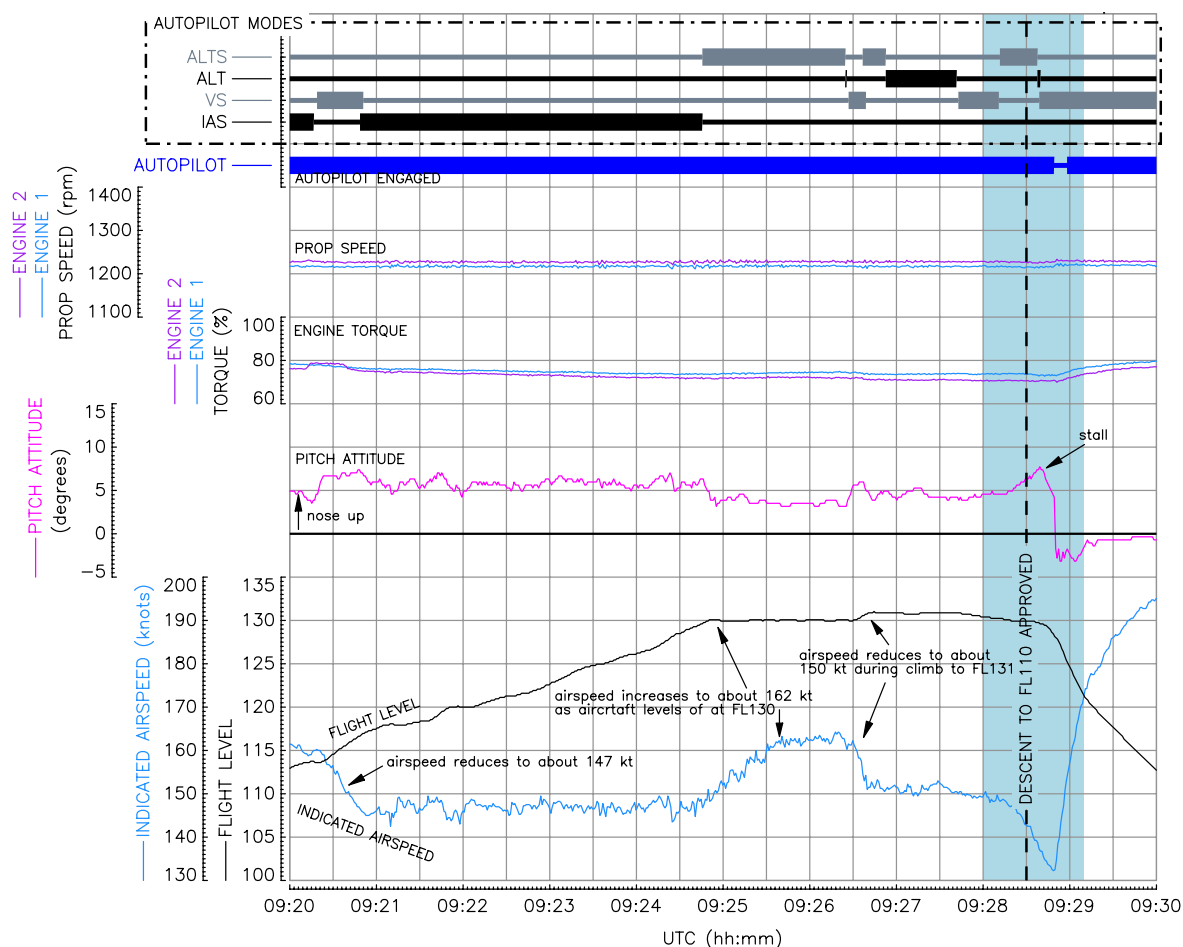
Figure 1
FDR data overview of event
(shaded area to the right is detailed in Figure 2)

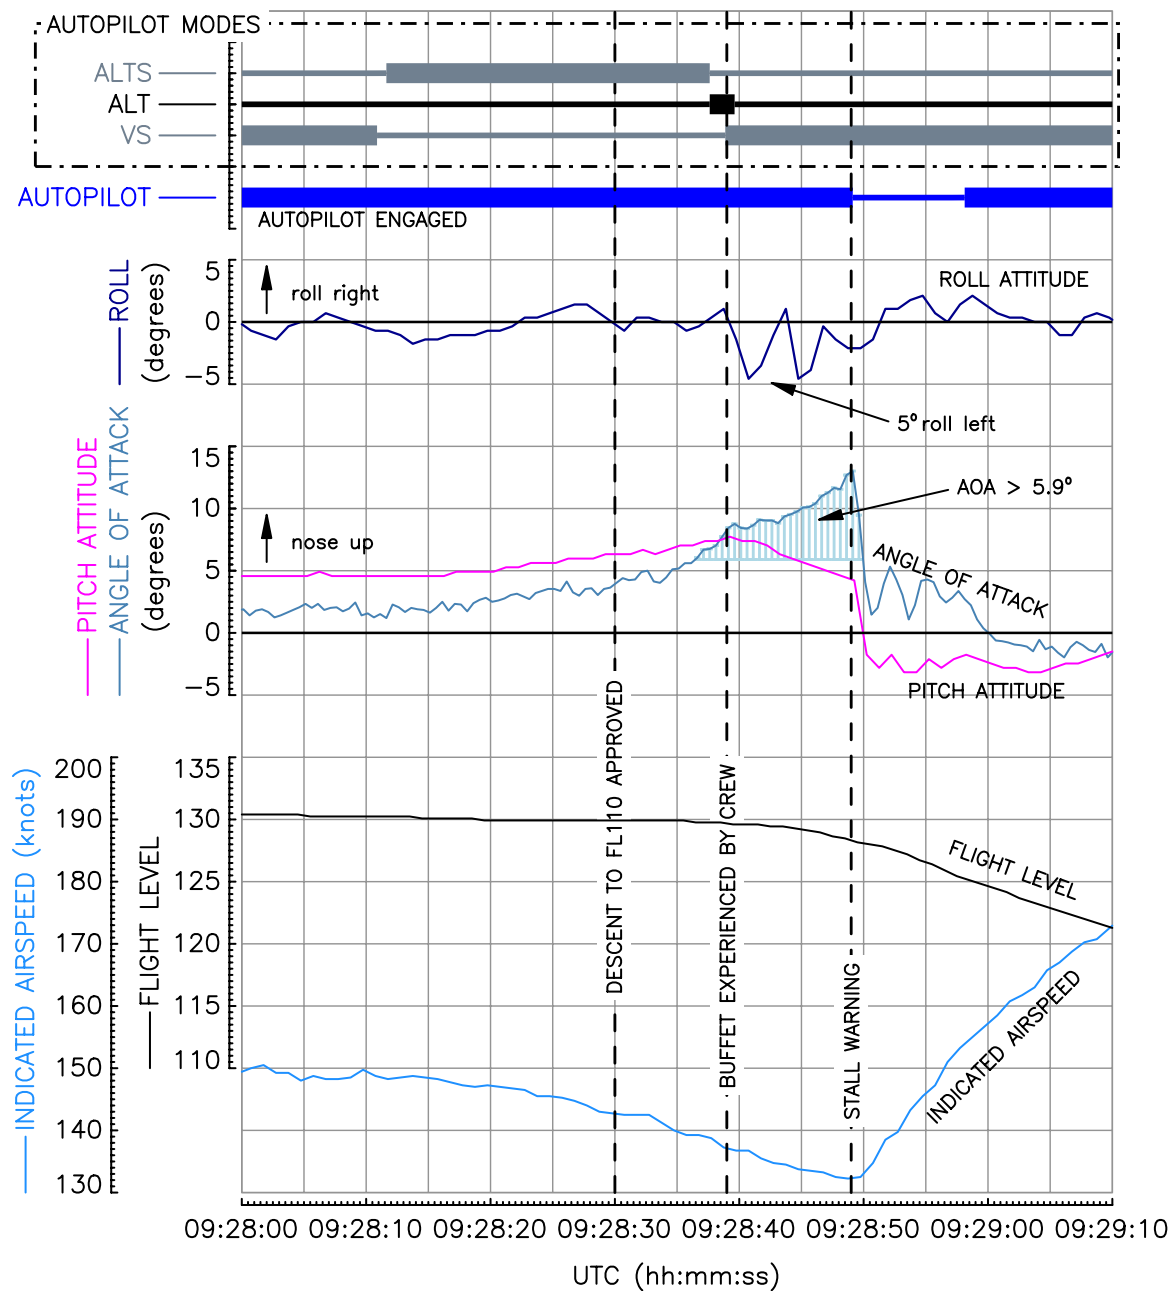
Figure 2
FDR data at the time of the event

The aircraft also rolled left, twice in quick succession, to 5° angle of bank (AOB). At 09:28:49, as the AOA reached 13° (with the pitch attitude at 4°), the stall warner sounded and the autopilot disengaged. The airspeed at this point was 132 KIAS. Subsequently, the AOA reduced, the airspeed increased and the autopilot was re-engaged.

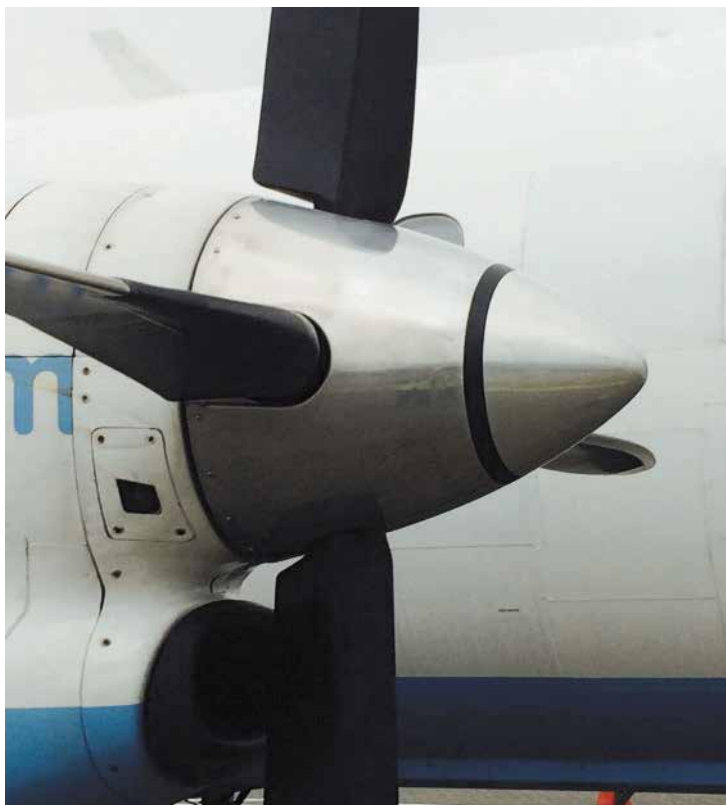
Figure 3

Both spinners on G-LGNM's propellers, in common with those on many of the operator's other aircraft, were painted with black rings (see Figure 3). The rings were not mentioned in any guidance material and the manufacturer stated that they had been incorporated on certain aircraft as part of a trial. The intention, which was not advised to operators, was that if ice was seen to accrete aft of this line it could indicate that the conditions were beyond the aircraft's certified limits ie a severe icing encounter. However, the manufacturer later determined that this was not an accurate cue for severe icing and was more conservative than the certified visual cue (see *Ice detection* section earlier in this report). The manufacturer has

Propeller spinner showing black-painted ring

The lines painted on the aircraft's spinners caused confusion. The manufacturer had painted them as a trial but there was no written information about them and both pilots had a different understanding of their significance.

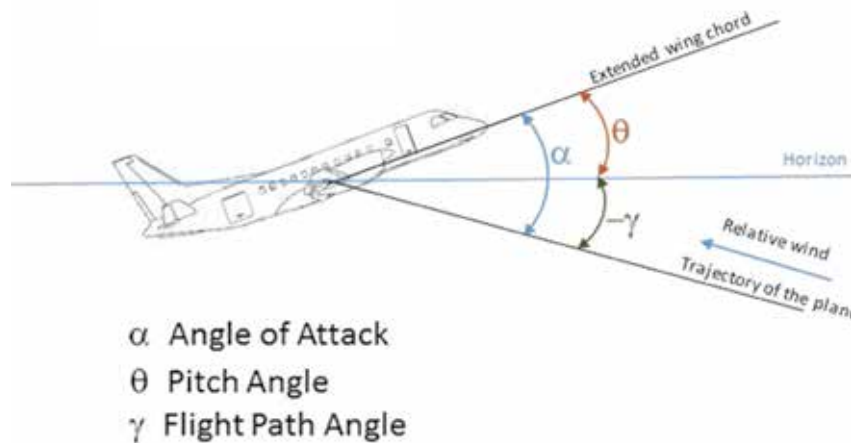
Figure 4

Manufacturer's illustration of AOA greater than pitch angle in descent
