Final report RL 2015:15e

Accident north-east of Munka-Ljungby, Skåne county on 5 June 2015 involving the sailplane D-KYDM of the model Ventus-2 cM, operated by a private individual.

File no. L-50/15

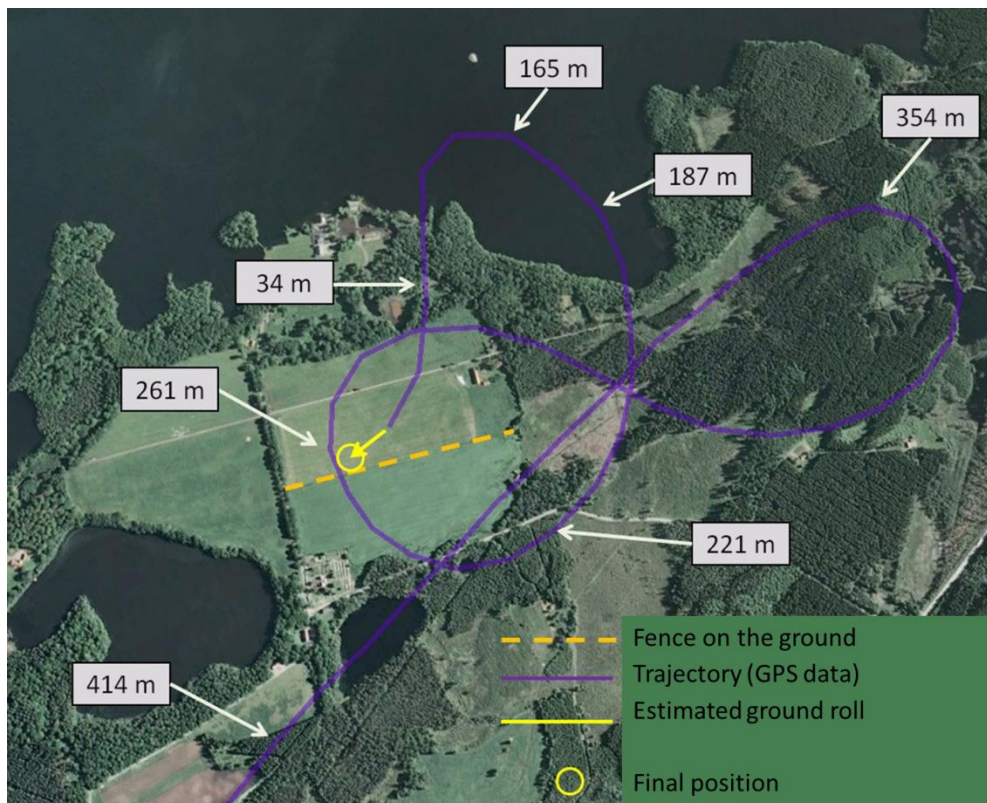
The pilot performed a short landing circuit to the left towards the designated field. Shortly before touchdown, the pilot spotted a fence on his left side, about 45 degrees out. He veered to the right by making a shallow turn in order to avoid the fence. The right wingtip made contact with the ground, and the aircraft yawed quickly to the right in the form of a ground loop. The pilot sustained no physical injuries. The sailplane's rear fuselage was, however, severed, and ailerons and flaps sustained damage.

Figure 1. Logged data showing the sequence of events in the landing. Heights stated are above the ground. The fence is marked with a dashed line. Image from Google Earth. Map data © Lantmäteriet Dnr R61749_13002.

The cause of the accident was that the fence was noticed at too late a stage before landing.

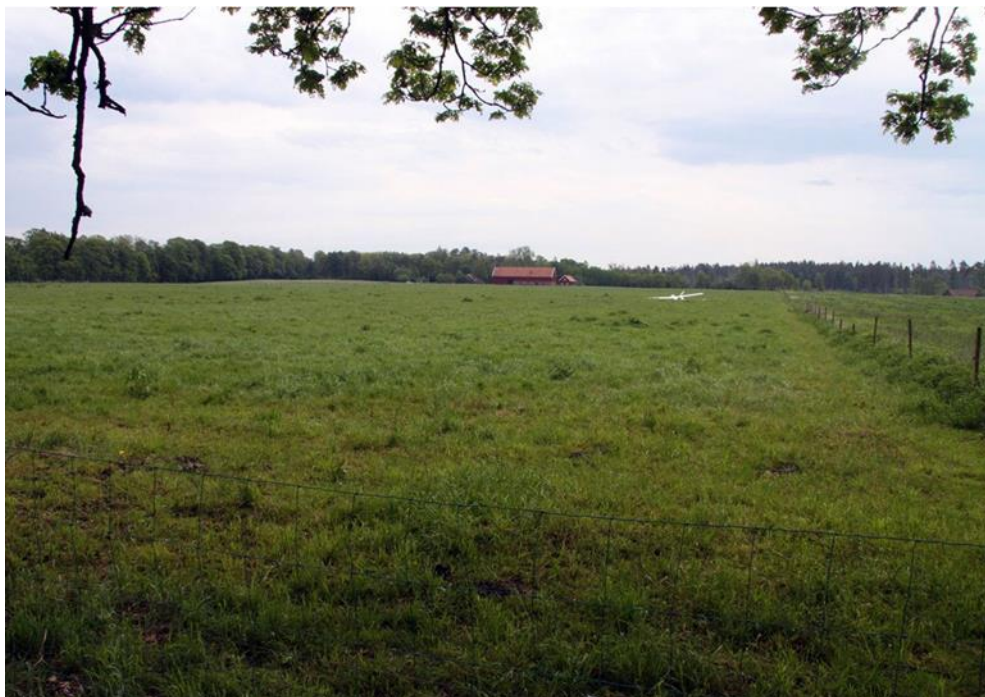
Figure 2. The outlanding field against the direction of approach with D-KYDM. Fence between the fields is seen on the right side of the picture. Photo: Mikael Roslund.

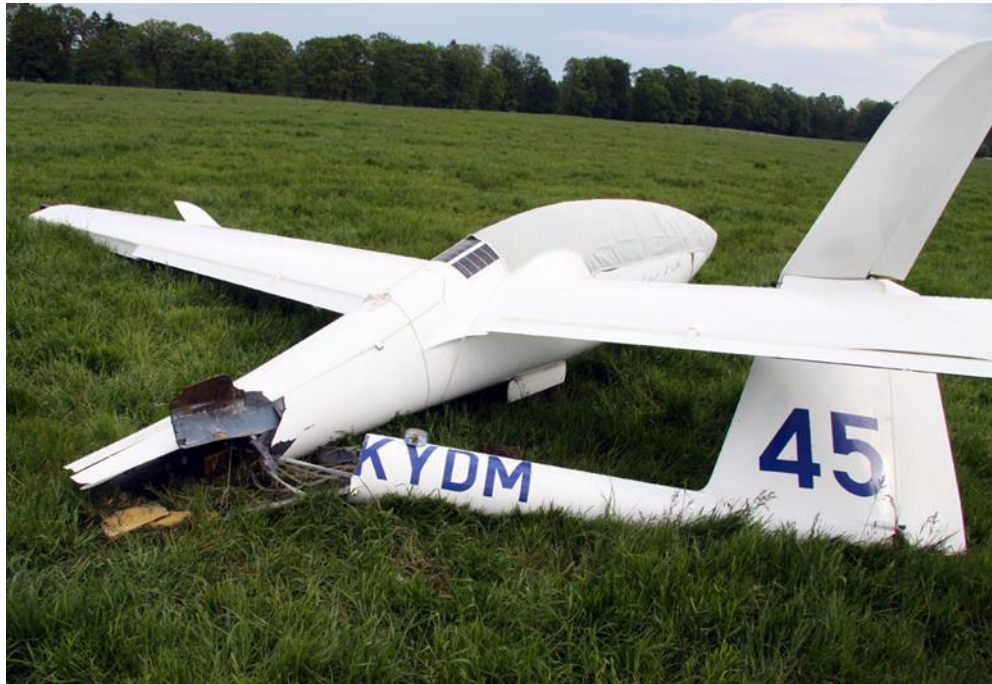
Figure 3. D-KYDM with severed rear fuselage after the accident. Photo: Mikael Roslund.
