Investigation Report 99/13

Serious Marine Casualty

**Fire on the con-ro carrier
ATLANTIC CARTIER on 1 May 2013 in the Port
of Hamburg**

9 October 2015

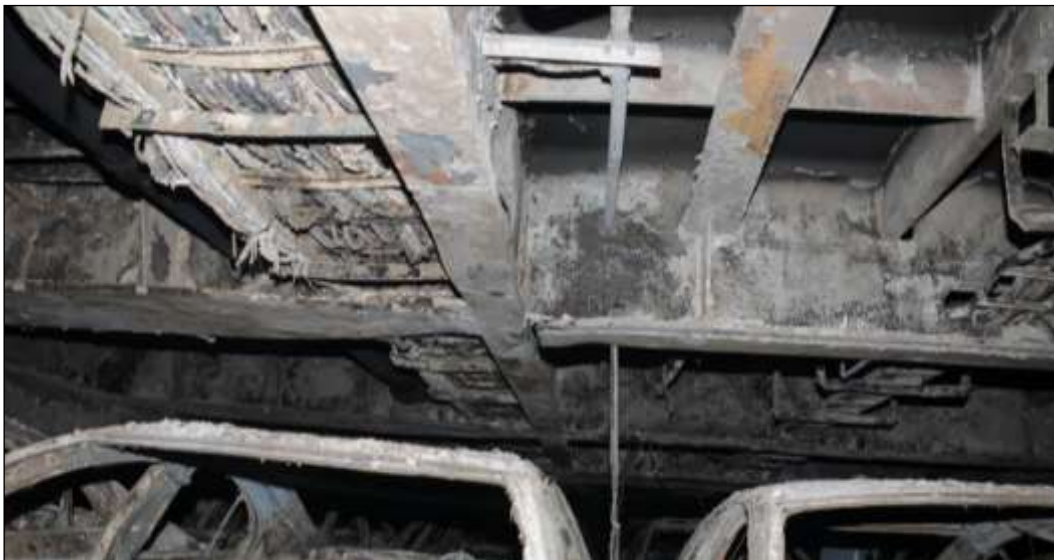
Damage to the ship was essentially limited to fire and heat-related destruction within the forward section of vehicle deck 3, which was primarily affected by the fire, where cable routing that runs along the ceiling was destroyed, supports were deformed, and paint was ruined, in particular (see **Figure 5**).

Figure 5: Effect of fire on the cargo hold ceiling and cable routing

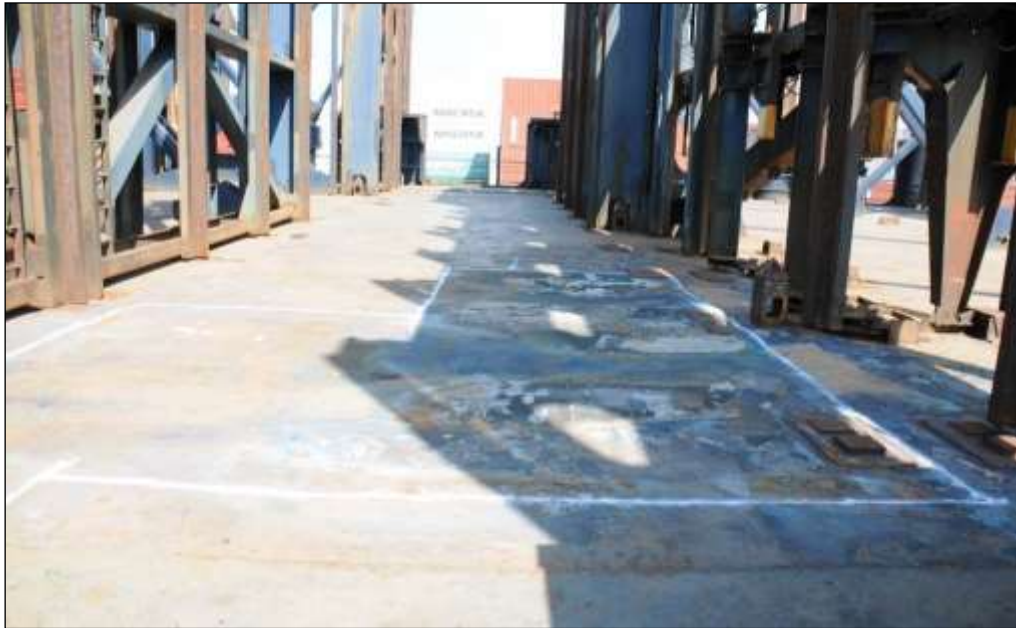
As a result of the immense heat radiation from the burning vehicle deck, parts of the floor of the main deck located above the seat of the fire were deformed (see **Figure 6** below). However, the cell guides installed on the main deck and also the ship's sidewalls were largely spared from the effects of the heat as a result of the cooling efforts, which were initiated immediately after the fire was detected and steadily intensified over the course of the other extinguishing activities.

Figure 6: Heat-induced discolouration and deformation on the floor of the main deck

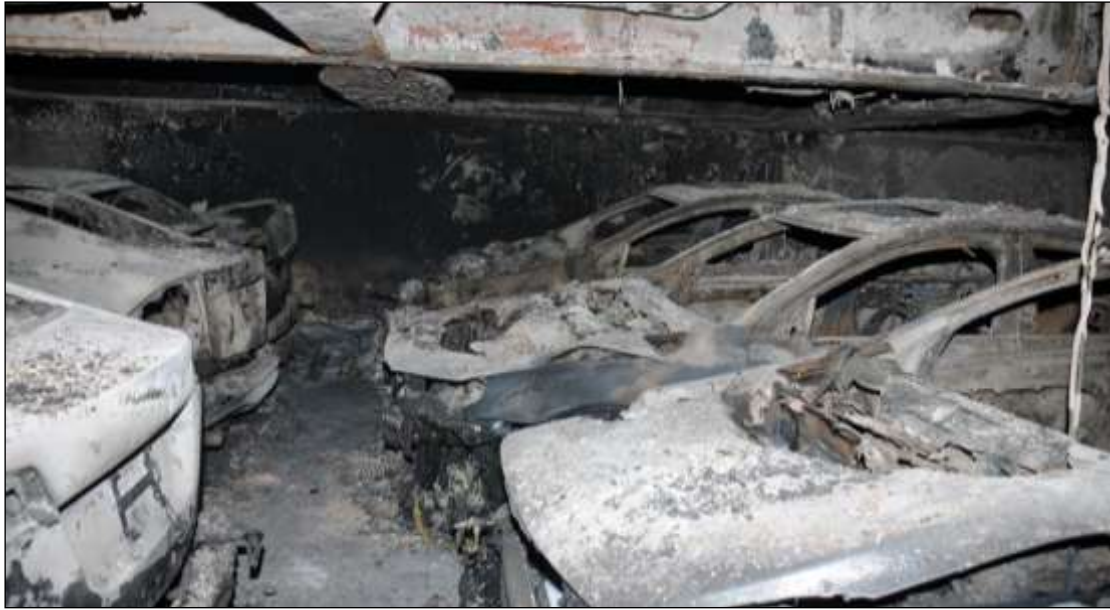
A total of 69 new vehicles (cars) from the manufacturer VOLVO were stowed in the forward part of vehicle deck 3 B, which was primarily affected by the fire. The fire destroyed nine of these vehicles. The build-up of fire, heat, and smoke on the deck affected another 57 vehicles so extensively that they also had to be scrapped. One other car stowed on deck 3 B according to the cargo papers could not be found according to the transport insurer.¹⁵

Figure 7: Completely burnt out vehicles on deck 3 B

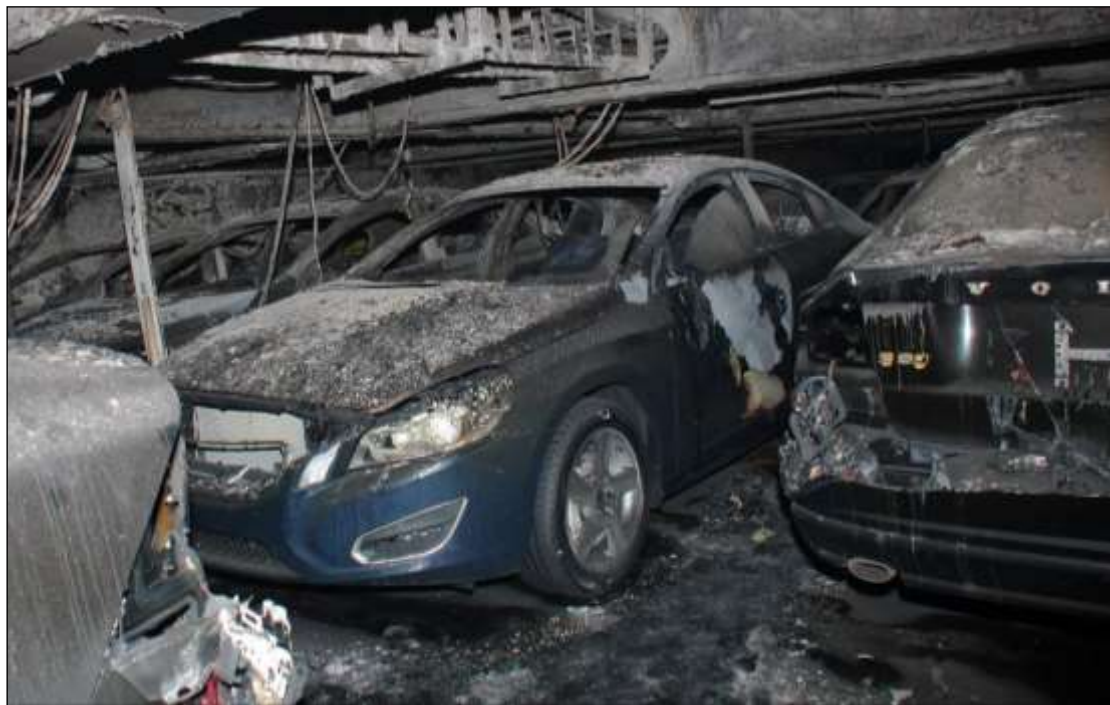
Figure 8: Cars damaged to varying degrees by the heat

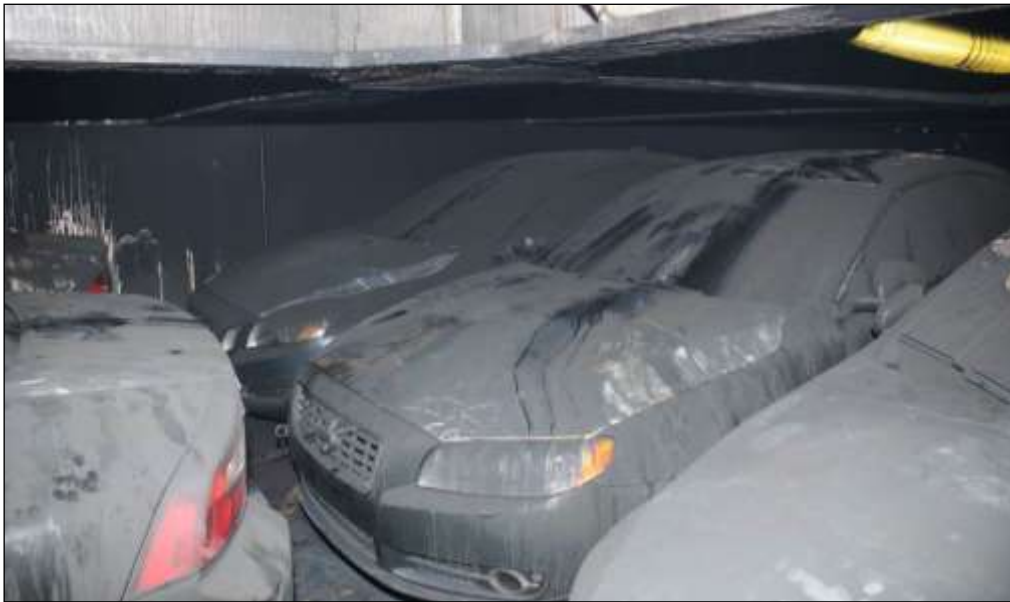
A total of 22 new cars stowed in the aft part of deck 3 B or in the other ro-ro decks affected by the fire only secondarily were so severely damaged by the build-up of heat and/or smoke or fouled by soot that they also had to be scrapped. Due to the damage caused, 38 vehicles could only be used for spare parts. The use of 194 vehicles could be continued after in some instances very extensive cleaning or minor repairs.

Figure 9: Cars severely fouled by soot

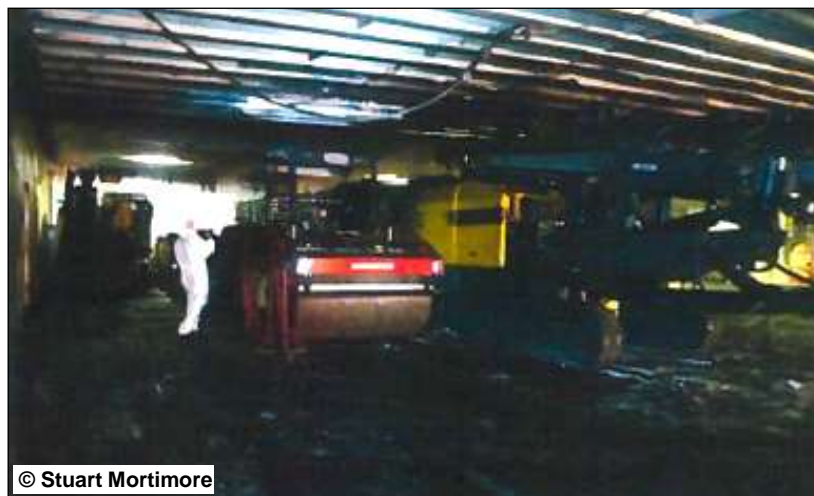
Several commercial vehicles, including a road roller, were stowed directly beneath the forward part of deck 3 B (i.e. on deck 3). The heat radiation emanating from deck 3 B damaged the commercial vehicles to varying degrees.

Figure 10: Damaged commercial vehicles on deck 3¹⁶

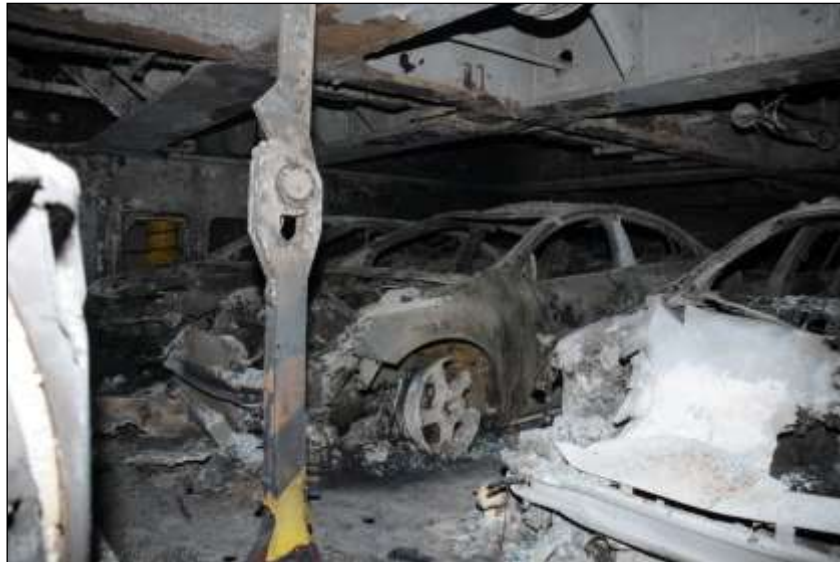
The fire damage on deck 3 B varies, spreading from the apparent seat of the fire in a circular pattern. Despite the relatively long and unimpeded spread of fire, the damage is extremely localised. From that it can be concluded that the fire reaches extreme thermal proportions over time in an affected car; however, the structural condition of new cars stops it from crossing to the adjacent vehicle for an extremely long period, even though the stowage distance is very low (less than 30 cm in places).

Figure 44: Apparent position of the seat of the fire (bay 26)

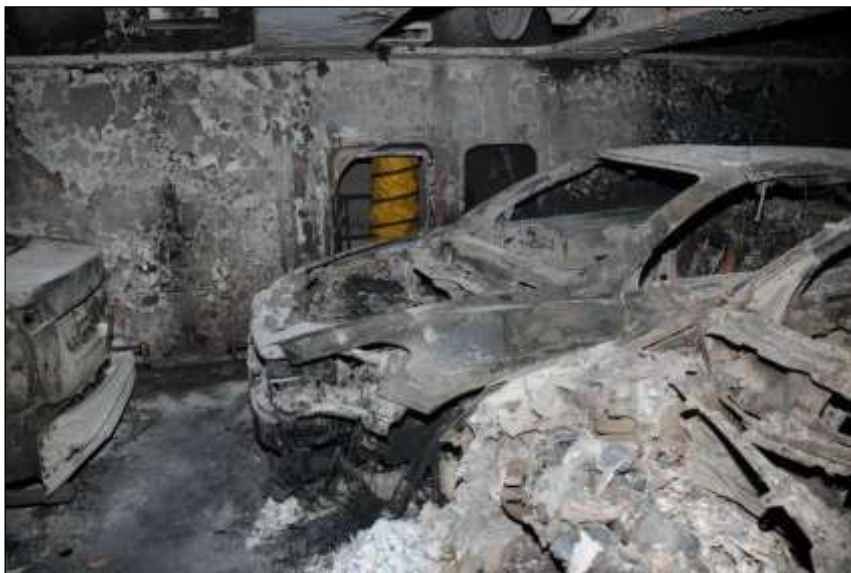
Figure 45: Position of the seat of the fire

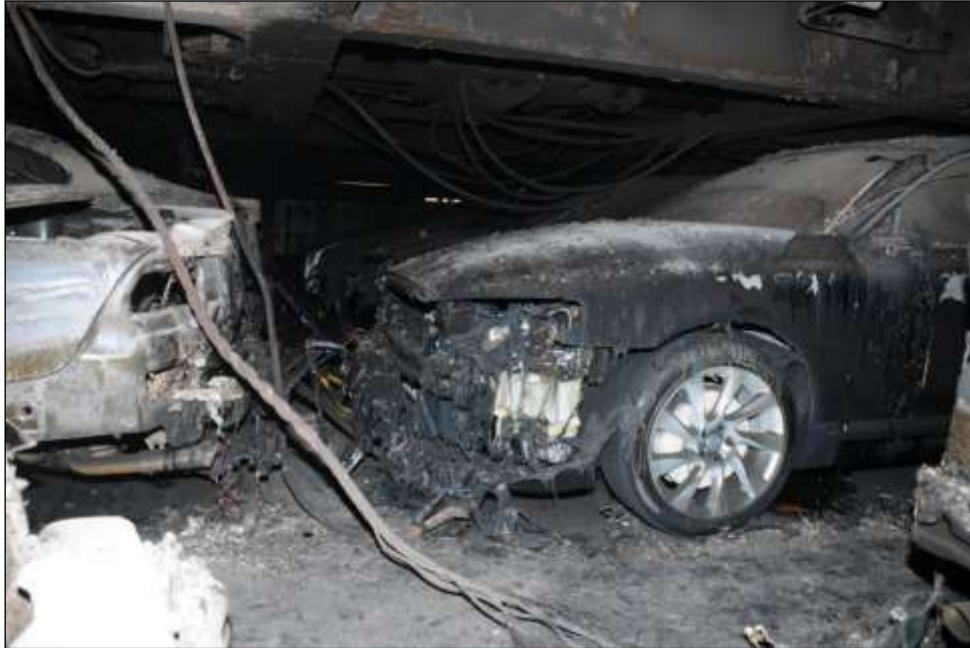
Rather than from the front of the vehicle, the fire spread from its side panels. It is apparent that each engine compartment acted as a firewall. Indeed, the fire raged beneath the ceiling, which is visible from the severe damage to the deck. However, an indication that the fire crossed from the boot of the car to the engine compartment of the next adjacent vehicle or through the front/rear window to the passenger compartment is not so clearly visible.

Figure 46: Damaged vehicle in the second row from the front

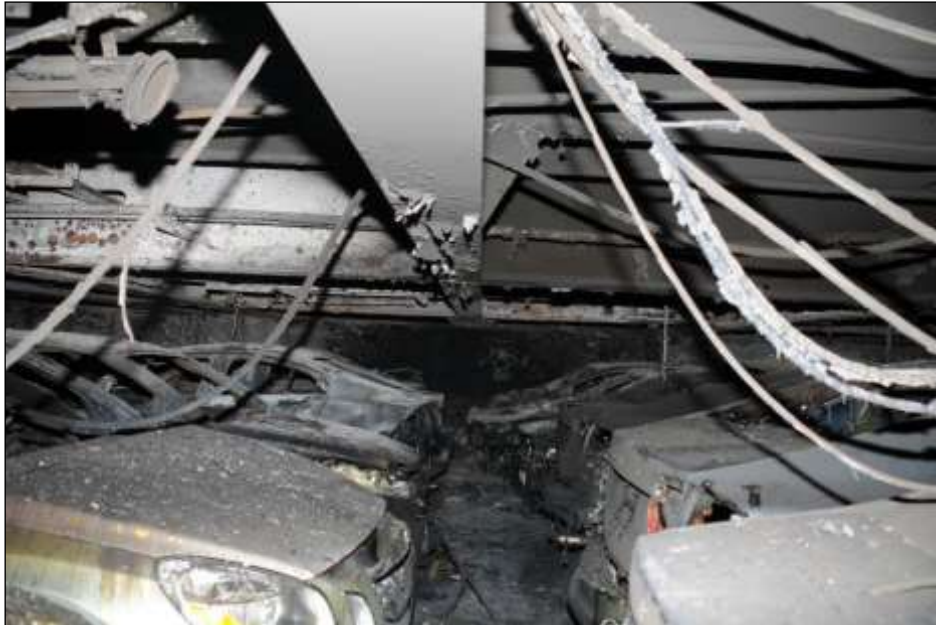
It is remarkable that the fire evidently stayed within a confined area in spite of the considerable intensity. It would seem that the accumulation of gases caused the formation of convective currents in the lower area, too. Due to extreme temperatures, most of the plastic parts on the vehicles and deck installations melted even in areas some distance away (distance of two to three cars), however.

Figure 47: Thermal stress on the deck's ceiling

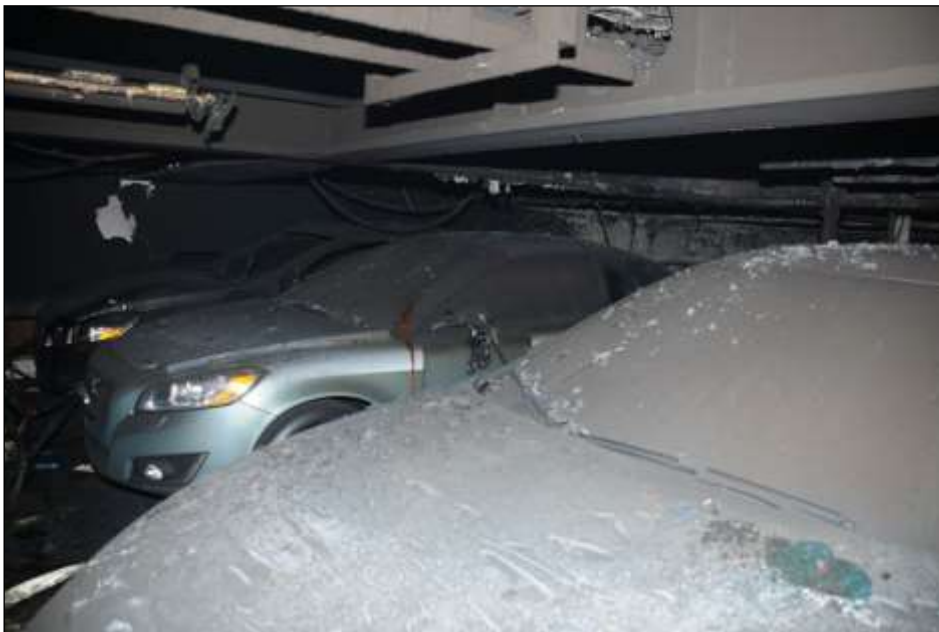
Figure 50: Various traces of damage to adjacent vehicles

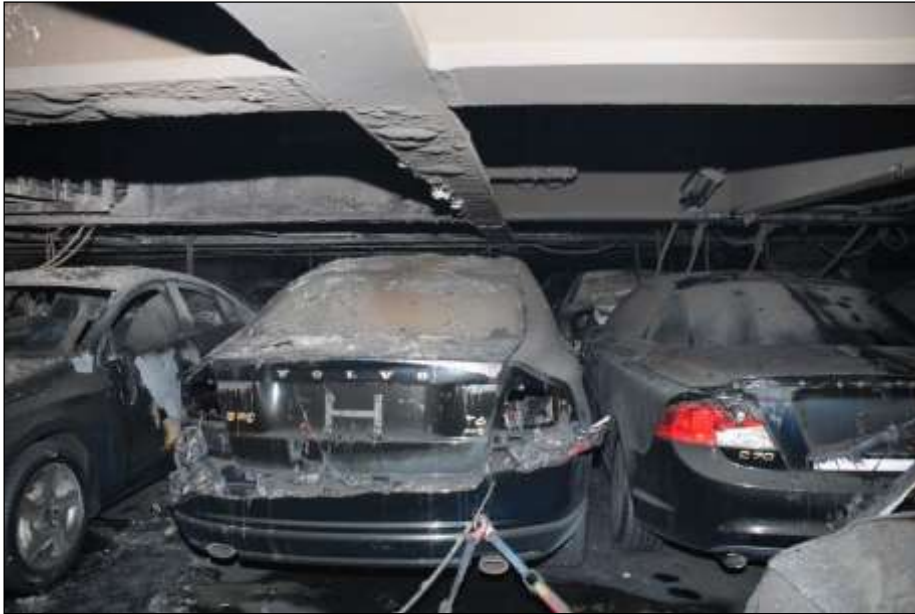
Figure 51: Destroyed plastic parts (in this case the rear lights) on the vehicles

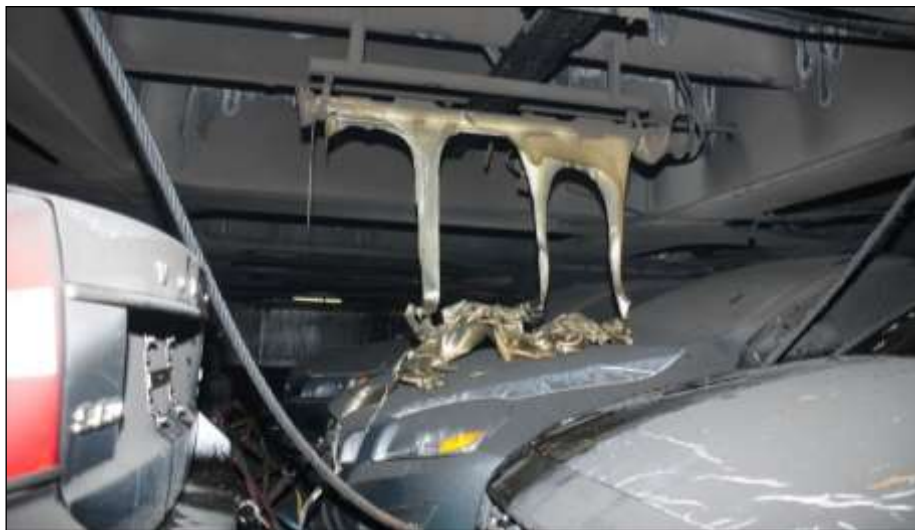
Figure 52: Plastic casing of a ceiling light melted by heat radiation

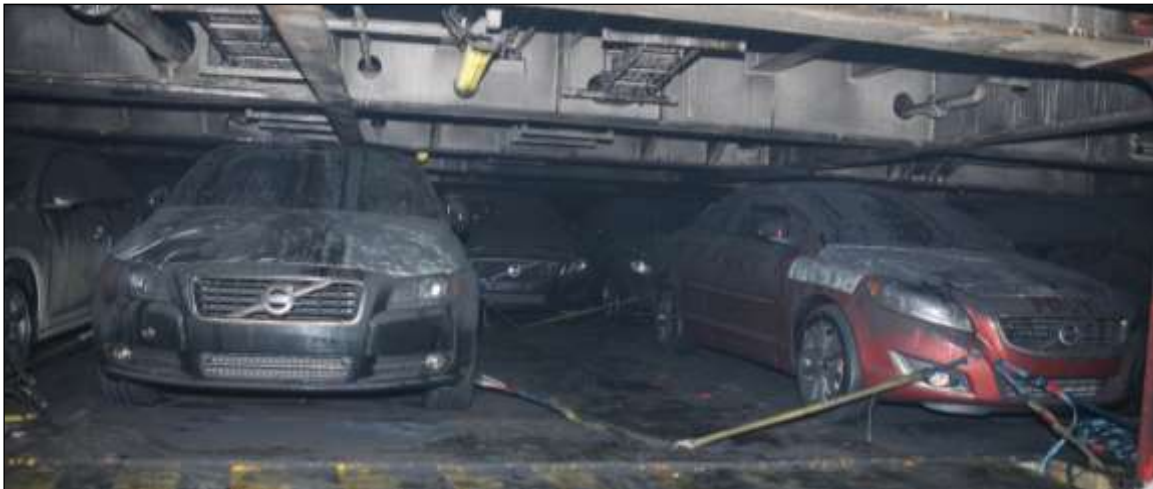
In summary, with regard to the extent and severity of the damage throughout the affected vehicle deck 3 B, it is noted that the damage sustained by the cargo was localised but comparatively severe. Even vehicles on the periphery aft were rendered largely unusable due to being fouled by soot.

Figure 53: Vehicles in the outer area fouled by soot

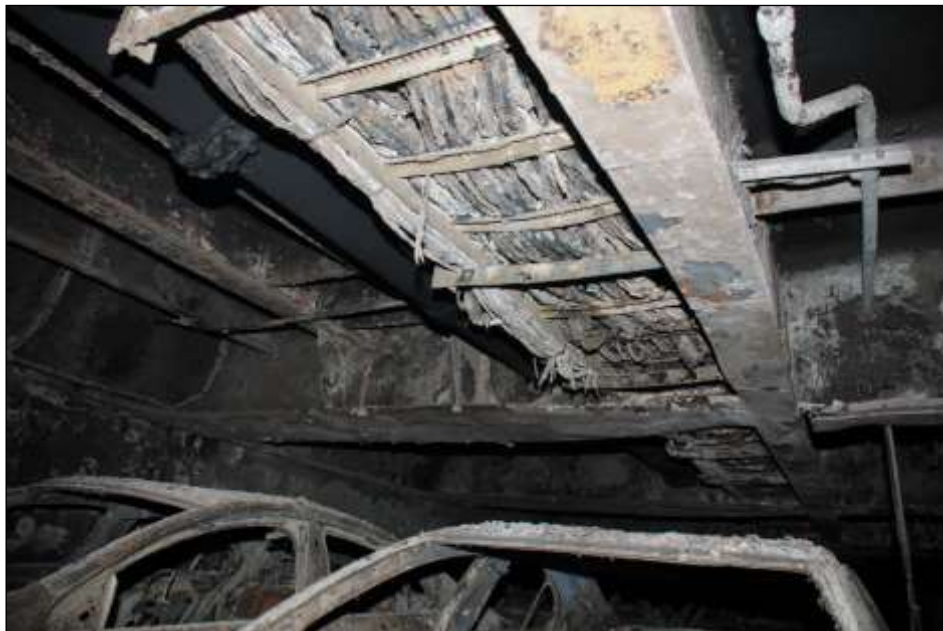
When considering the damage to the ship, a differentiation must be made between the consequences of the fire on the deck primarily affected (3 B) and the main deck (upper deck). Damage was sustained by the deck structure and installed technical equipment in the affected deck. The heaviest damage is on the cable routing beneath the ceiling. However, the deck structure was also heavily deformed in places due to the long period for which the fire persisted unimpeded.

Figure 54: Destroyed cable routing and deformed girders beneath the ceiling

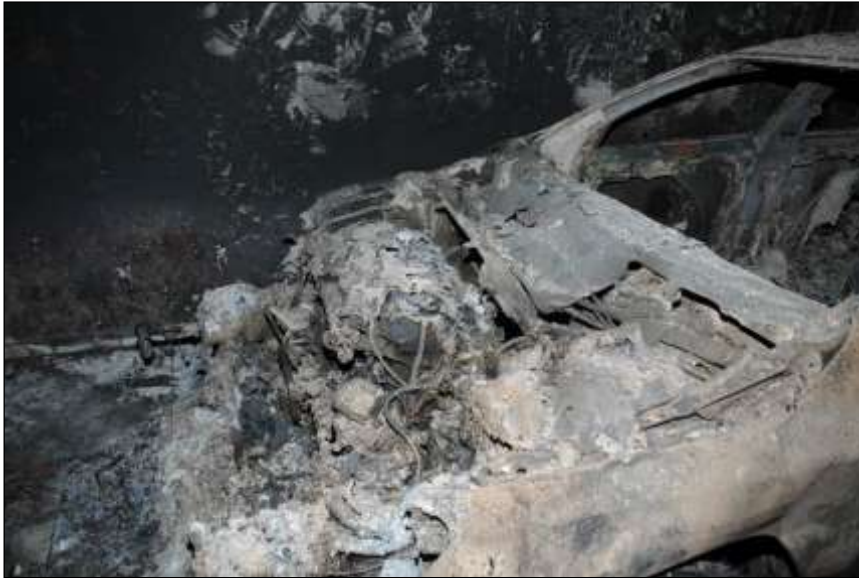
*Metal fires occurred on vehicles in the main fire zone. Occurring at extreme temperatures in excess of 1,000°C, these fires caused the damage found (see **Figure 55** below). Parts of the permanently installed CO₂ low-pressure system were also destroyed in the main fire zone.*

Figure 55: Engine compartment of a car destroyed by metal fire

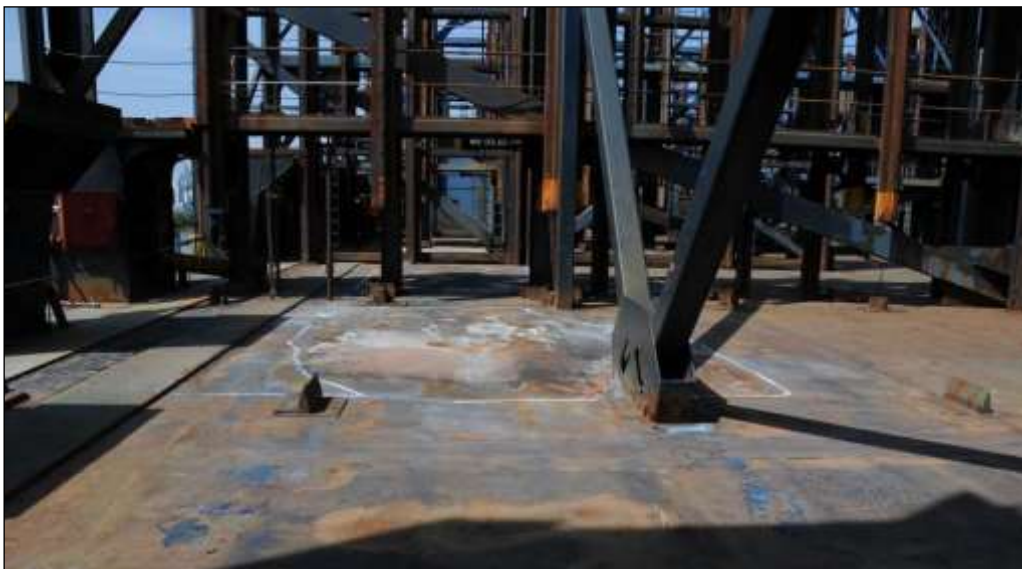
*On the main deck, warping occurred on the floor in the main fire zone. The paint is burnt in places (see **Figure 56**). It is apparent that there was no significant heat conduction vis-à-vis the cell guides on deck, however.*

Figure 56: Warped deck and fire damage in the area of bay 26

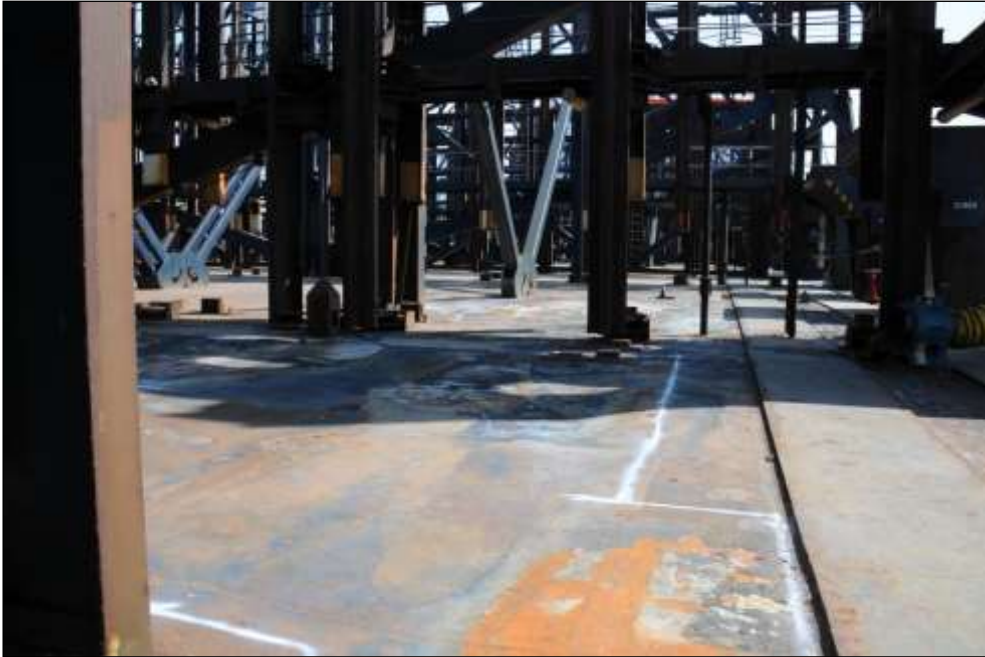
*Thermal traces can only be demonstrated up to the actual edge of the cargo hold. The deck area above the void space and the ventilation ducts sustained hardly any thermal stress (see **Figure 57** below).*

Figure 57: Damage threshold (cargo hold/void space)

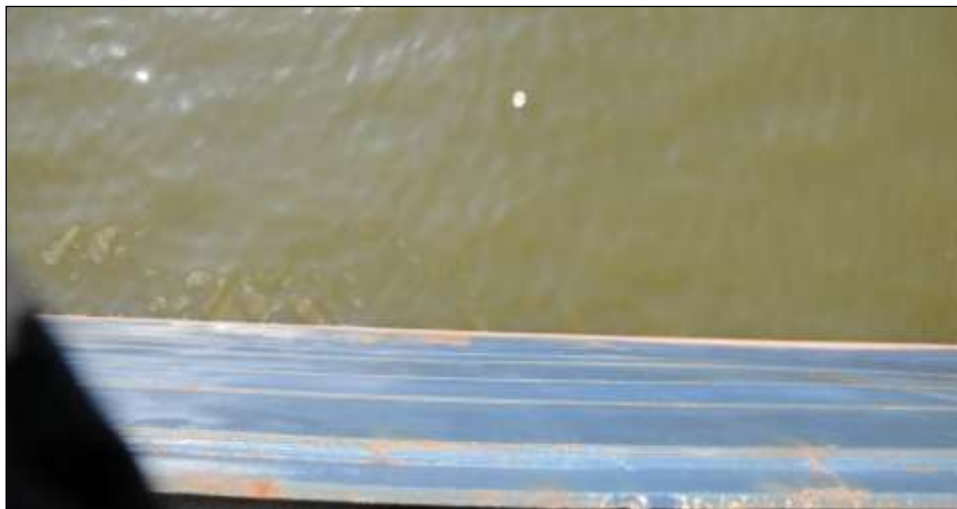
Furthermore, no thermally induced damage was found on the shell plating – not even in the main fire zone.

Figure 58: No thermally induced damage to the hull wall in the area of bay 26 (port side)

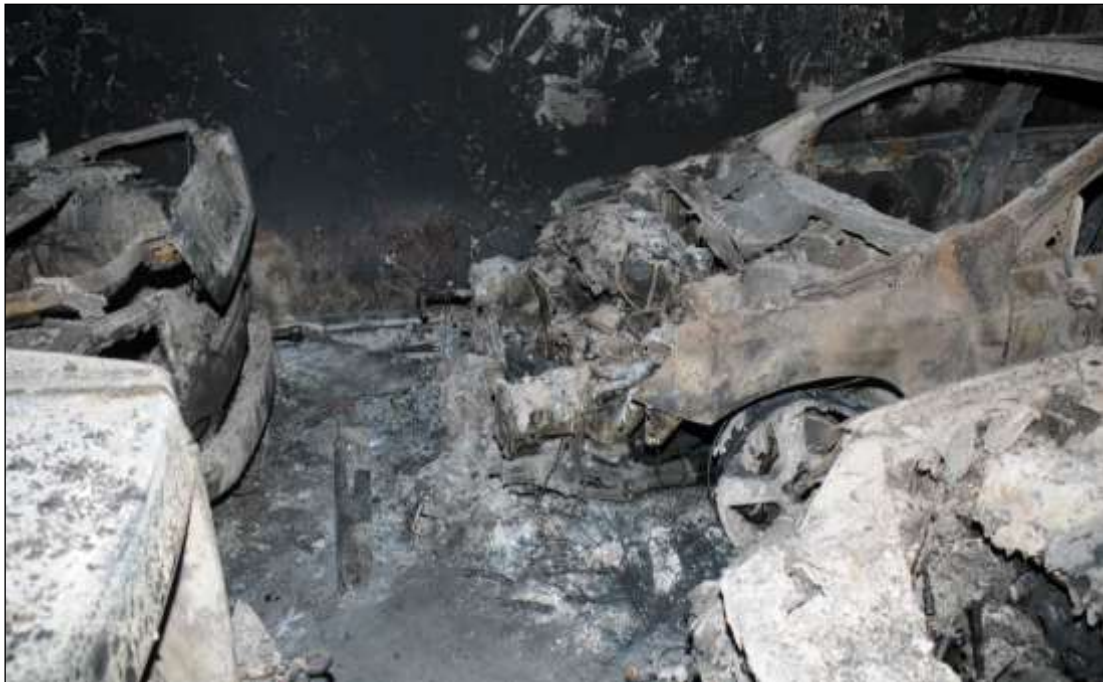
- full and complete combustion of all inner and outer plastic parts, such as dashboard, seat cushions, steering wheel, indicators, headlights;*
- exterior paint burnt off completely;*
- complete destruction (metal fire) of the engine compartments, engines, bonnets, and large parts of the chassis;*
- complete destruction of all the tyres and wheels, and*
- complete destruction of all the windows, including rubber seals*

Figure 59: Completely burnt out vehicles

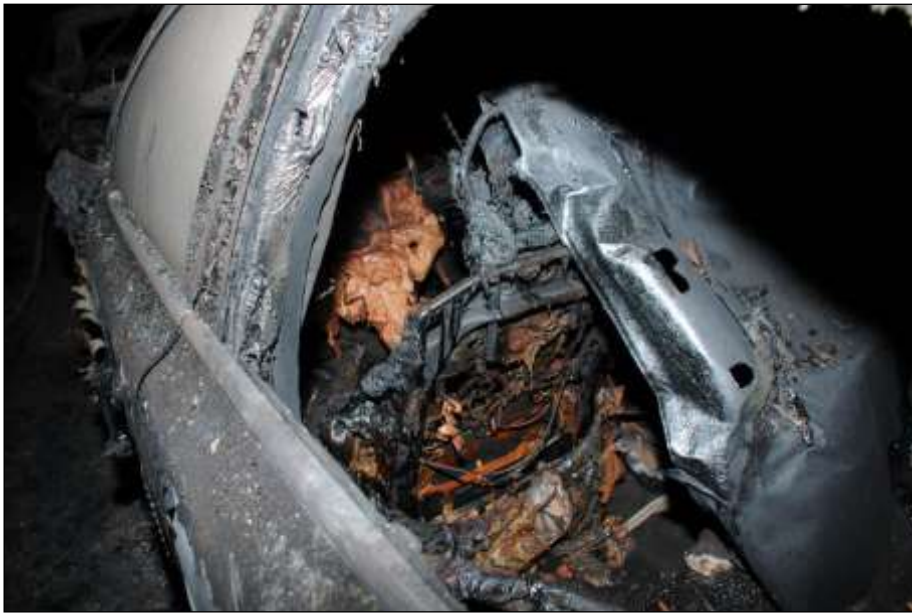
Experience has shown that even a fuel-induced initial fire inside a closed vehicle develops for up to 15 minutes before windows burst and a fully-fledged fire thus ensues. According to the statement given by the person who discovered the fire, there was a heavy build-up of smoke on the deck and the upper deck felt warm only some 30 minutes after the previous safety inspection, however. On the other hand, this fact supports the possibility of a spontaneous event. The presumed detonations or even explosions cannot be substantiated, however. Rather, the noises repeatedly heard during the extinguishing activities can be attributed to burst tyres and triggered air bag systems.

Figure 60: Fragments of a triggered air bag inside a car

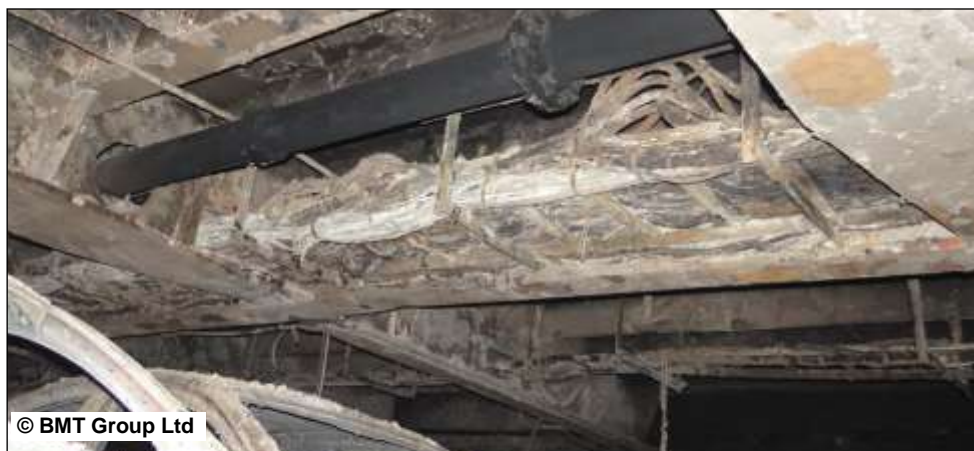
*In the opinion of the cargo insurer's expert, all the electric wiring on board the ship was defective and fire prone to an unusually high degree. According to that, evidence of inadequate wiring was revealed by cable loops protruding from the protective sheath, traces of corrosion on cables, cable connections of inconsistent strength, existing damage to cables due to welding operations, damage due to abrasion caused by metal cables, forcibly bent cables inside the insulation, damage to the insulation due to overheating, and traces of several earlier fires on deck 3 B. Indicative of the cable routing was numerous cable splices originating for the most part from the lengthening of the ship (see **Figures 61 f.**).*

Figure 61: Cable splices on the ceiling of vehicle deck 3 B³⁴

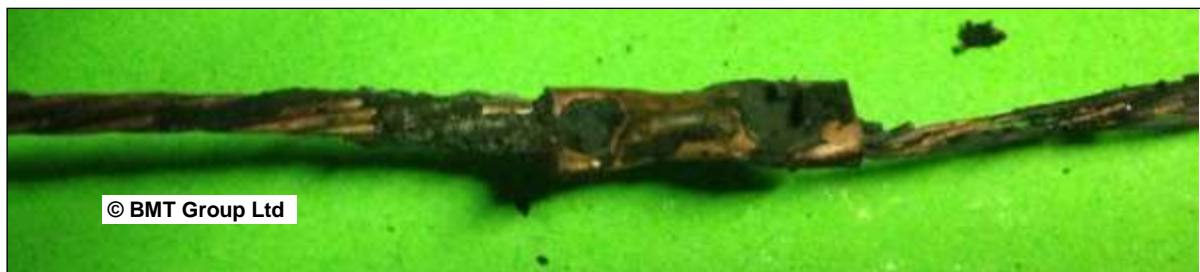
*The cable splices in the vicinity of the subsequently inserted section led from cables with a larger diameter or more conductors to cables with a smaller diameter or fewer conductors. At the time of the fire, there were various cables that consisted of three conductors, each with a diameter of 2.5 mm in the aft part of deck 3 B, while in the forward part they were continued with only two conductors, each with a diameter of 1.5 mm (see **Figure 65**).*

Figure 65: Cable splice with inconsistencies in respect of diameter and number of conductors³⁸

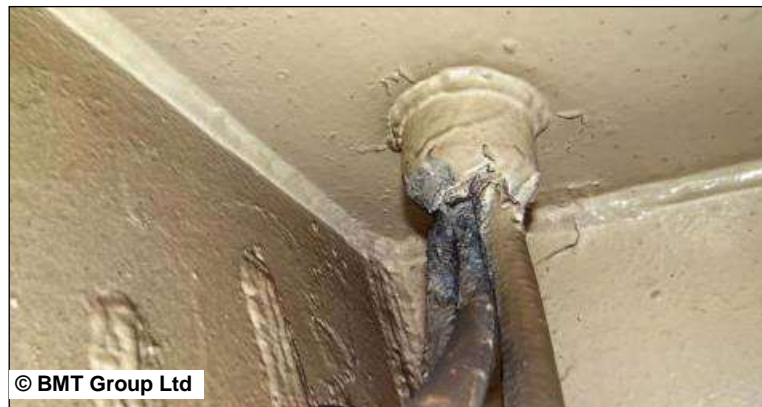
Figure 68: Example of charred cable insulation (3)⁴¹

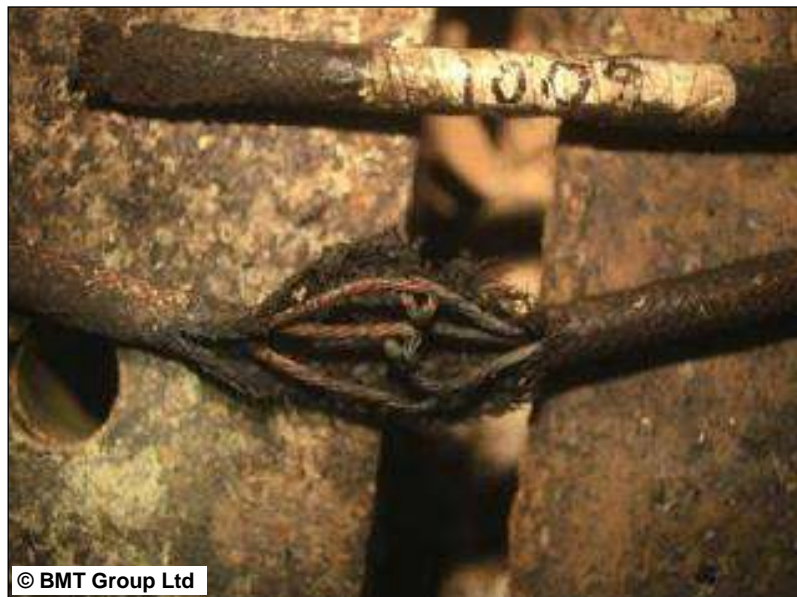
Figure 70: Example of metal conductor within the insulation⁴³

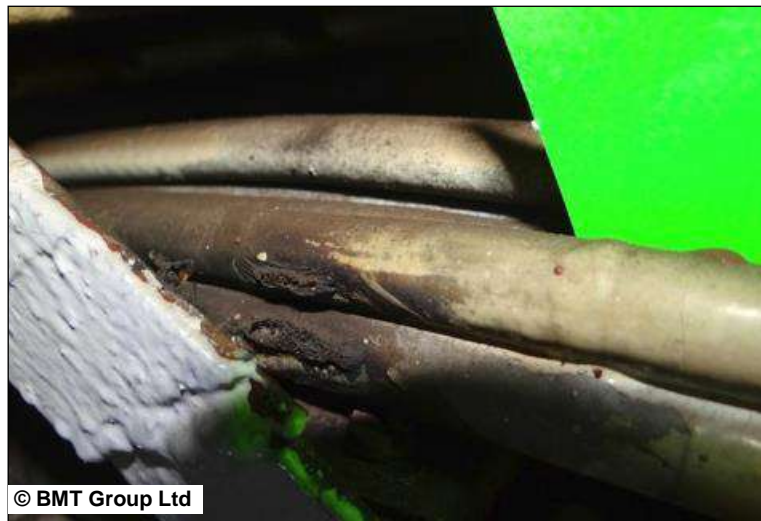
Figure 71: Example of cable insulation damaged by welding operations (1)⁴⁴

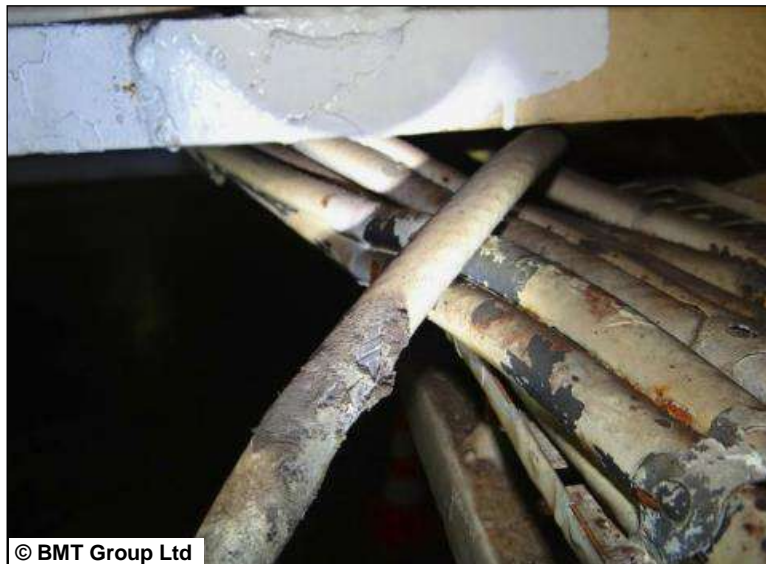
Figure 72: Example of cable insulation damaged by welding operations (2)⁴⁵

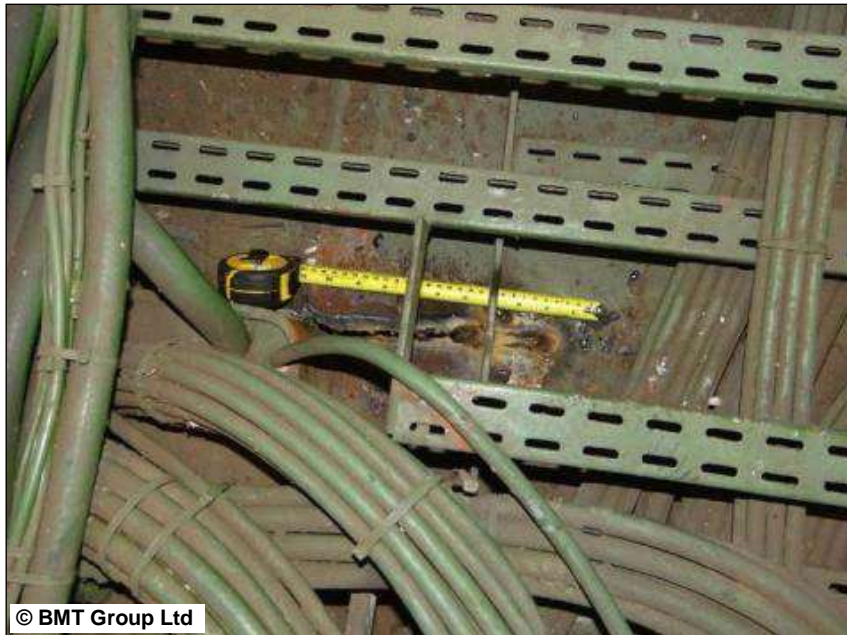
Figure 73: Example of close proximity between welding spot and wiring⁴⁶

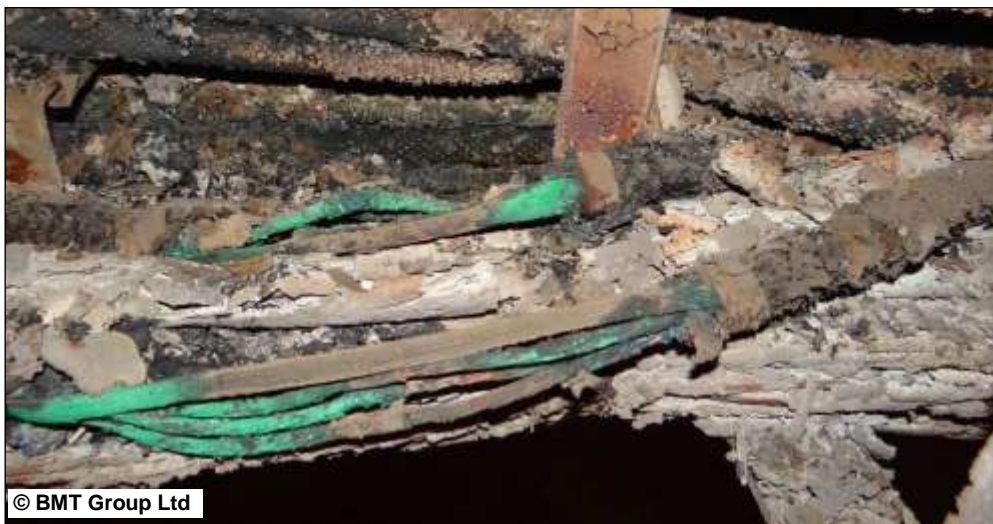
Figure 74: Example of conspicuous signs of corrosion in the wiring⁴⁷

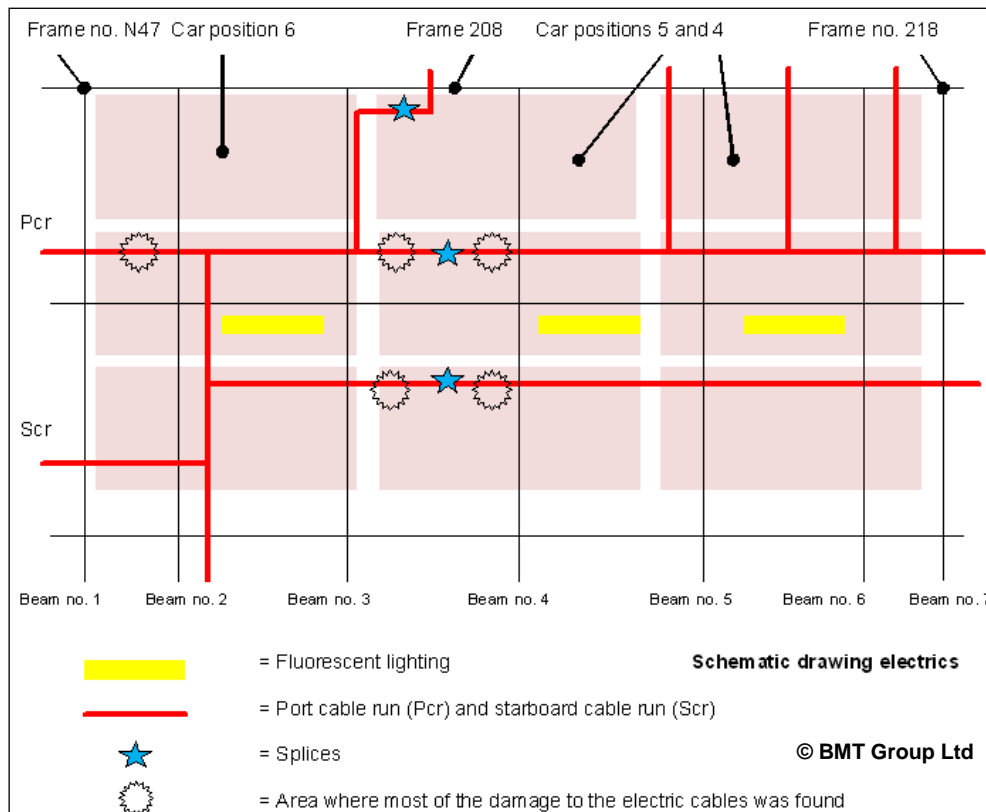
Figure 77: Schematic drawing of the defects in the wiring on deck 3 B ⁴⁸

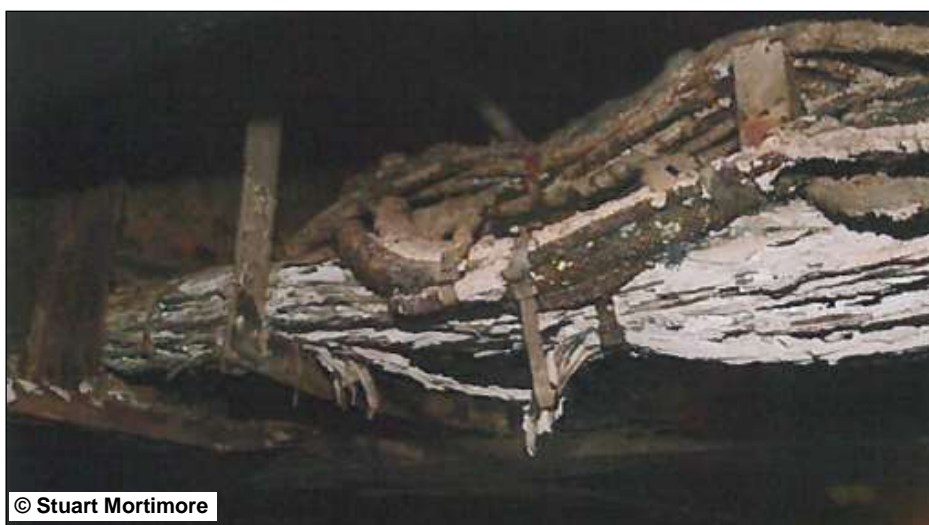
Figure 80: Cable splice above vehicle 5 B⁵³

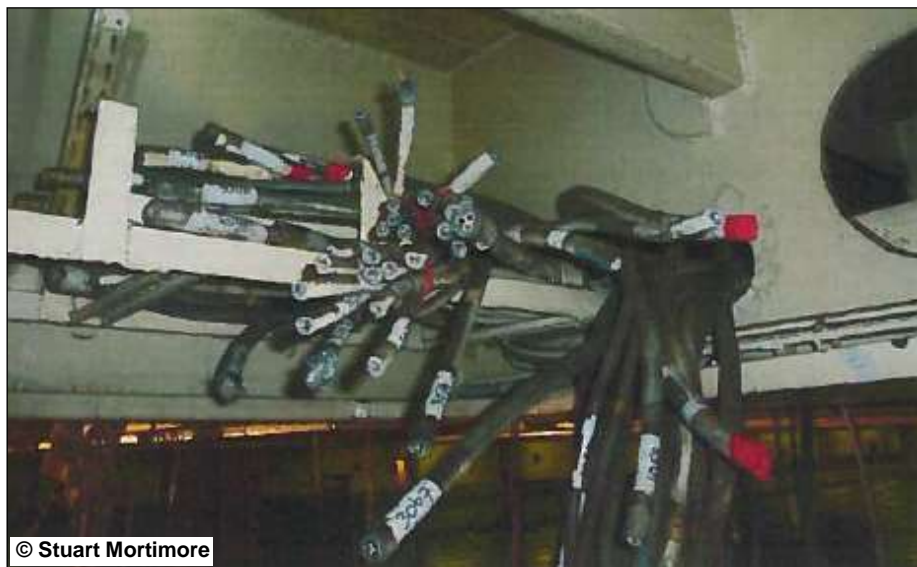
Figure 82: Cable marked for repair purposes⁵⁵

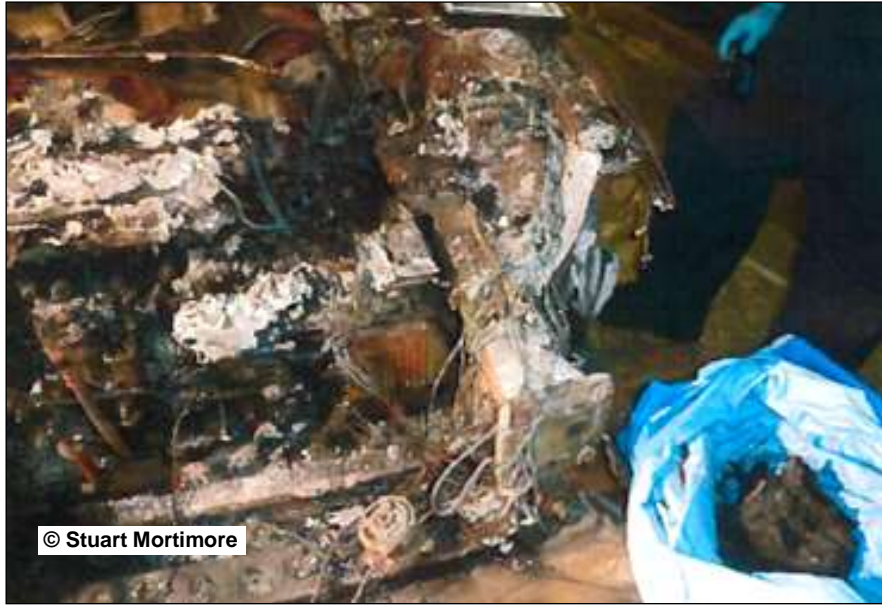
Figure 99: Burnt out engine compartment (example)⁷²

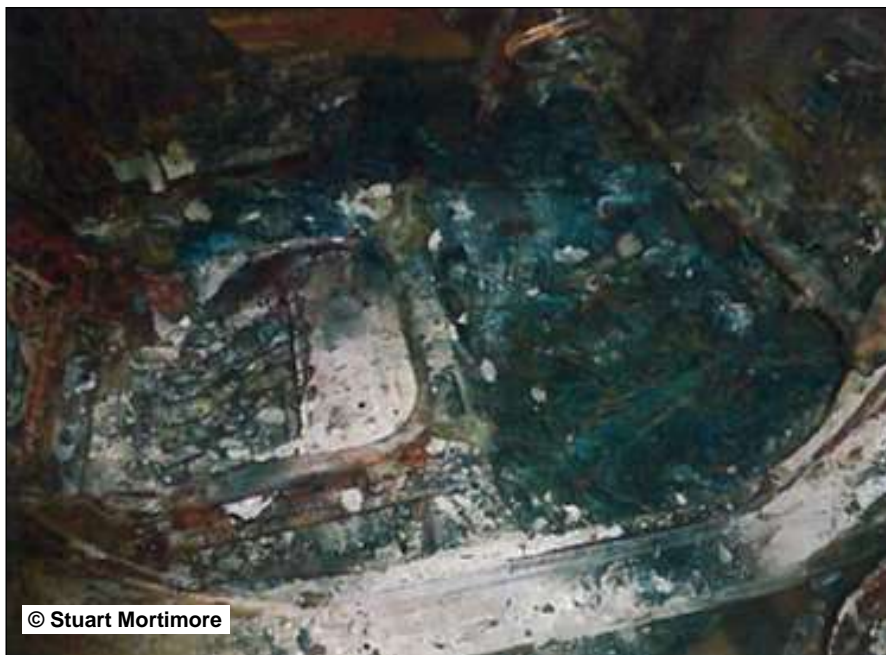
Figure 100: Burnt out passenger compartment (example)⁷³

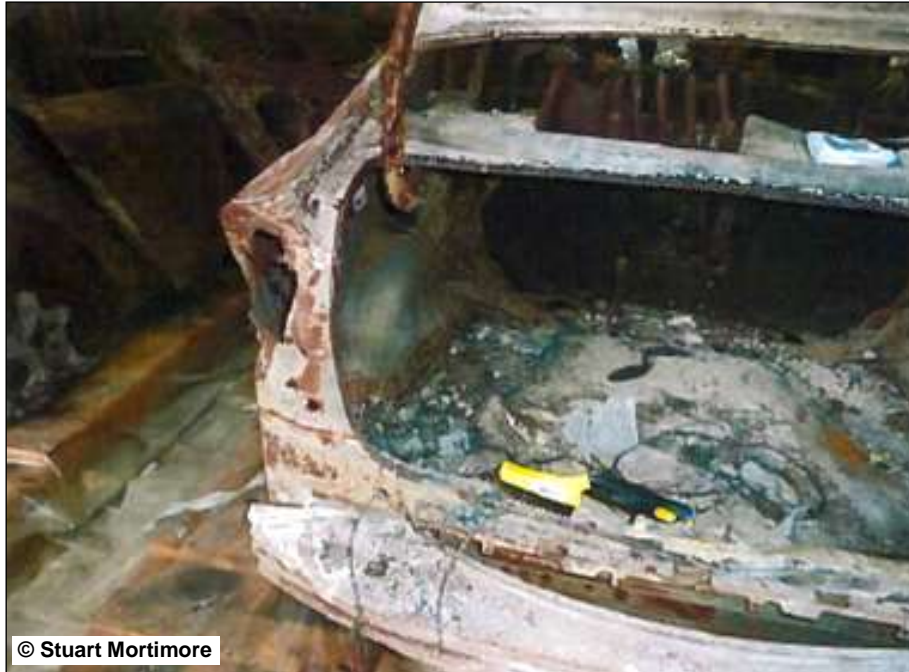
Figure 101: Burnt out boat (example)⁷⁴

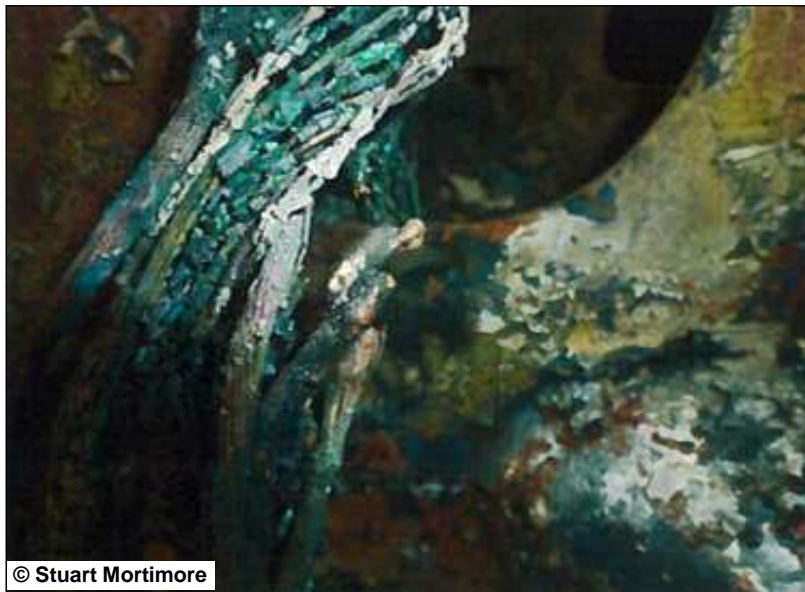
Figure 102: Example of arcing activity caused by electric current (1)⁷⁵

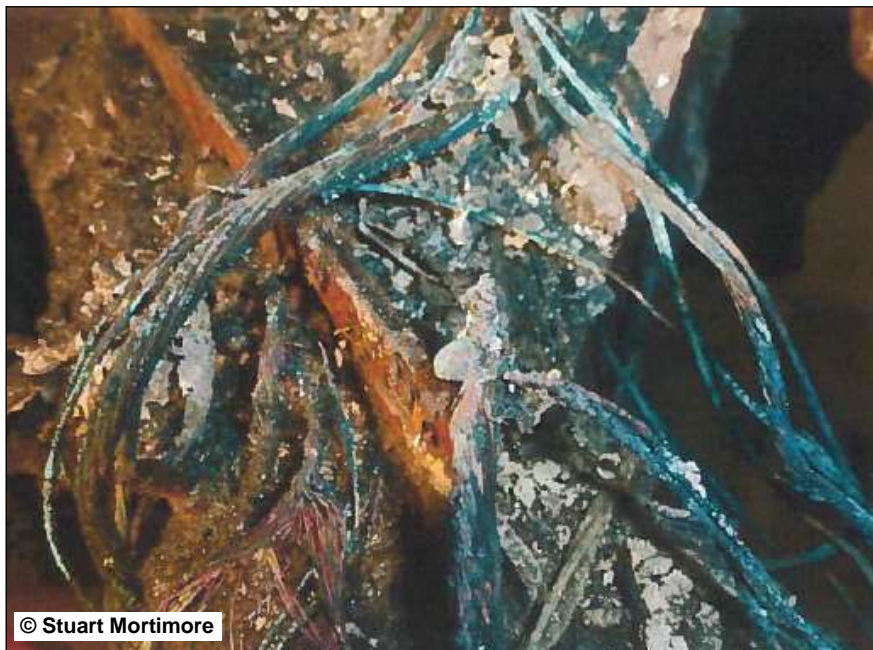
Figure 103: Example of arcing activity caused by electric current (2)⁷⁶
