Investigation Report 99/13

Serious Marine Casualty

**Fire on the con-ro carrier
ATLANTIC CARTIER on 1 May 2013 in the Port
of Hamburg**

9 October 2015

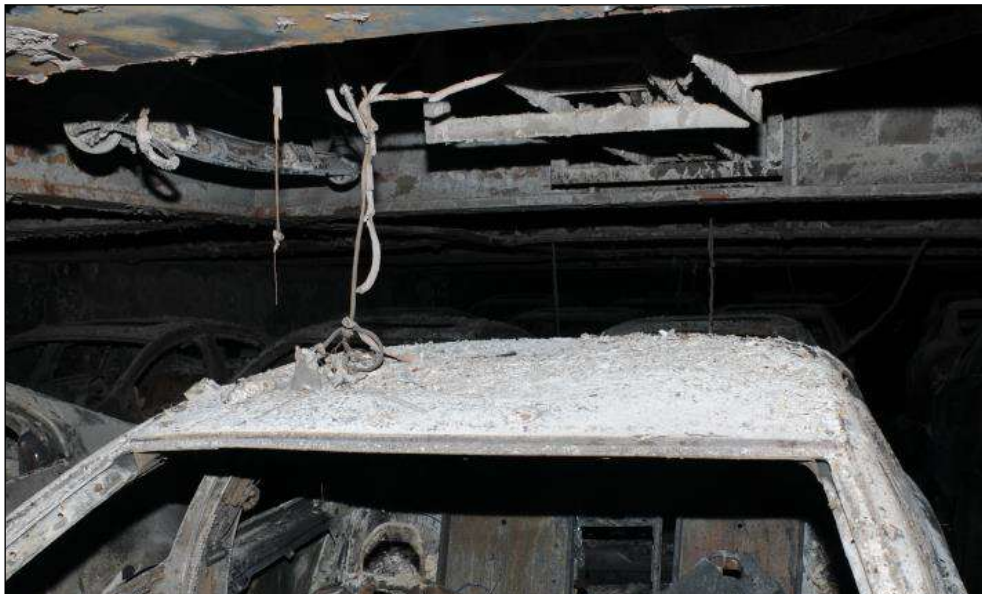
Figure 110: Incompletely burnt cable insulation above car (shielded by the roof of car 4 C)

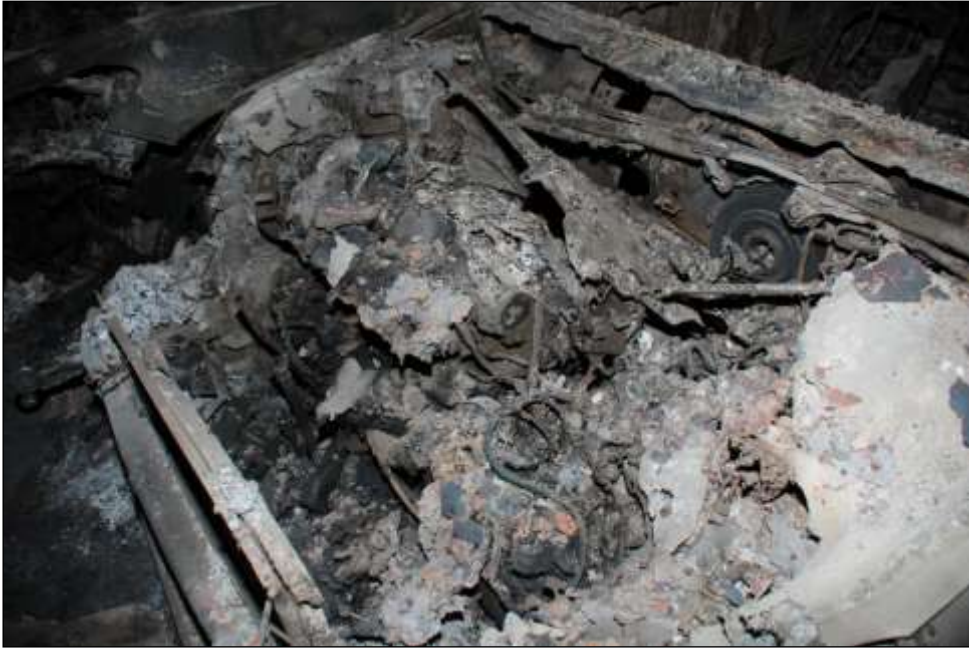
Figure 111: Car 4 B (the car destroyed by the fire most severely and thus the most likely location of the seat of fire)
