REPORT C 1993:57

**Air Traffic Accident
on 27 December 1991
at Gottröra, AB county**

Case L-124/91

The Board of Accident Investigation (SHK) has investigated an aircraft accident which occurred on 27 December 1991 at Gottröra, AB county, involving an aircraft with registration OY-KHO.

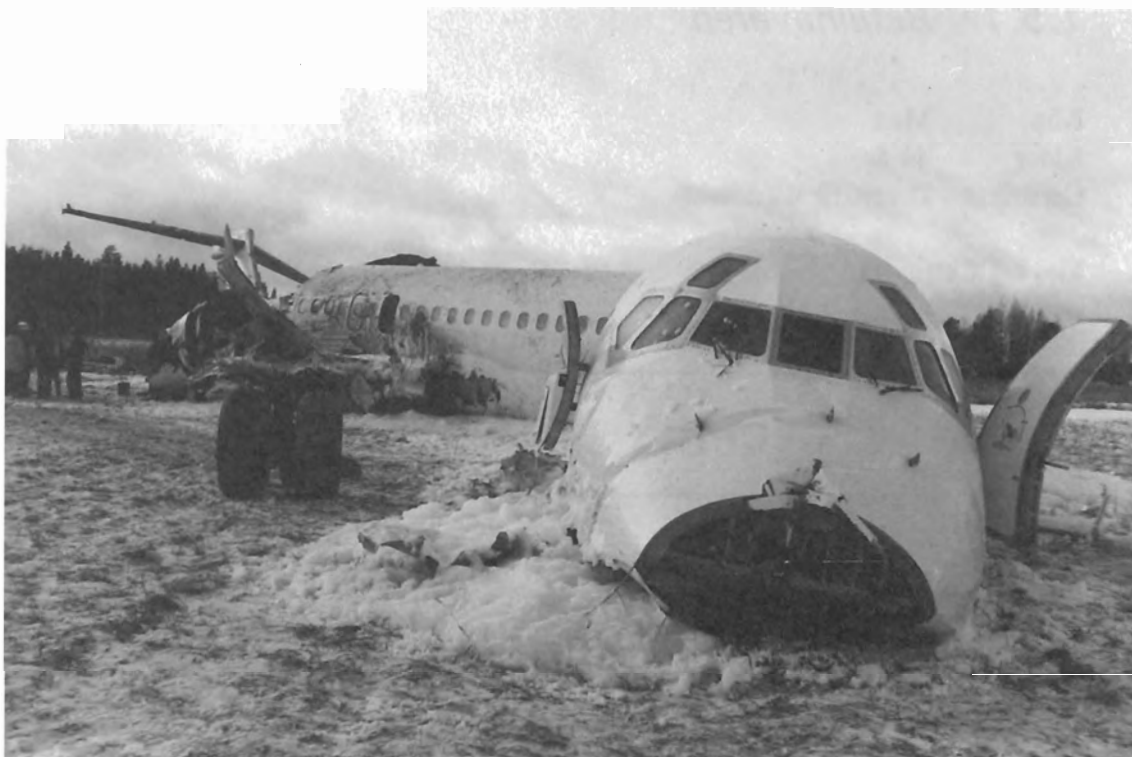
1.3 Damage to the aircraft

The aircraft was totally destroyed on impact.

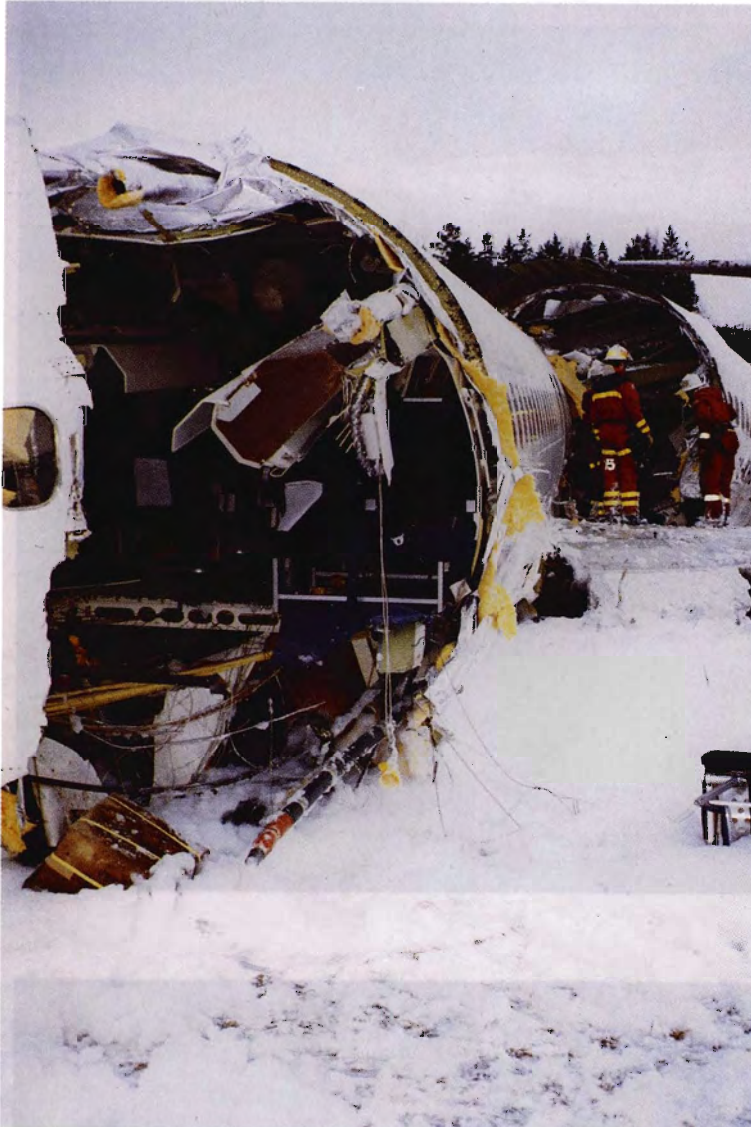
Openings in the fuselage

Both forward emergency exits were open. The entrance door slide had not inflated. The service door slide had inflated but was punctured. The slides had been detached and used as somewhere for people to lie down. Both rear emergency exits were shut. According to information from the crew it was impossible to

open them immediately after the crash. The rear service door could be opened later. Three of the four emergency exit windows were open. According to information from witnesses, the rear right exit was blocked with loose seats, cabin luggage etc.

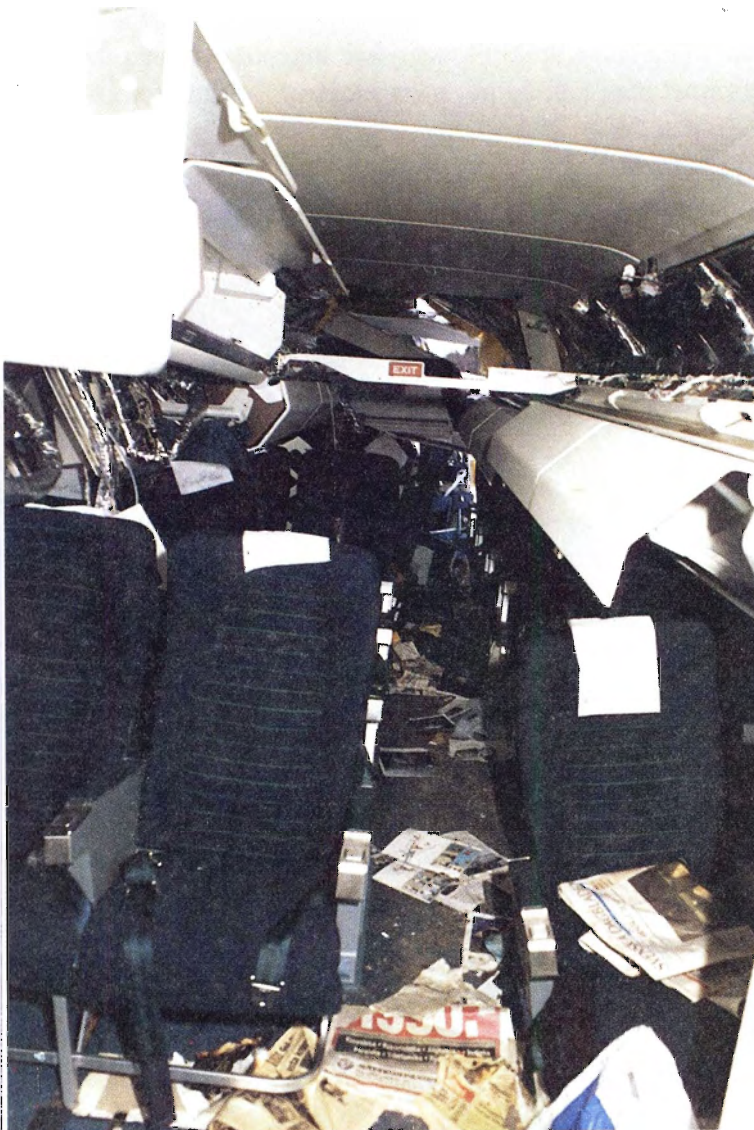
Cabine damage

In the forward portion of the passenger cabin the overhead bins and their mountings had been damaged. The two modules on the left had parted completely from their mountings and fallen down onto the backs of passenger seats. On the right side the modules had parted from their ceiling mountings but not from the wall mountings. The modules from row 3 and rearwards were resting on seat backs. A number of bin lid locks had broken and the lids had come open. The cabin divider – which was between rows 3 and 4 – had fallen down together with the bins. In the middle portion of the wreck the damage was limited to the break areas. At the forward break the forward part of the left bin had fallen. At the rear break the bins on both sides had fallen. A number of bin lid locks had broken. According to available information, the bins were not excessively loaded with baggage.

In all three parts of the wreck most of the PSUs had loosened from the bin structures and were hanging either by their outer hinges or by wiring. Many of the oxygen masks had been released from the PSUs and some had also been activated. Some of the cabin crew oxygen masks had also been released.

In the forward galley area the walls of galley 3 had been deformed in two places and one floor mounting had ruptured. The ceiling at galley 1 had been pressed downwards. The ceiling panel between galleys 2 and 3 had fallen in. The exit sign at galley 3 was missing. The door to the flight deck had broken off.

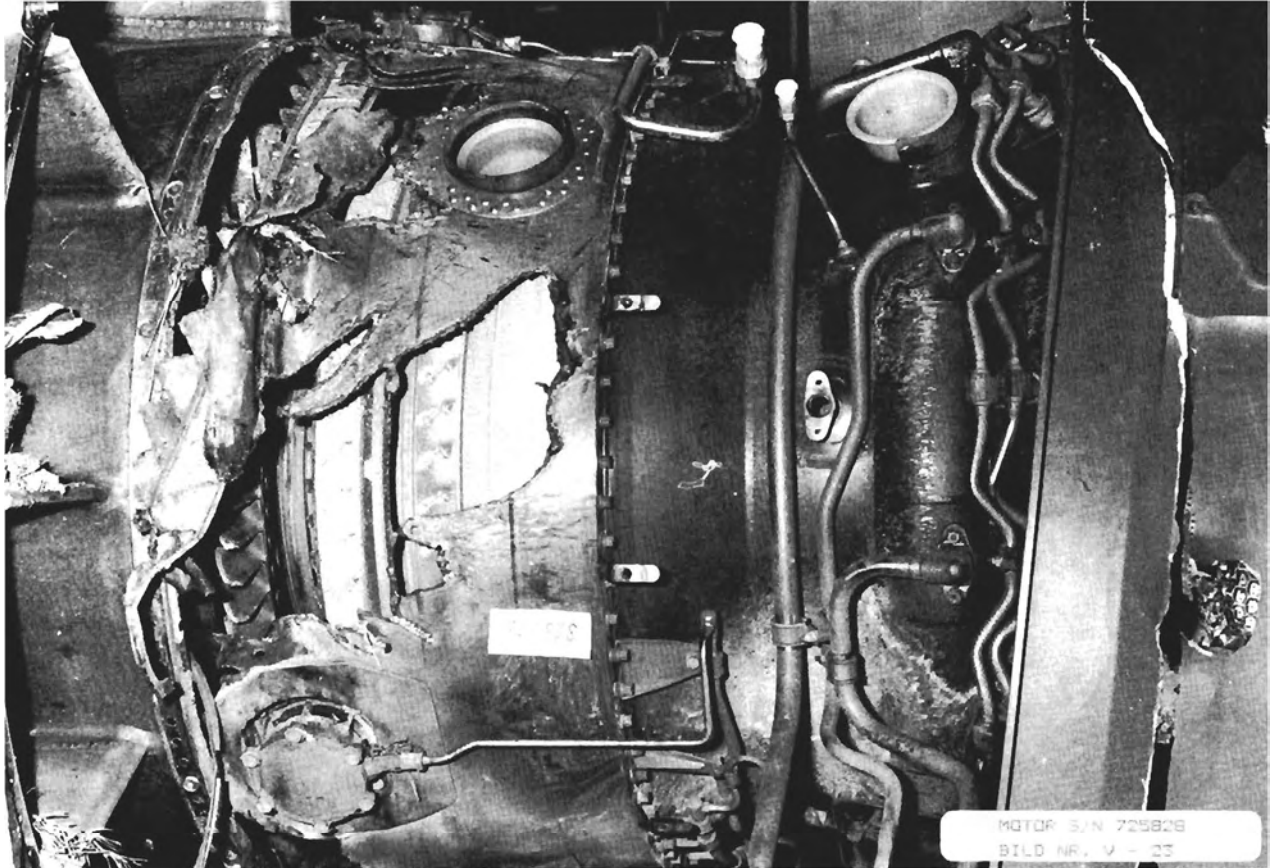
Compressor cage damage

The stg 7 stator had ruptured and left its original position between rotor stgs 7 and 8. Parts of its outer shroud with suspended vanes stuck out through the rear compressor case between the 9-o'clock and 1-o'clock positions. The inner shroud

with its seal had ruptured and projected from a hole in the rear compressor fan duct between the 4-o'clock and 7-o'clock positions. Of a total of 52 guide vanes in stg 7, 12 had left the engine.

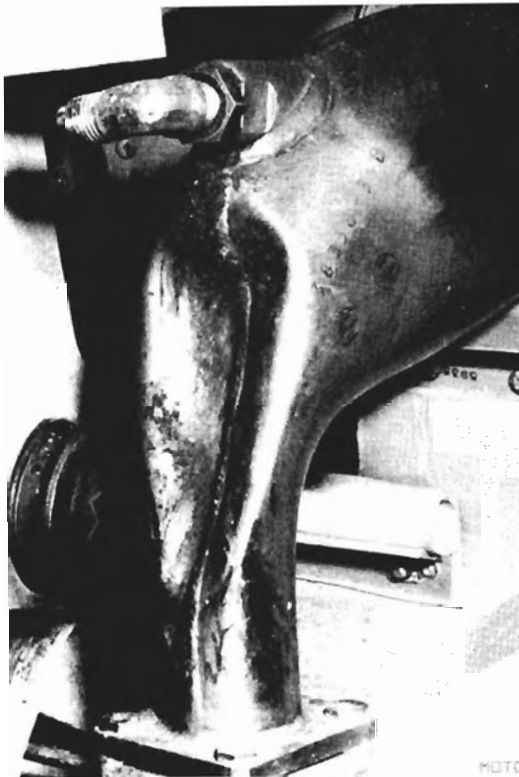
Damaged fuel duct

Fuel duct P/N 9938338-6 between the fire bulkhead towards the fuselage and the engine fuel regulator at compressor stg 7 had impact damage on the side facing the engine. On the opposite side of the fuel pipe approx 42 mm from its upper flange there was an approx. 22-mm-long fissure in a welded seam, with a maximum gap width of approx. 1.2 mm. In tests, the measured flow through the fissure was approx. 5 litres per min at a fuel pressure of 1 psig and approx 13 litres per minute at 15 psig.

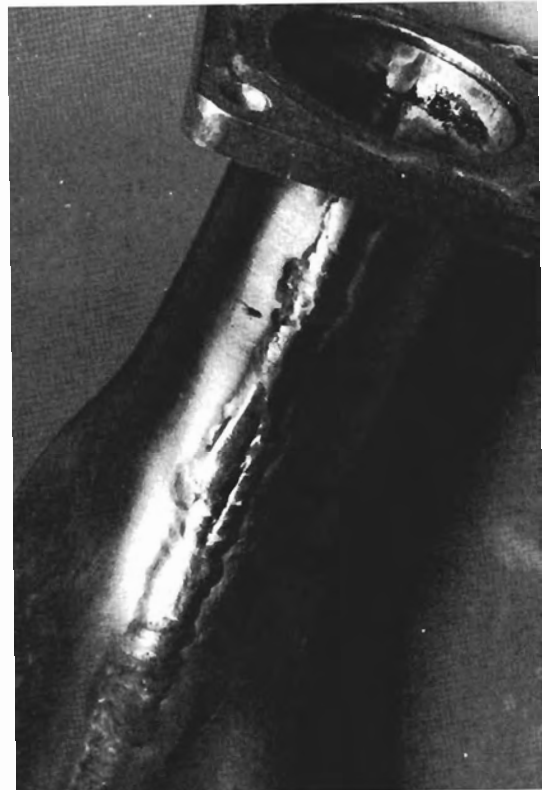
Fissure in welded seam

Metallurgical examination of the pipe revealed that there were manufacturing defects in the weld seam in the area where the fissure had occurred. The weld fissure is judged to have arisen in connection with the opposite side of the fuel pipe being subjected to the impact that caused the damage on that side. The impact created tensions in the defective weld joint which caused it to crack.

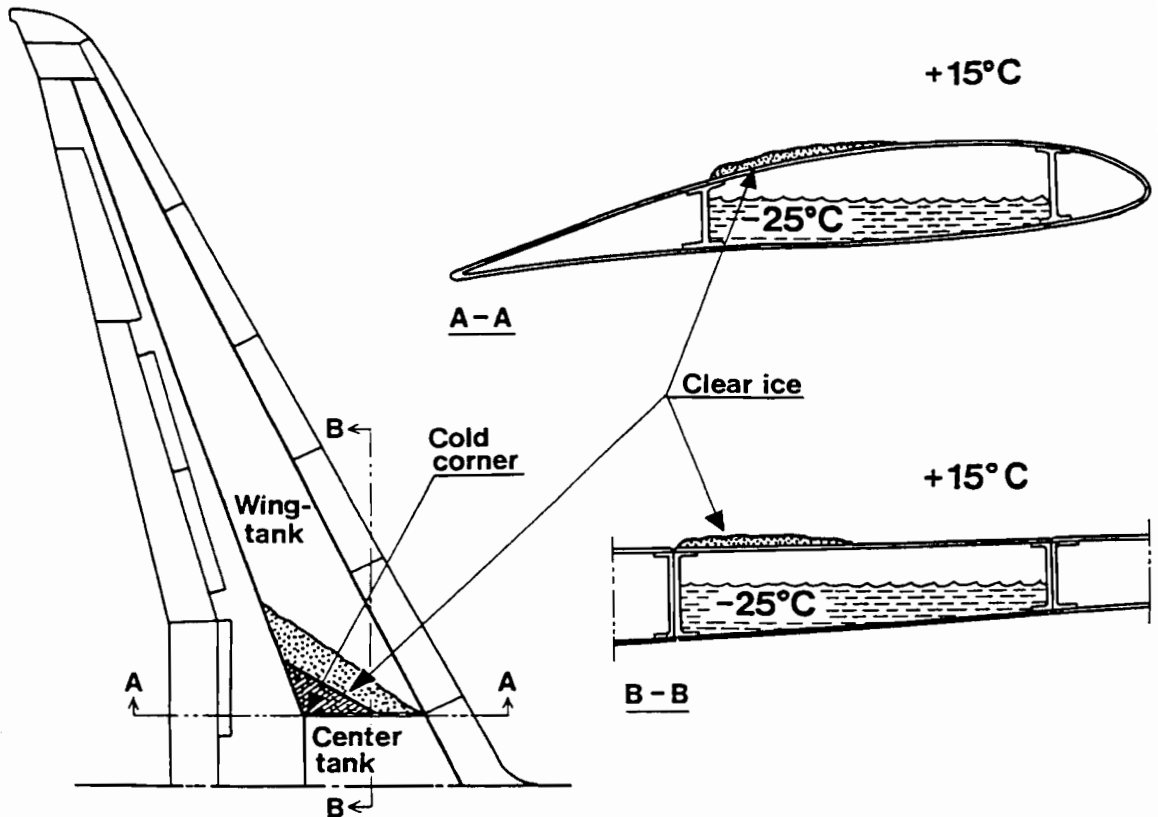
Clear ice

series the volume of the centre tank was increased by partly extending it into the enlarged wings. The innermost part of the neighbouring wing tanks, which contain the unused, often greatly chilled, remaining fuel, then came almost exactly in front of the engine air intakes.

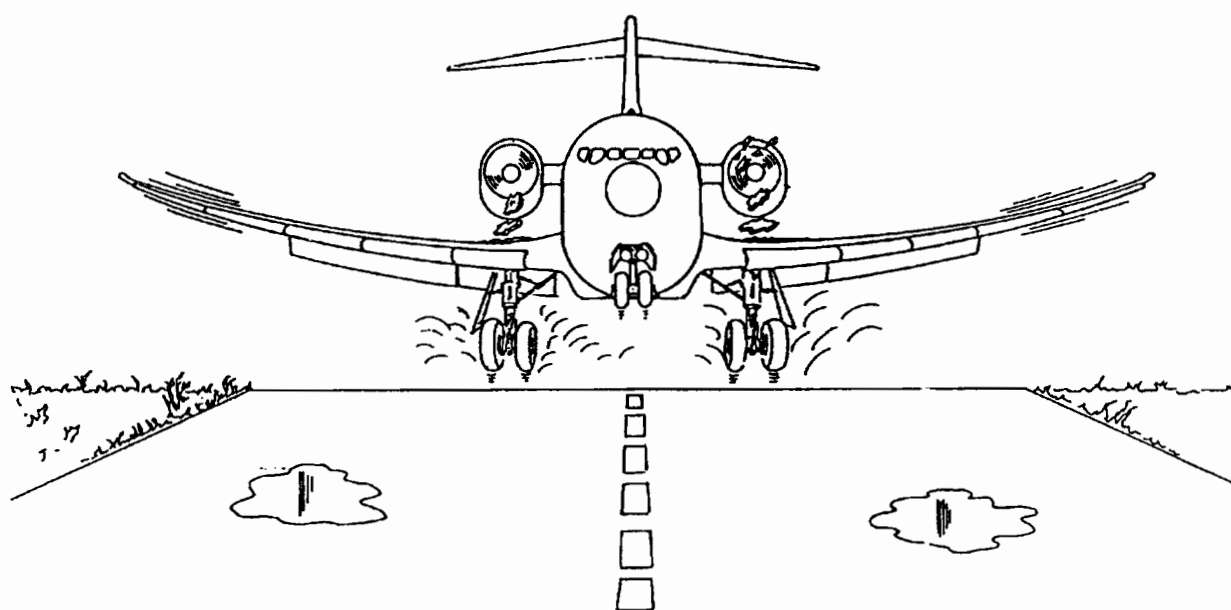
“CLEAR-ICE”.

**WHEN THE AIRCRAFT ROTATES, THE
ICE WILL BREAK LOOSE DUE TO THE
NATURAL FLEXING OF THE WINGS,
AND WILL BE SUCKED INTO THE
ENGINES AT THE MOST CRITICAL
PHASE OF THE FLIGHT!**
