AIRCRAFT ACCIDENT REPORT

N98610 (USA-REG)

CESSNA 340A

HISINGEN, GOTHENBURG

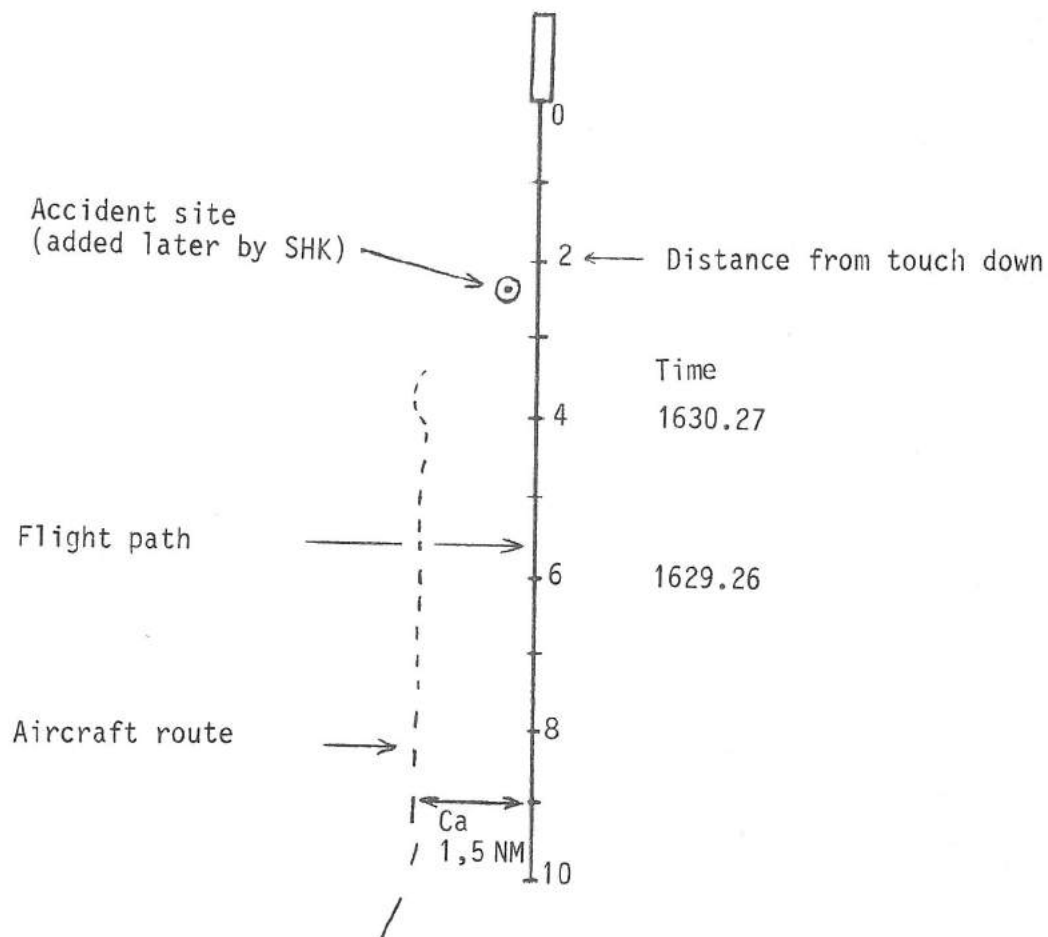
At 1631.16 the flight controller announced "November six one zero you are still well left of track. Turn right heading zero four zero". A sketch of the aircraft's flight path is shown in Fig 1.

Fig 1. Flight path of N98610 drawn from memory by radar flight controller.

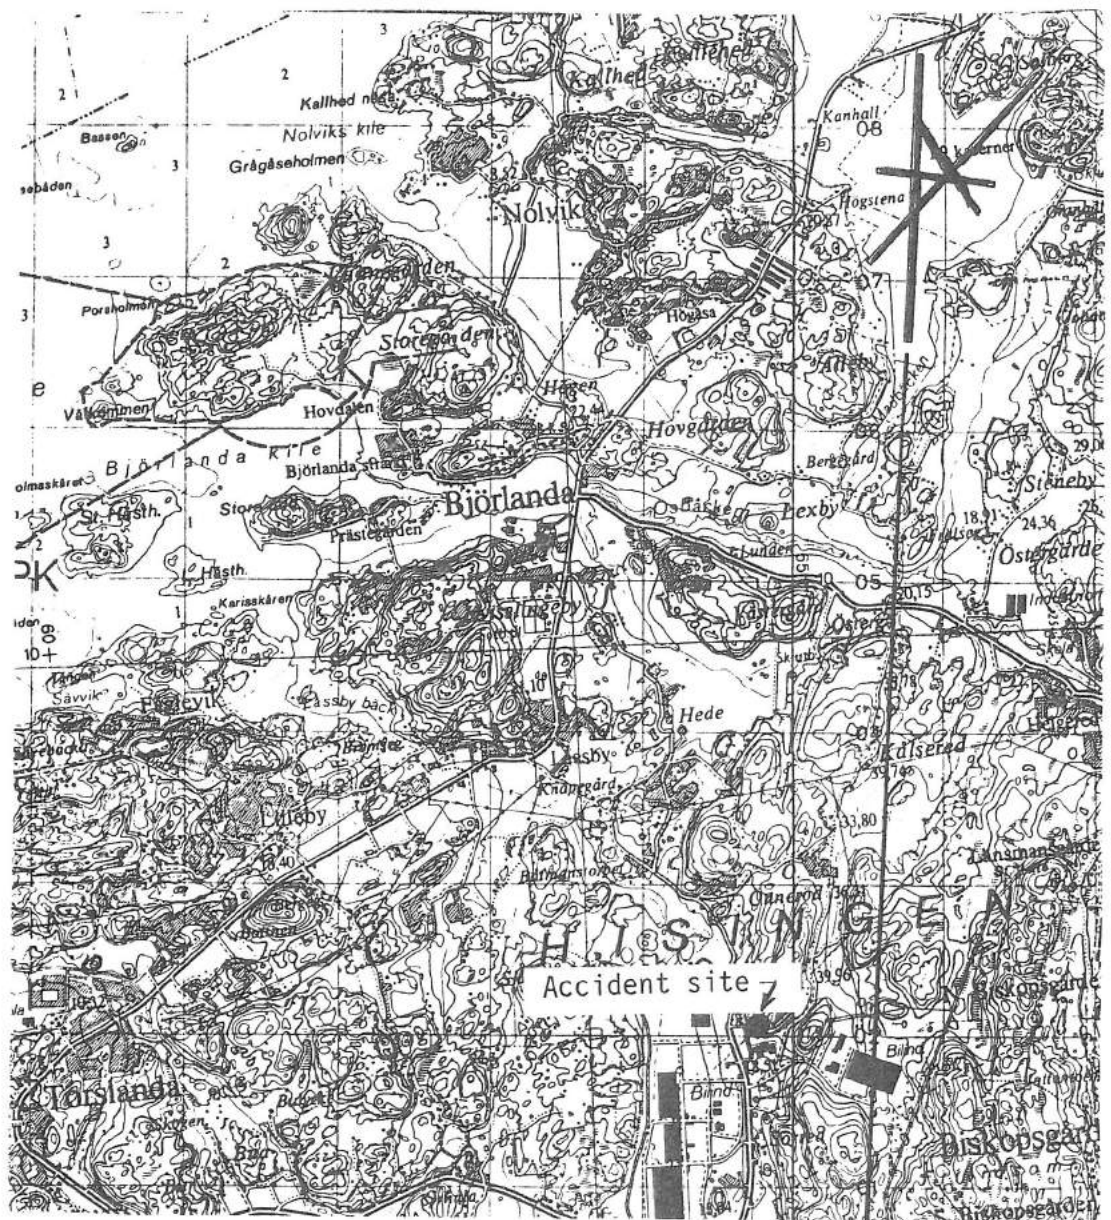
At 1726 the aircraft was found crashed in rolling terrain close to the Volvo head office, see Fig 2. Doctors established that the pilot and one passenger were dead. Two seriously injured persons were immediately taken to the hospital. The impact site is located approximately 800 m to the west of the approach path to runway 01, Säve, and approximately 4,6 km from the runway end.

Fig 2. Accident site $57^{\circ} 43,6' N$ $11^{\circ} 51,1 E$.

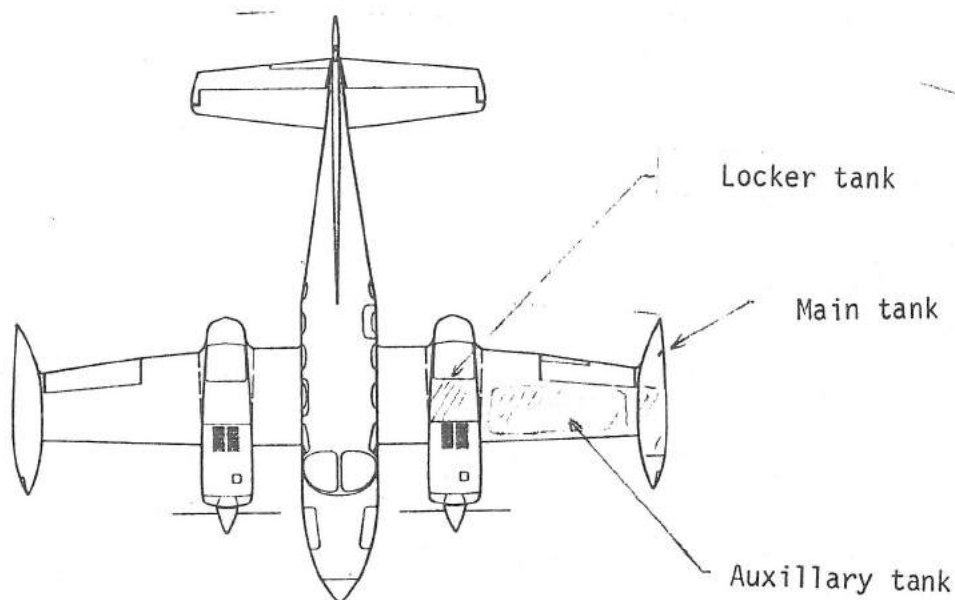
The aircraft had a maximum tank volume for this type, see Fig 3, which means that it had two main tanks (wing tip tanks) each holding 51 gallons, whereof 50 are said to be usable, two auxillary tanks in each wing outside the nacelles, each pair holding 32 gallons, whereof 31,5 are said to be usable and in the nacelles

Fig 3. The aircraft fuel tanks.

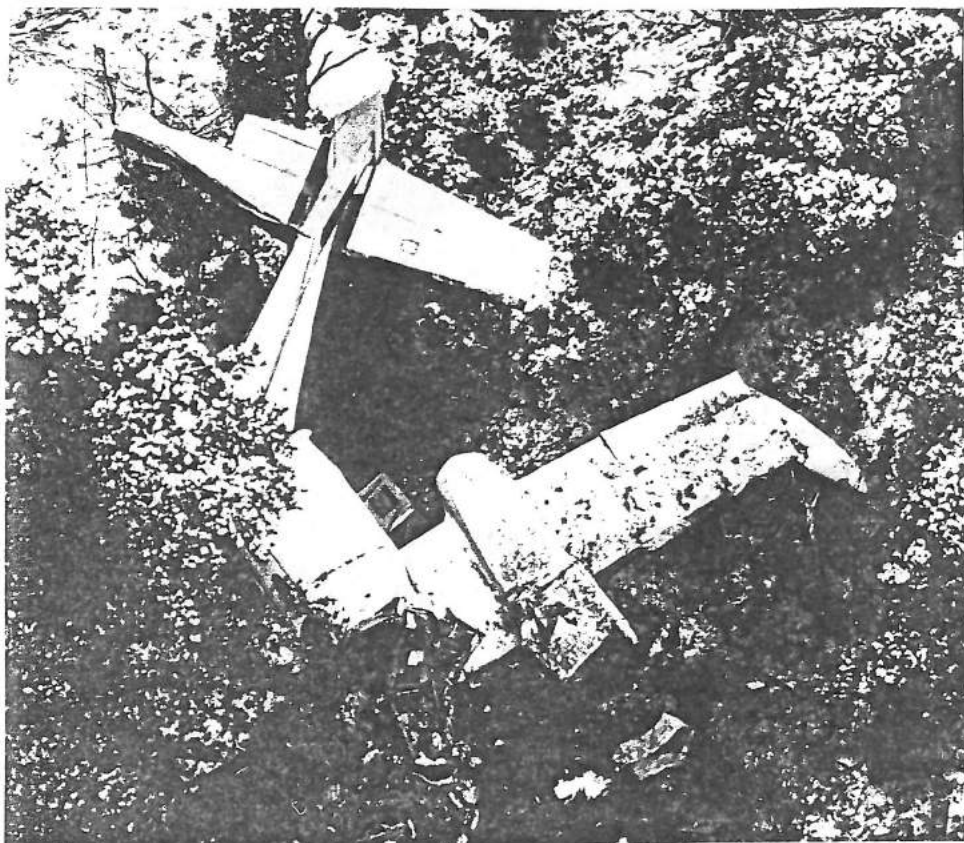
The aircraft crashed on a forest covered rocky hillside ca 30 m (approximately 100 ft) above sea level. The flight direction into the forest was approximately 45° . Marks on trees indicate a shallow flight path and show that the aircraft must have had a bank angle of approximately 90° to the right when it flew into the trees. At the collision with the ground the aircraft had rolled another $30-40^{\circ}$ to the right. It flipped over and came to rest on its belly with the tail in the flight direction, see Fig 8.

Fig 8. Aircraft wreckage.

The aircraft fuselage was crushed from the nose to the wing leading edge. The fuselage was broken immediately behind the rear cabin bulkhead, see Fig 8.

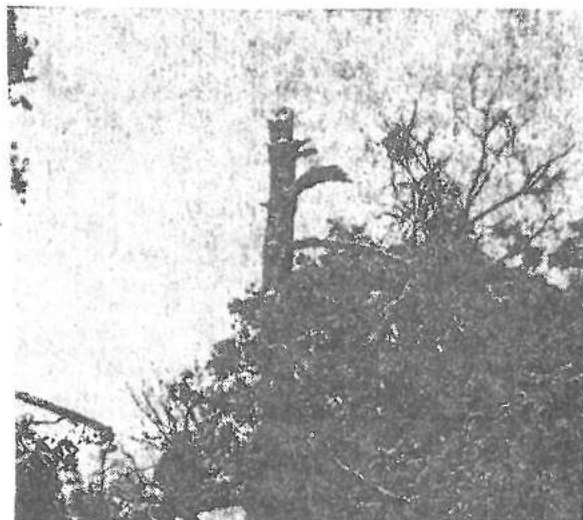
On its way through the trees the left propeller cut off a pine tree approximately 25 cm thick, see Fig 9. There were no signs of the right propeller cutting trees or thick branches.

Fig 9. Cut-off pine tree.

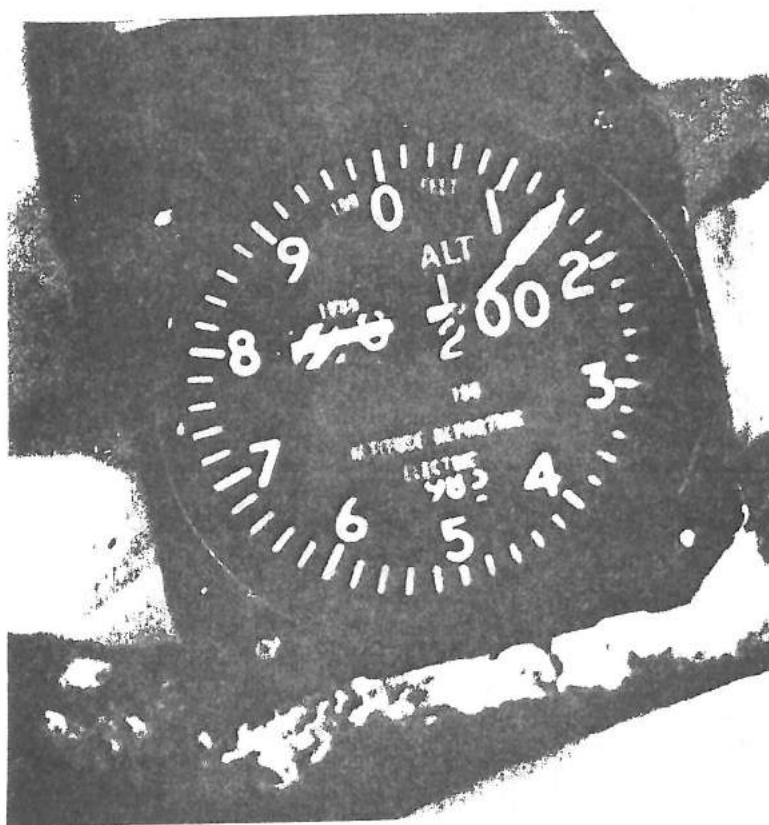
The aircraft altimeter was set at 983 mb, see Fig 10.

Fig 10. Altimeter. The altitude of the impact site corresponds roughly to the position of the needles.

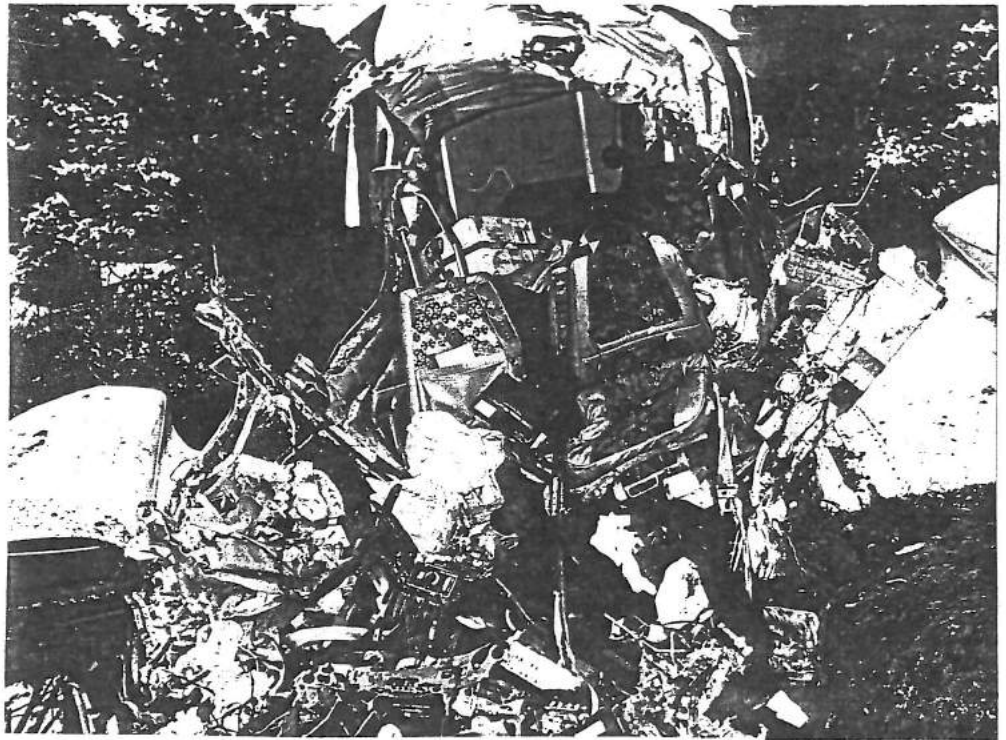
The pilot and the passenger in the right front seat died at impact. As shown in Fig 11 the aircraft was crushed in this area.

Fig 11. Damages to the aircraft fuselage.

There was no possibilities for survival in the front seats.

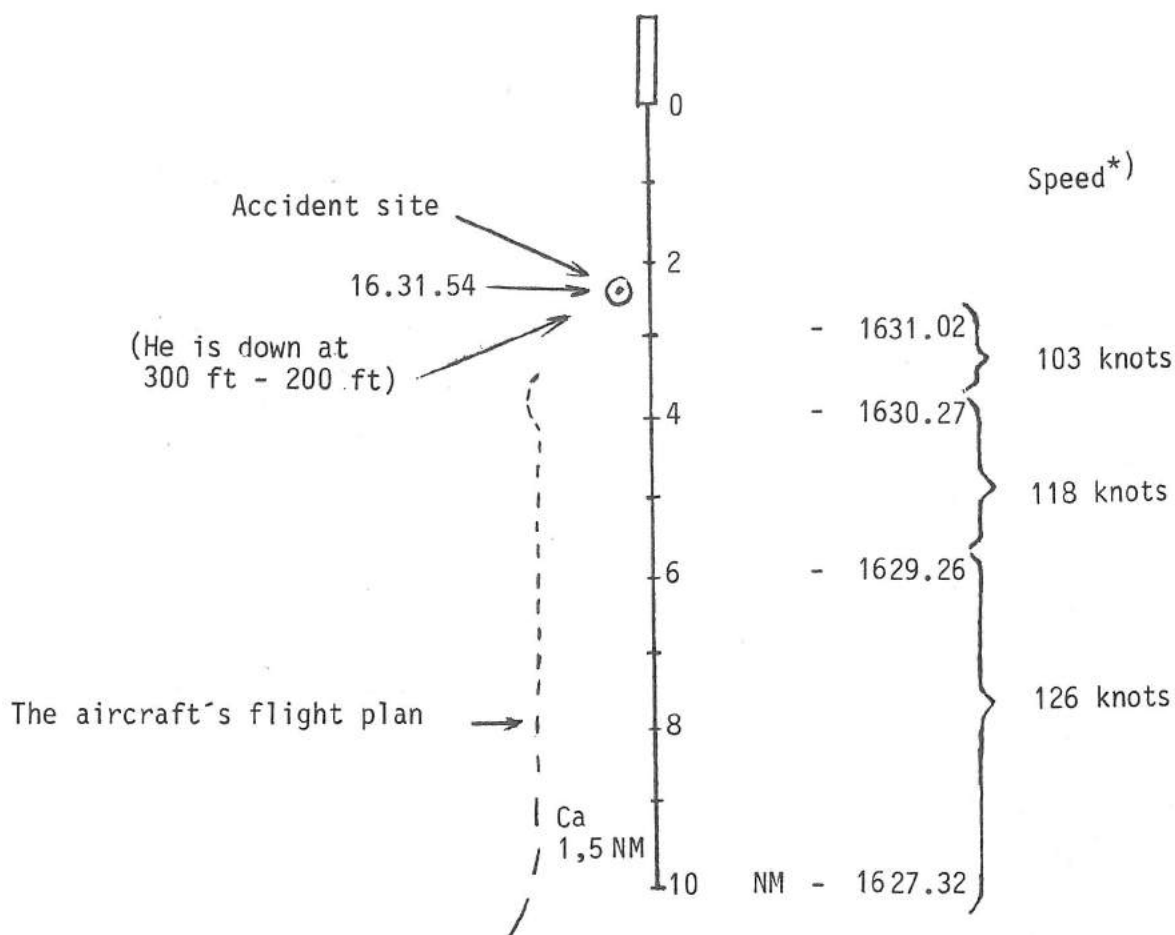
Fig 12. Estimated speeds according to transcript.

However, they show that the speed during the last 3-4 min before the accident has been low, which agrees with the witness observations. It has, however, probably been considerably higher than V_{MC_A} (= 82 knots). It is also evident that the speed was low 2-3 minutes before it was noticed that the aircraft altitude had decreased to 300 ft.
