Final report *SHK 2023:03e*

Accident at Örebro Airport, Örebro County, on 8 July 2021 involving the aeroplane SE-KKD of the model DHC-2 Mk III, privately operated in connection with parachute operations

File no. L-47/21

2023-01-30

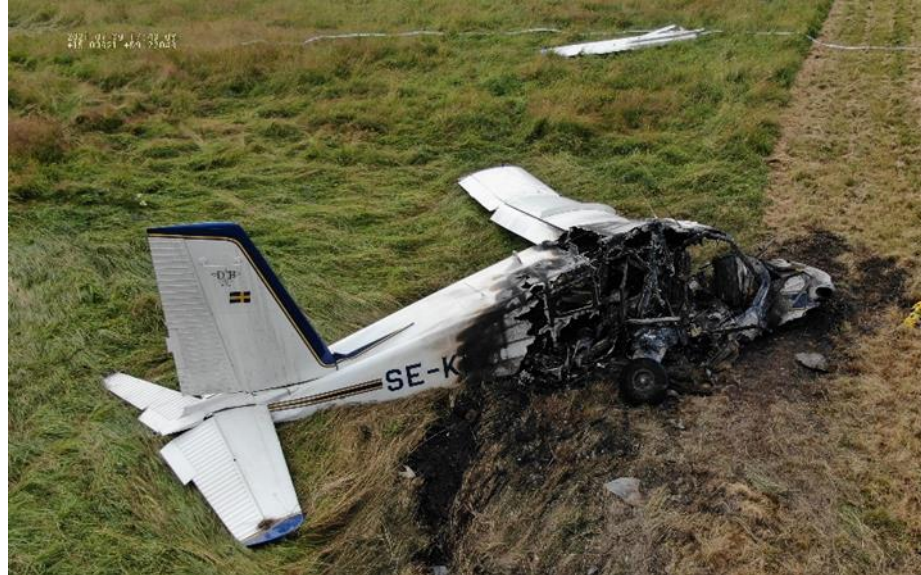
At impact, parts of the aircraft separated, such as the propeller, right wing and left main landing gear along the 48 metres that the aircraft skidded.

Figure 24. The aircraft at the accident site.

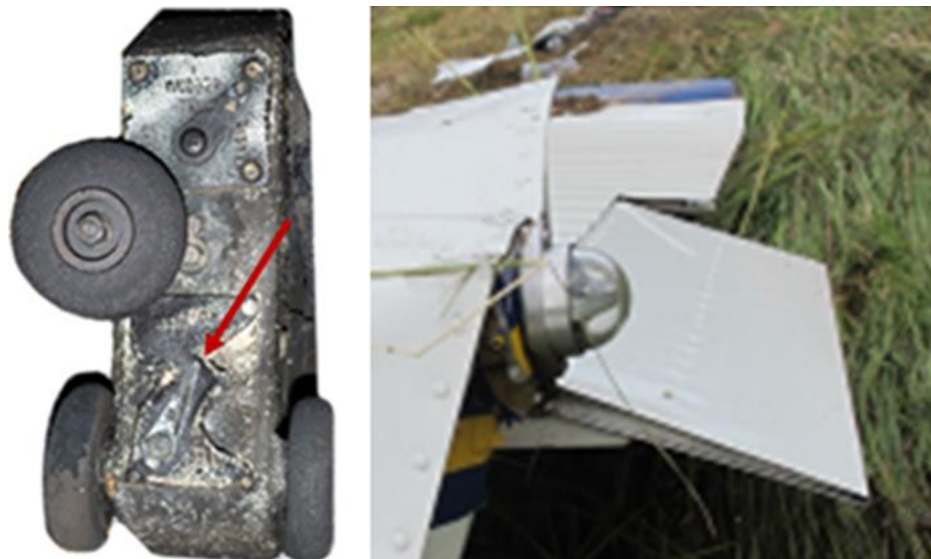
The trim panel and elevator trim tab were found in a position as seen in Figure 25 below.

Figure 25. The left picture shows the trim panel where the arrow points to the set position of the elevator trim. The right picture shows the corresponding position on the right elevator trim tab.

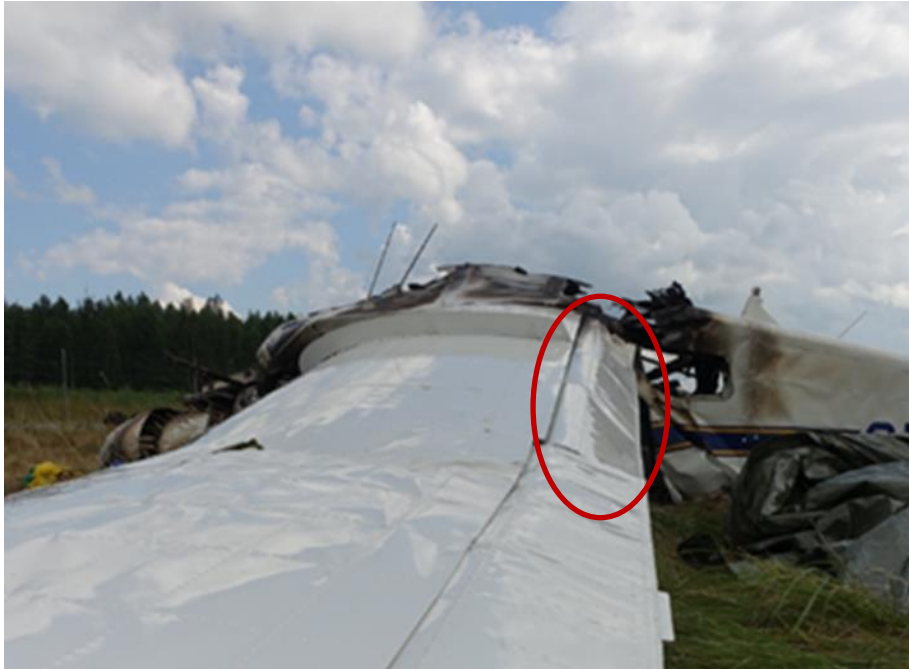
During the investigation of the accident site, the wing flap were found to be in the extended position.

Figure 26. The left-wing flap marked with a red circle.

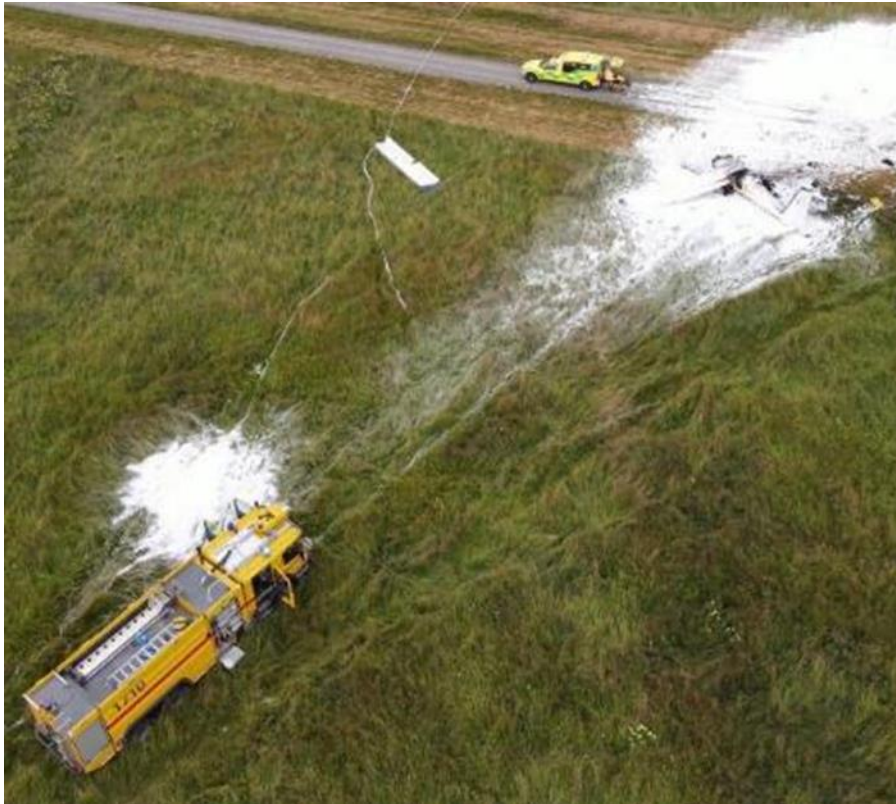
Figure 28. The situation after the operation had ended. The white is the extinguishing foam. Image: Police Authority.

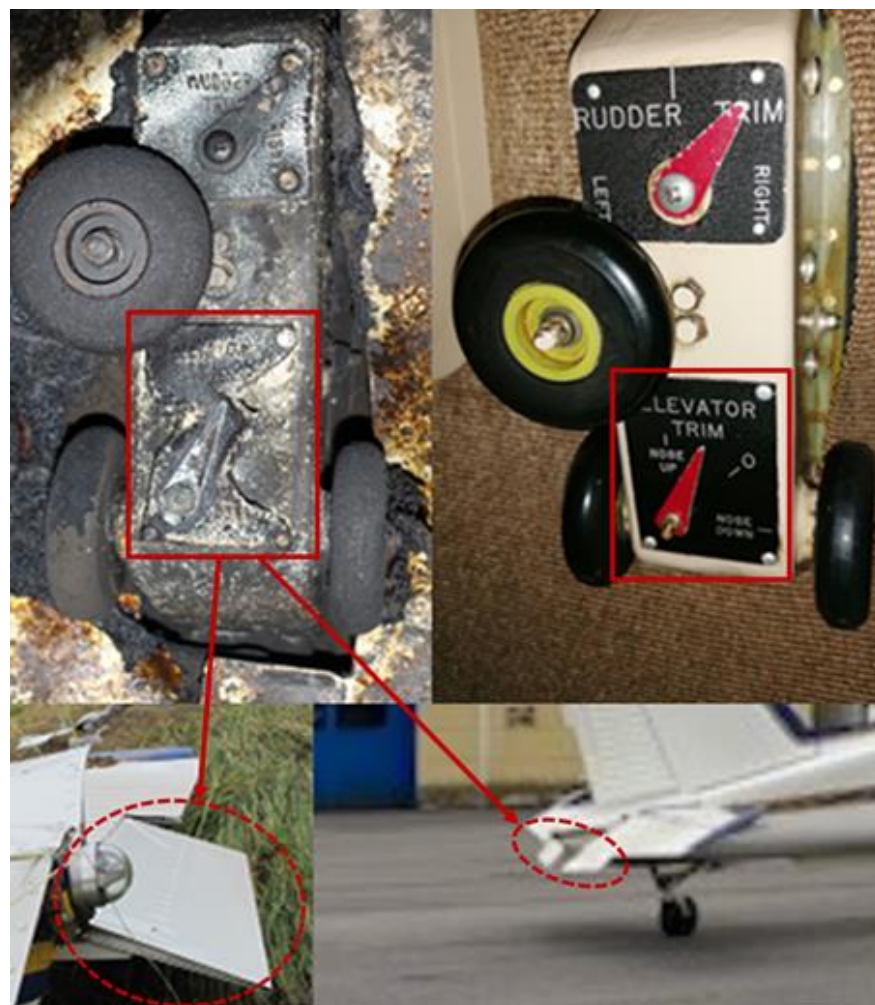
Figure 30. The pictures present the elevator trim indication and trim tab position before and after the accident. Lower right image: Private person.

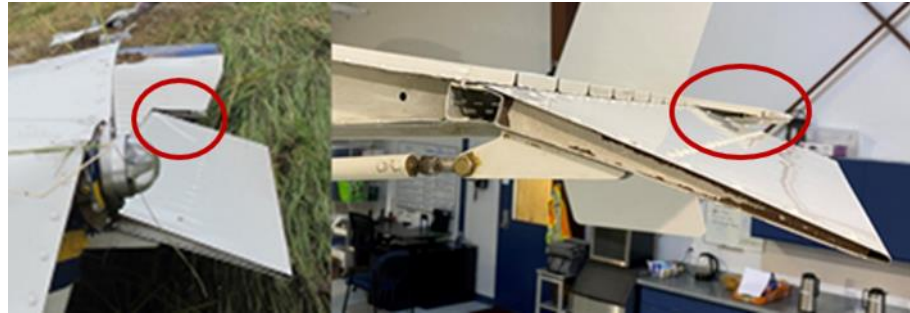
Figure 33. The left part of the picture shows the position of the elevator trim tab after the accident. The right part shows the elevator trim tab position at 16.5 degrees nose up according to the type certificate holder.

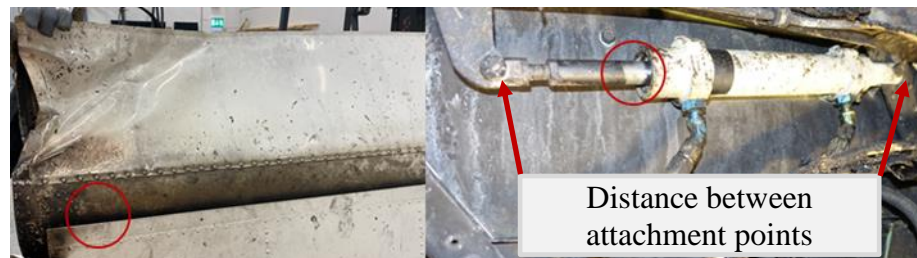
Figure 34. The left picture shows soot trails around the wing and wing flap. The right picture shows the operating cylinder and attachment points. Soot edge circled in red.

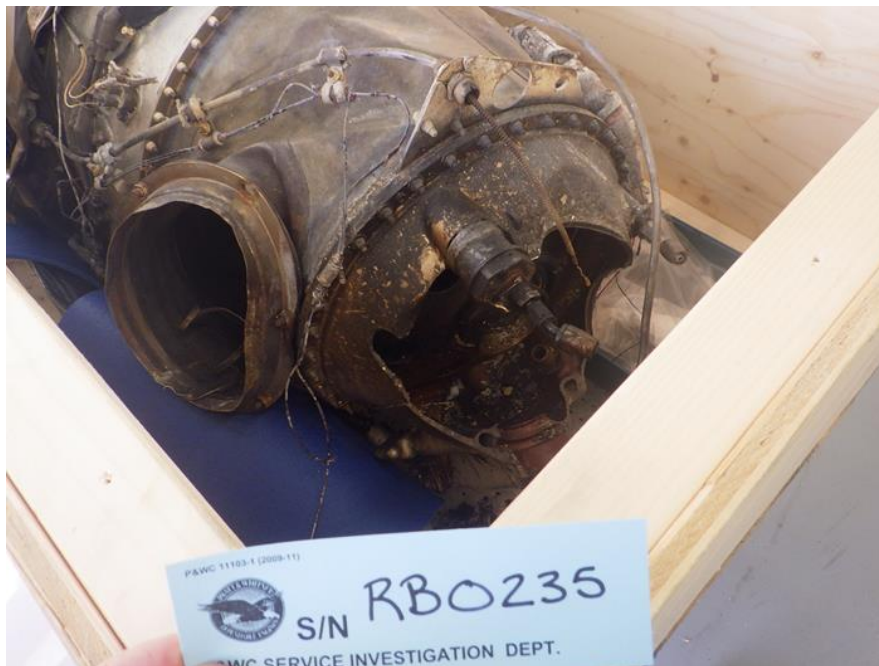
An initial external examination of the engine revealed that the front reduction gearbox had cracked and the exhaust section was damaged. The engine controls and the reversing linkage were damaged. The engine had been exposed to fire in the area around the auxiliary gearbox. Due to these damages, the engine could not be tested in a test bench.

Figure 35. The front gearbox housing was cracked, exposing the internal components. Photo: Pratt & Whitney Canada Corp.

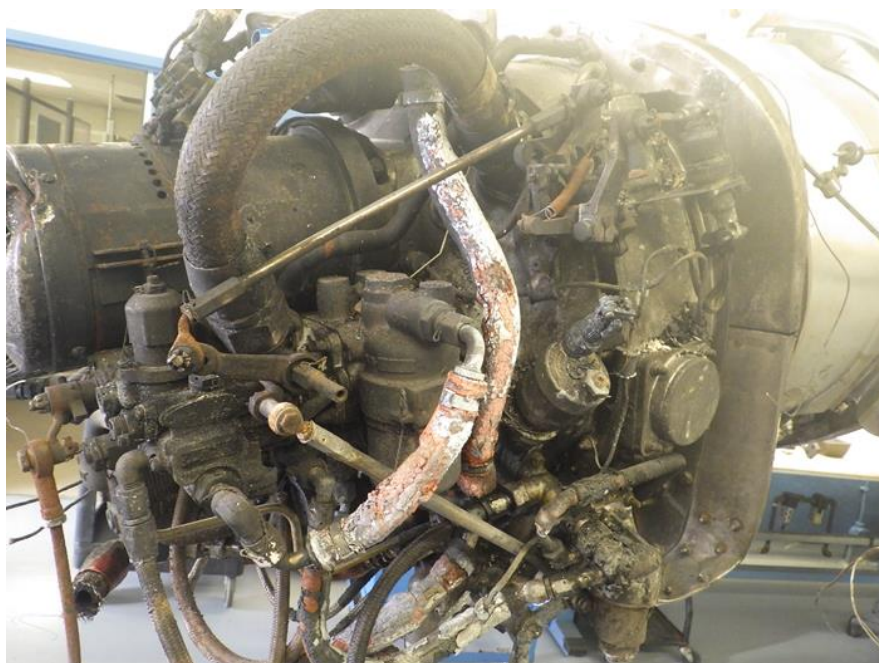
Figure 36. The auxiliary gearbox had been exposed to fire. Photo: Pratt & Whitney Canada Corp.

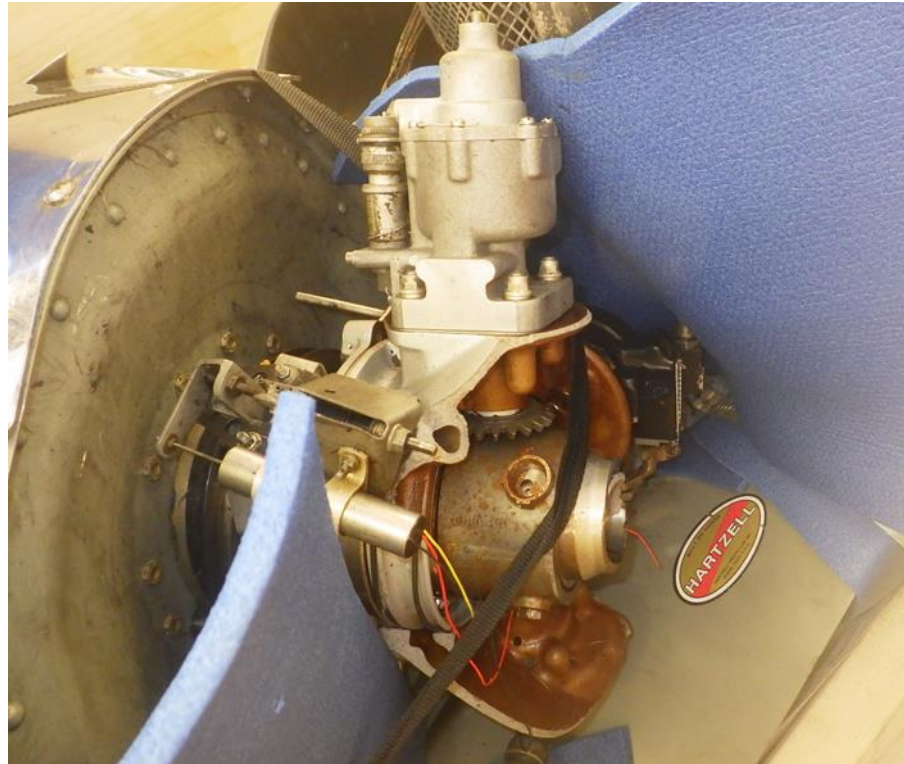
Figure 37. The propeller's overspeed governor and propeller governor remained on the housing from the reduction gearbox which, together with the propeller, separated on impact. Photo: Pratt & Whitney Canada Corp.

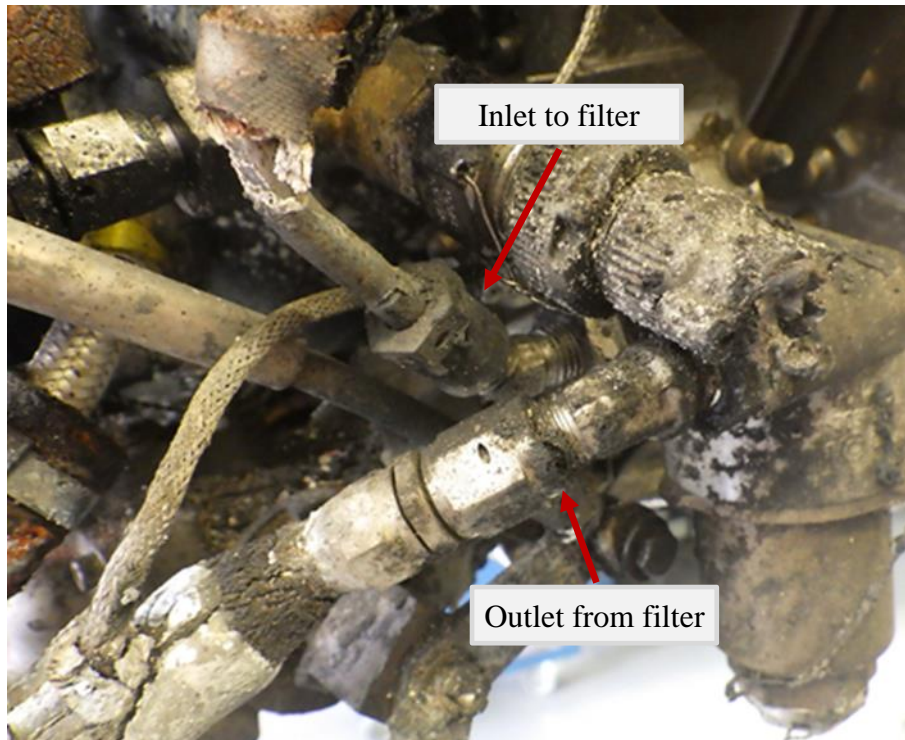
When examining the external lines for the compressor bleed air (P3), it was discovered that the locking wire that secures the lines for inlet and outlet to the P3 air filter was missing (see Figure 38). The nut on the inlet pipe to the air filter could not be loosened by hand but did not indicate any torque when disassembling it with a torque wrench. The torque on the nut at the outlet from the air filter was within specifications.

Figure 38. The picture shows which nuts that were not lock wired. The upper nut in the picture lacked the specified torque. Markings inserted by SHK. Photo: Pratt & Whitney Canada Corp.

Further investigation has been carried out to evaluate a possible leakage and possible influence of the compressor bleed air (P3). The test results revealed a small leak. The measured leakage was reviewed by the engine manufacturer who stated that the leakage was negligible and that it did not affect the operation of the engine.

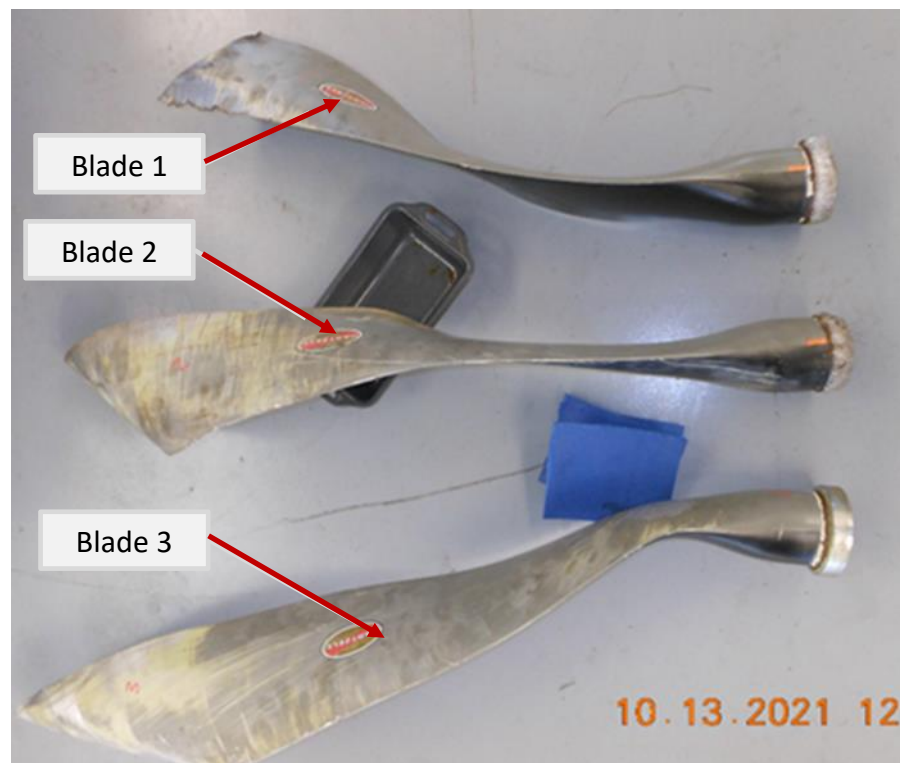
The examination showed damage to all three propeller blades (see Figure 39). Two of the propeller blades had been torn off at the attachment to the propeller hub. The propeller blade that still was connected to the propeller hub had slipped in the clamp.

Figure 39. The propeller blades during examination. Markings inserted by SHK. Photo: Hartzell Propeller Inc.

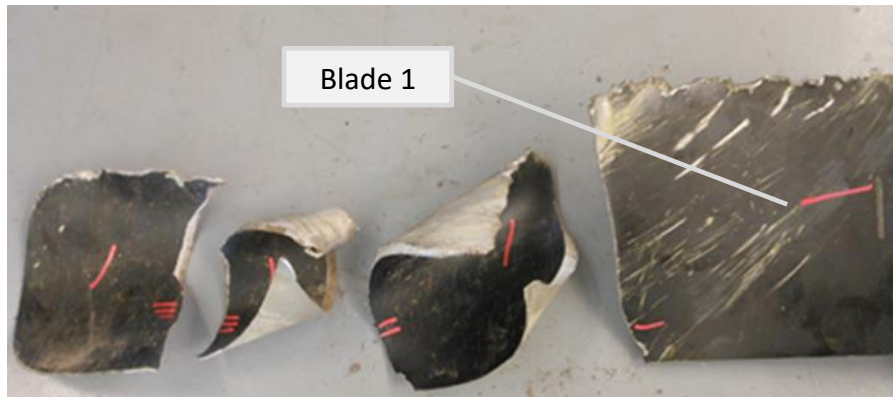
Figure 40. The three separated blade pieces from propeller blade number one. Markings inserted by SHK. Photo: Hartzell Propeller Inc.

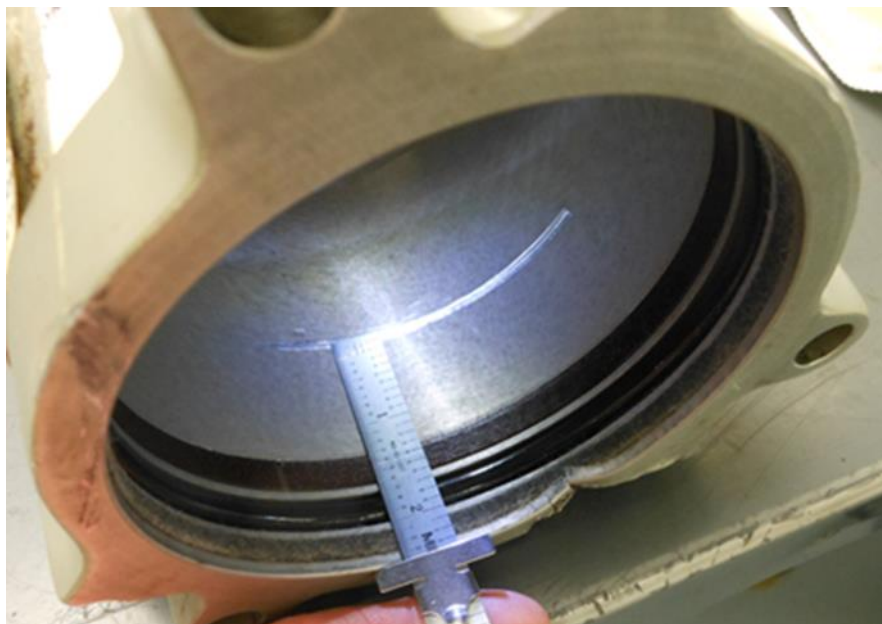
Figure 41. Impact marks in the propeller cylinder head.

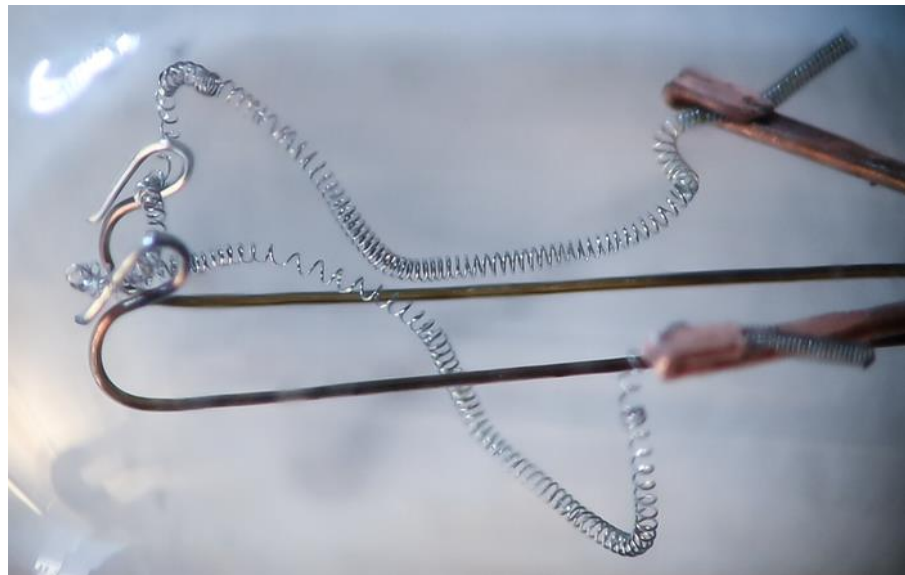
Figure 42. Enlargement of an image of the stall warning light bulb. The picture shows the deformed filament.
