Interim Statement *SRL 2022:01e*

Accident at Örebro Airport, Örebro County, on the 8 July 2021 involving the aeroplane SE-KKD of the model DHC-2 Mk III, privately operated in connection with parachute operations.

File no. L-47/21

2022-01-27

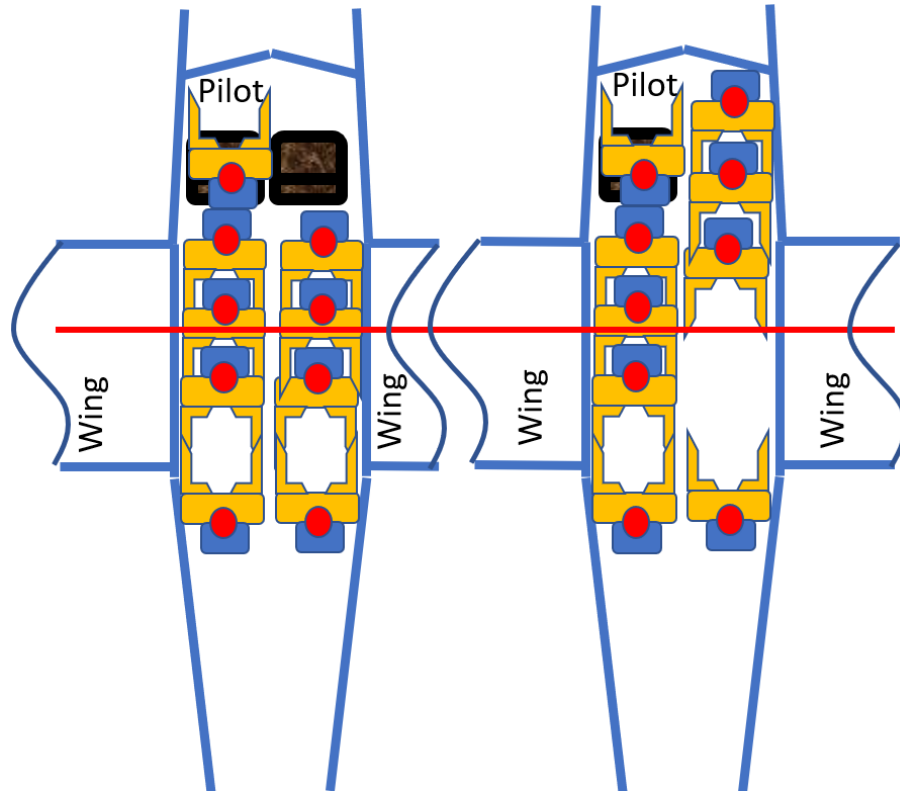
Figure 4. The left picture shows how those on board were seated during the accident flight. The right picture shows how the parachutists normally would be seated when the right pilot seat was removed. The red line shows the rear limit of the permissible centre of gravity.

At the time of the accident, the right pilot seat was installed, which meant that the parachutists sat further back than normally compare to when two parachutists are sitting to the right of the pilot (see Figure 4).

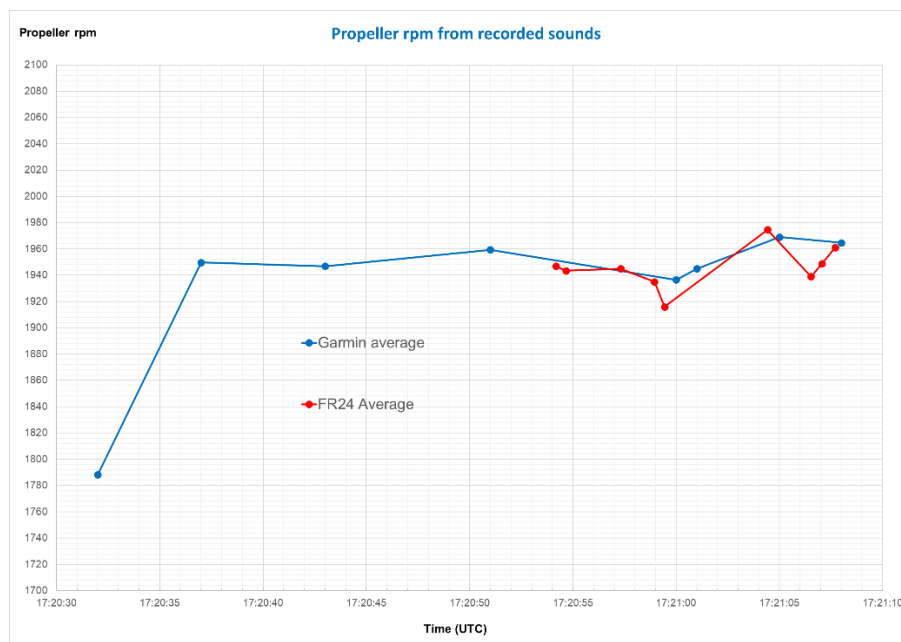
Figure 13. Mean value of propeller rpm corrected for the Doppler effect. Image Magnic AB.

A preliminary analysis of the sound recordings shows the propeller rpm in Figure 13. The propeller rpm is the mean value corrected for the Doppler⁹ effect based on the position indications from Flightradar24 (section 1.11.2) and Garmin GPS (section 1.11.3).

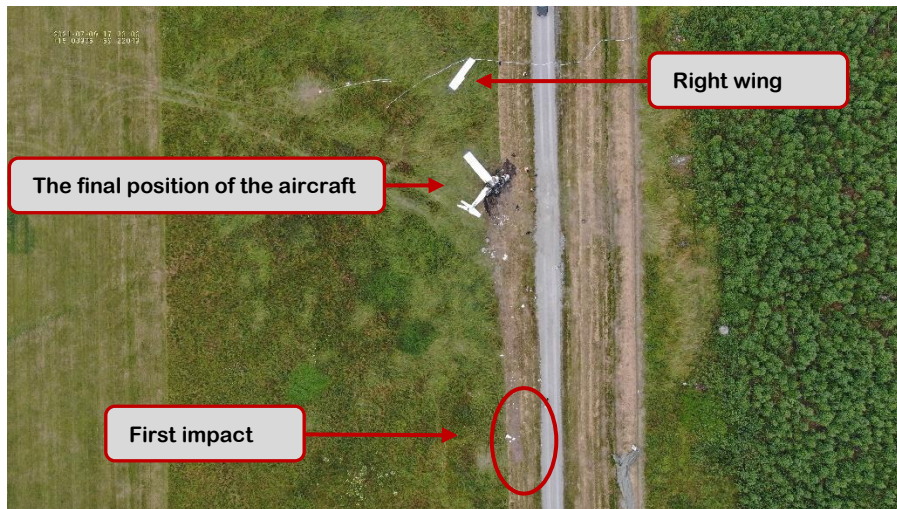
Figure 15. The accident site and the aircraft's position next to a road east of the runway.

The final position was to the east of the runway, 142 metres from the runway centre line and 1,540 metres from the end of runway 19, next to a road within the airport area.

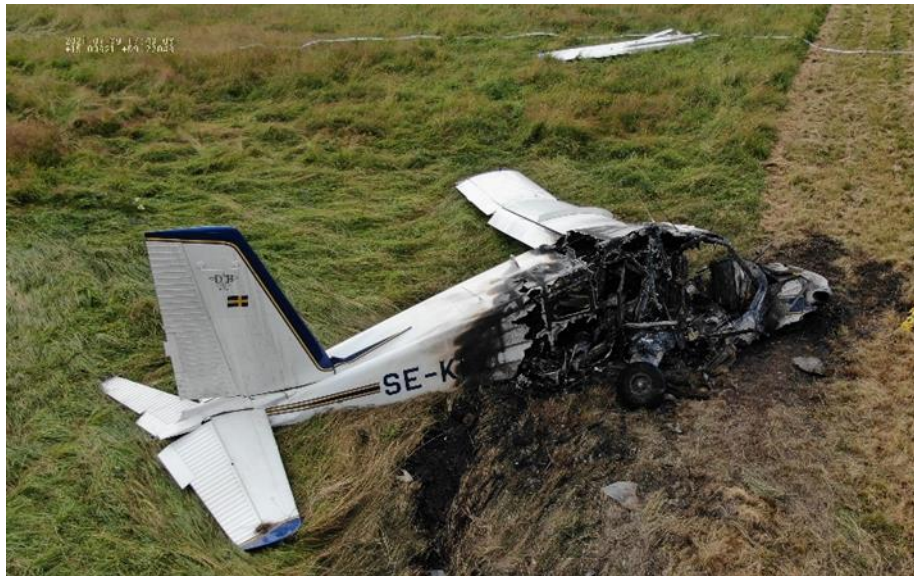
Figure 16. The aircraft at the accident site.

During the impact, parts of the aircraft separated, such as the propeller, right wing and left main landing gear along the 50 metres that the aircraft skidded.

The right wing detached from the aircraft in connection with the impact and ended up 20 metres in front of the aircraft. Two propeller blades broke away from the hub and the hub separated from the engine gearbox.

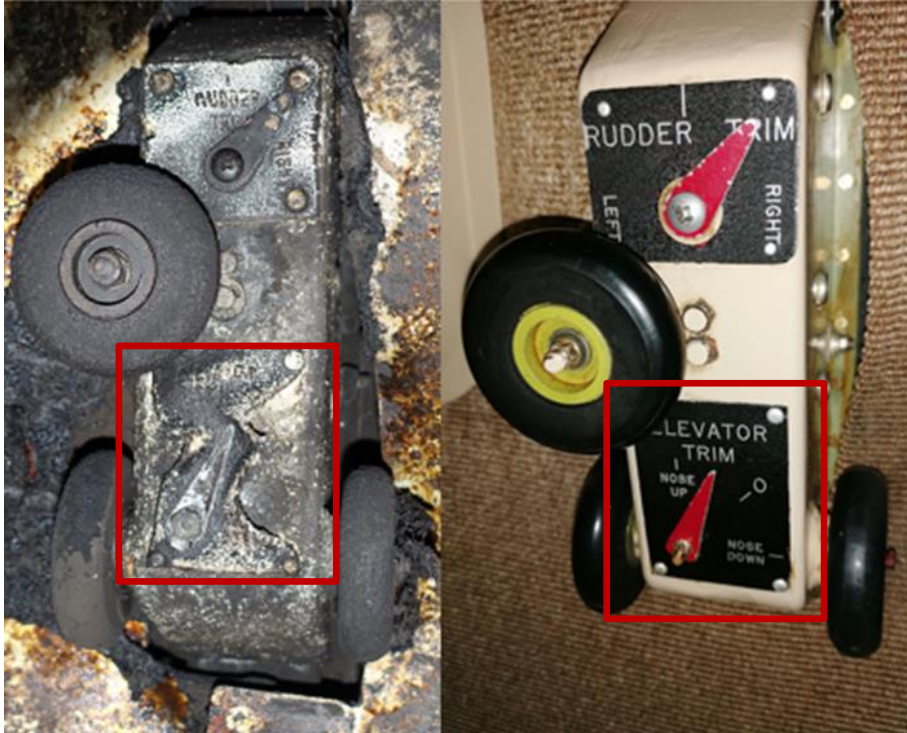
Figure 17. The picture on the left shows the trim panel from the wreckage and the picture on the right shows an intact panel with the same setting. The red boxes show the elevator trim.

The trim settings on the trim panel in Figure 17 show an elevator trim setting which, according to other pilots who have flown the aircraft in parachute operations, is normal for landing with a pilot and without parachutists onboard.

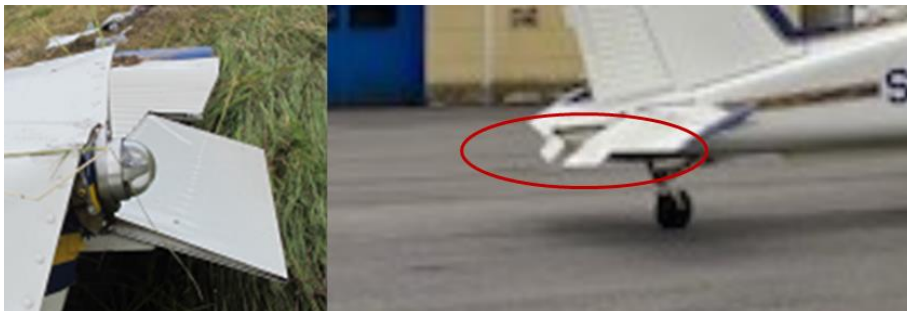
Figure 18. The left image shows the position of the elevator trim after the accident and the right image is taken from a surveillance camera when the aircraft is taxiing out to the runway.

The trim setting corresponds to the position in the figure 18.

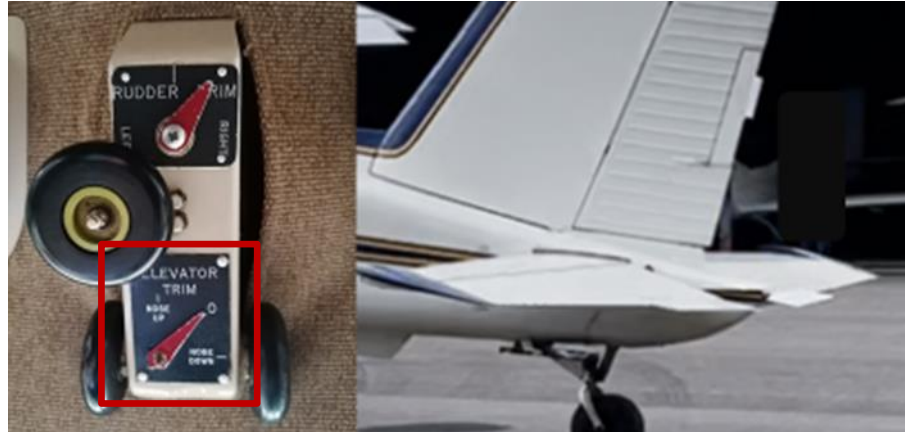
Figure 19. The left part of the picture shows a trim setting which, according to other pilots, is normal for take-off with a pilot and eight parachutists on board. The red box shows the elevator trim. The right part shows the position of the rudder before one of the previous flights during the day.

The left image on figure 19 shows an elevator trim setting which, according to other pilots, is normal for take-off with a pilot and eight parachutists on board. The right image in the same figure shows the position before one of the other flights during the day. The trim position on the panel in the figure corresponds with the trim tab position in the figure.

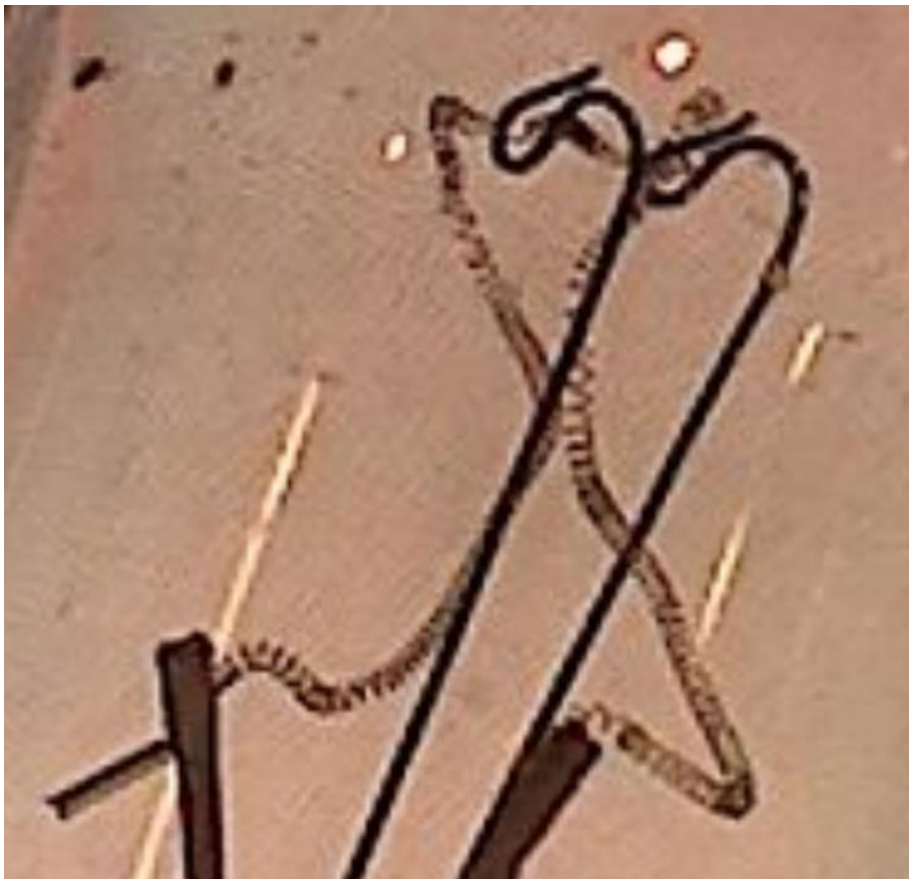
Figure 20. Enlargement of an image on the stall warning light bulb. The picture shows the deformed filament.

The filament in the light bulb had been deformed without breaking, which indicates that it was hot and illuminated at impact.

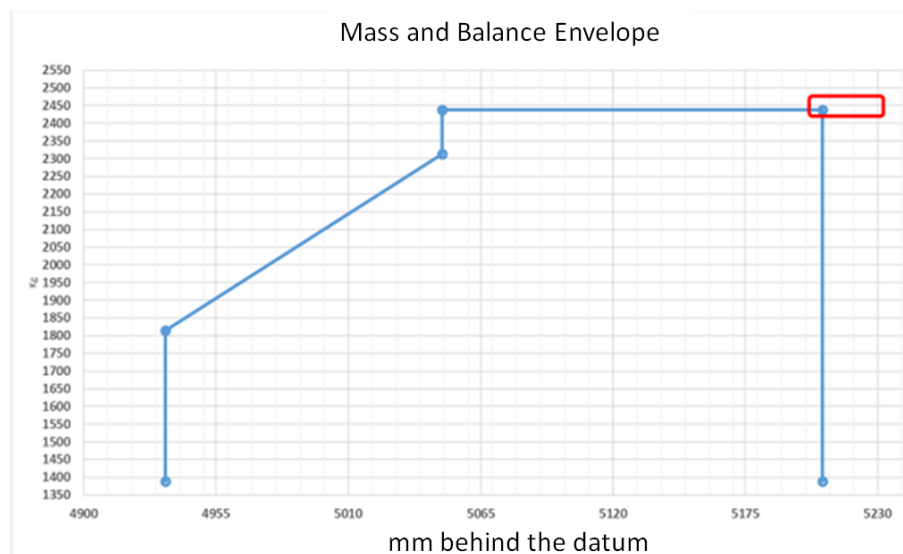
Figure 22. Mass and balance envelope. The vertical axis shows the mass of the aircraft and the horizontal axis shows the mass centre position of the aircraft. The blue lines show the permissible range.

In order to more thoroughly determine where each individual parachutist's mass centre was, a model of the passenger cabin was built. A weighing exercise with eight parachutists sitting in the model was performed and resulted in the determination of the mass centre position for each row, to be used for further calculations. There are currently several uncertainties in the calculations. For example, it is not established in what order and exactly where the parachutists were seated. All calculations made so far shows that the mass and balance position was within the red rectangle near the aft upper corner of the envelope (see Figure 22).
