Statens haverikommission
Swedish Accident Investigation Board

Report RO 2003:01e

Accident involving a Mercedes Benz articulated bus, registration no STK 595, on Glömstavägen in Stockholm/Huddinge, AB County, Sweden, on the 2nd of April 2002

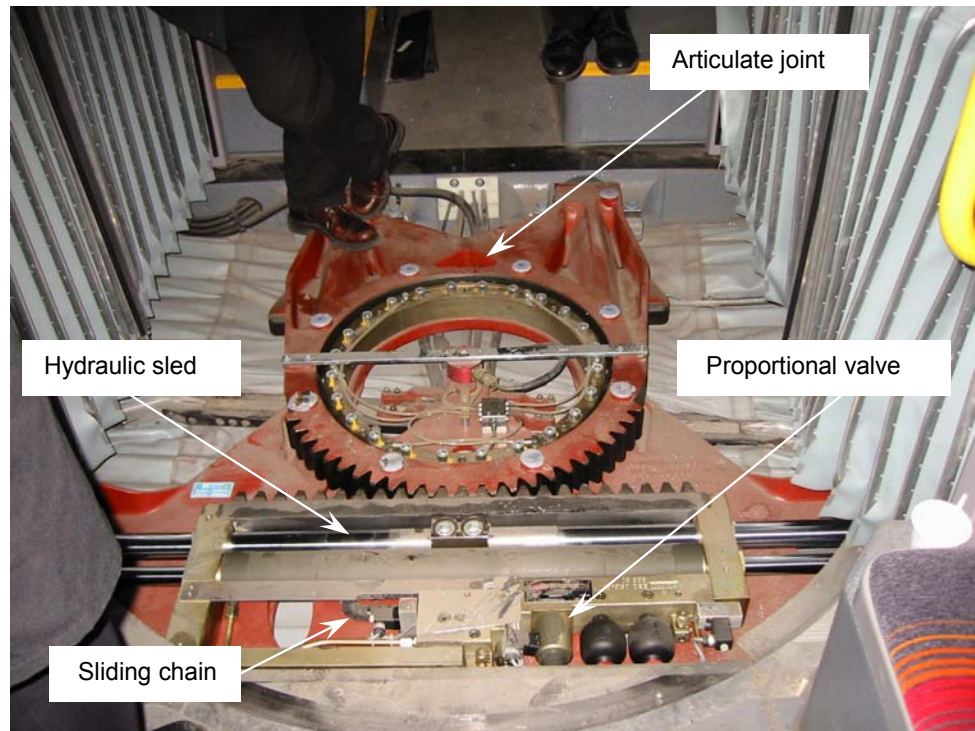
In order to prevent the cable from being damaged, it is mounted in a so-called sliding chain, made of plastic. The system is not doubled, which means that the articular joint becomes completely non-dampened if the electricity to the valve is cut-off.

The bus's articulate joint section with removed floor plates

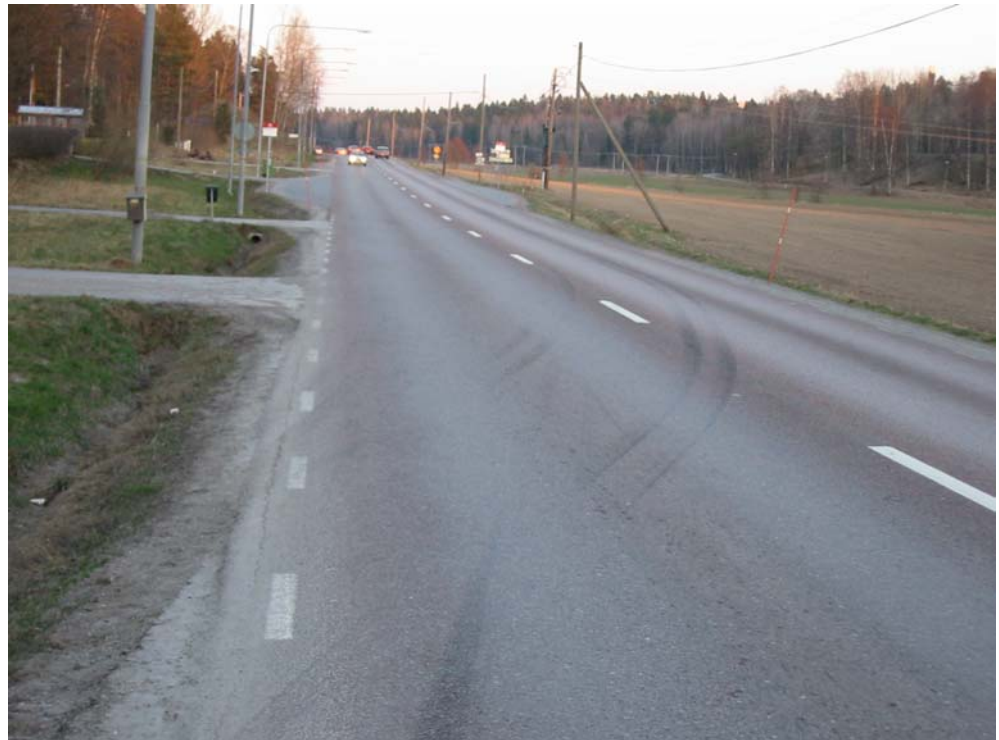
The accident occurred on Glömstavägen approximately 100 meters prior to the intersection with Lovisebergsvägen. The bus ran down into an approximately one-half meter deep ditch on the right-hand side of the roadway.

The accident site viewed opposite the direction of travel of the bus

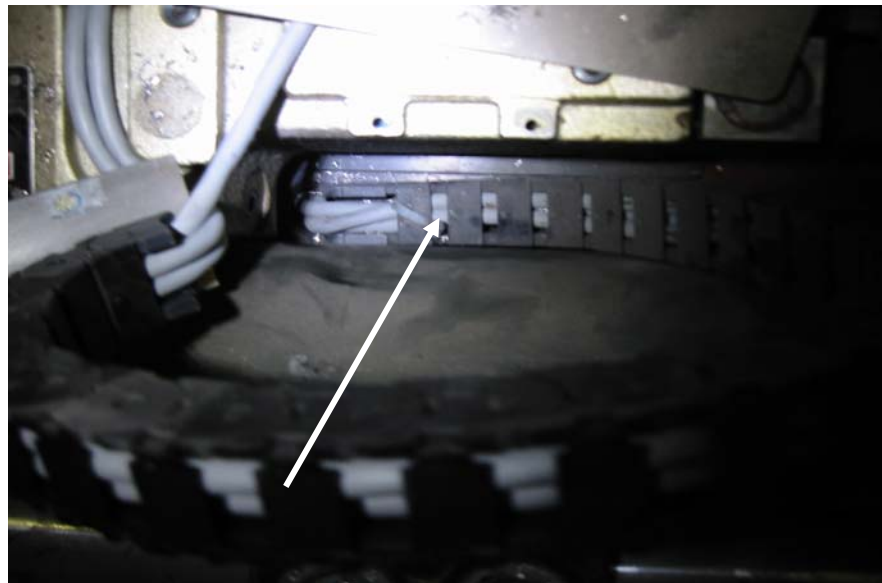
- The securing of the cable to the ends of the sliding chain was improperly carried-out. The so-called cable-tie, which is used to secure the cable, was mounted around several cables. In a correct installation, each cable-tie shall be installed around only a single cable.

Several cables secured with the same cable-tie

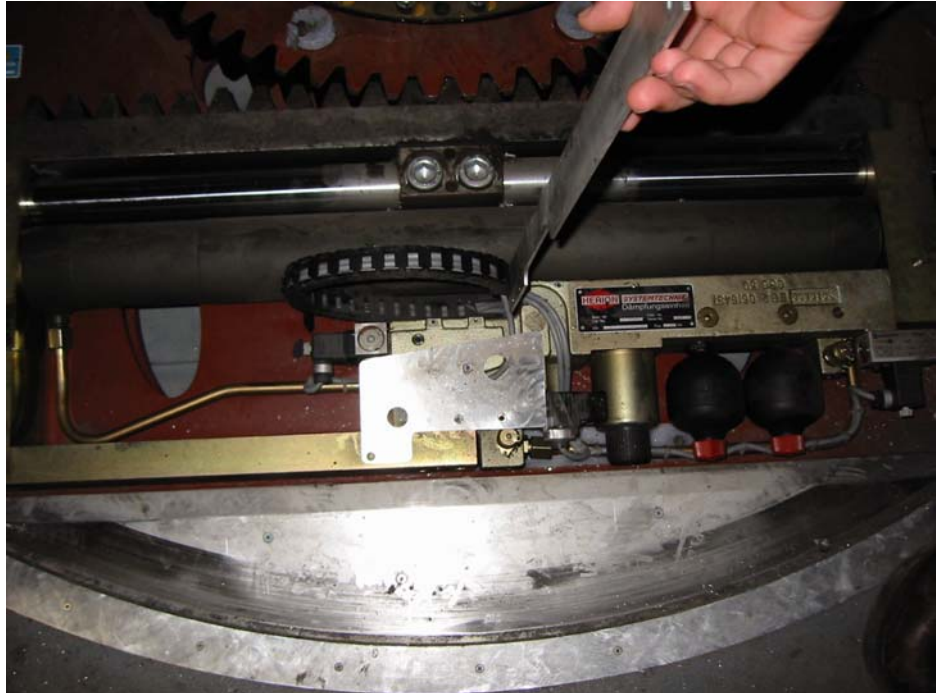
- The cables were drawn tightly through the sliding chain. When correctly installed the cables should be able to move freely without any tension force applied. The cables are not to be secured to each other within the sliding chain.

A strained cable

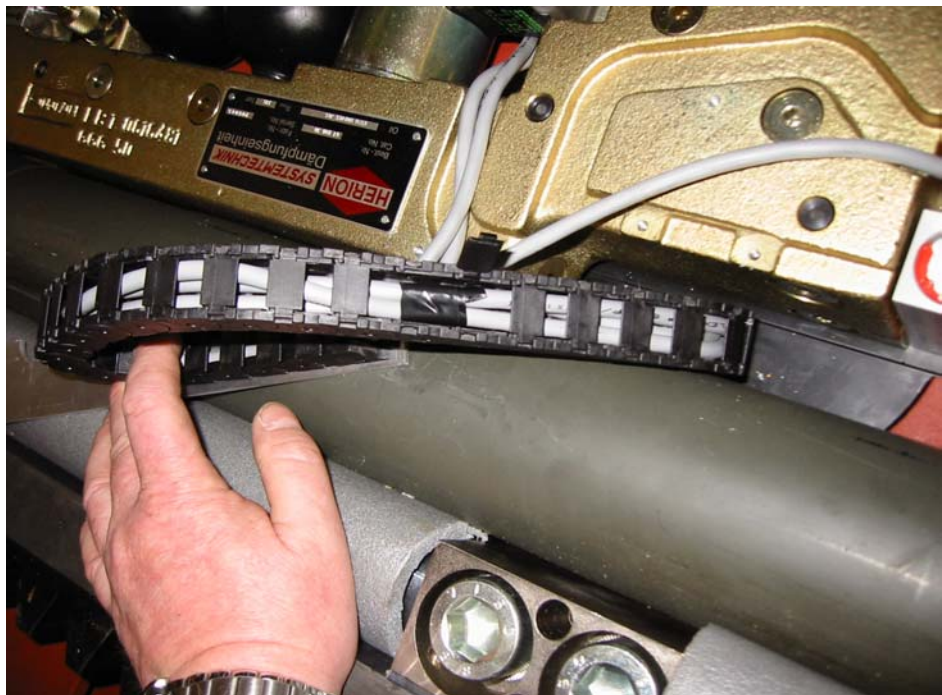
- The width of the sliding chain was insufficient in order that the three cables could lie free next to each other. The cables were lying on top of each other and in several places they were crossed.

Crossing cables

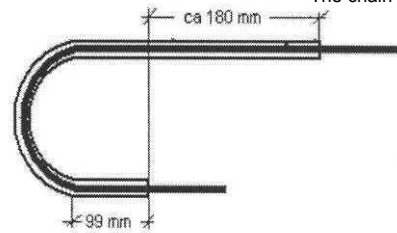
[Extract from the manufacturer's specifications](#)

- The curve radius and the length of the sliding chain did not meet the manufacturer's specifications.

According to the manufacturer's instructions, the cable curve radius may not be less than five times the cable diameter, i.e. $5 \times 6.6 \text{ mm} = 33 \text{ mm}$. The chain's curve radius = 25 mm

According to the manufacturer, the portion of the cable that is not exposed to bending shall be 15 times the cable diameter, i.e. $15 \times 6.6 \text{ mm} = 99 \text{ mm}$. The allowable lateral movement would then be approximately 180 mm. In practice, the lateral movement is approximately 300 mm.
