Report RO 2001:04e

**Bus fire following traffic accident at
Fjärdhundra on national route 70,
C county, Sweden, 21 November 1998**

Case No. O-10/98

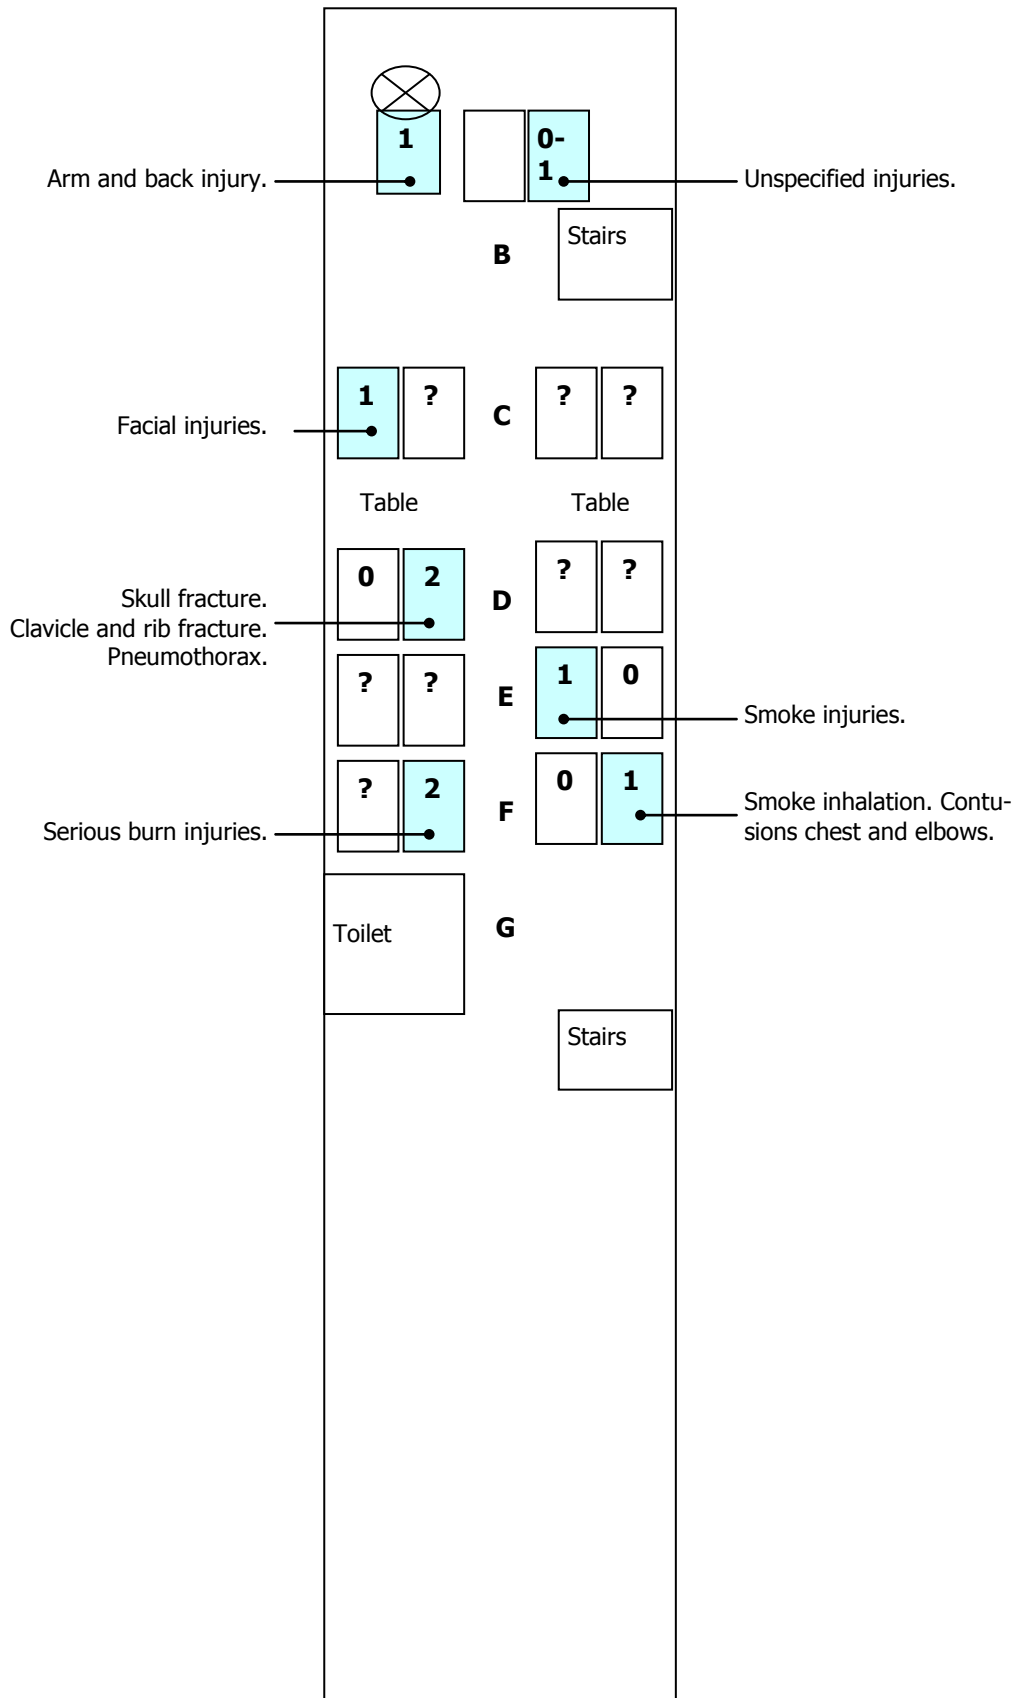
Bus, lower deck

The accident produced a broad sample of different types of bodily injury. Dominant were contusion injuries with bruises and pain in various parts of the body. About ten of the passengers incurred fractures. In many cases these were rib fractures, in some combined with pneumothorax (injury to the pleura). There was also a case of fracture of the skull base, followed by paralysis of facial nerves. Back pain, including cervical was common. Three of the cases incurred fractures of cervical vertebrae, in one with serious paralysis below the fracture. There were also cuts on the face and/or hands.

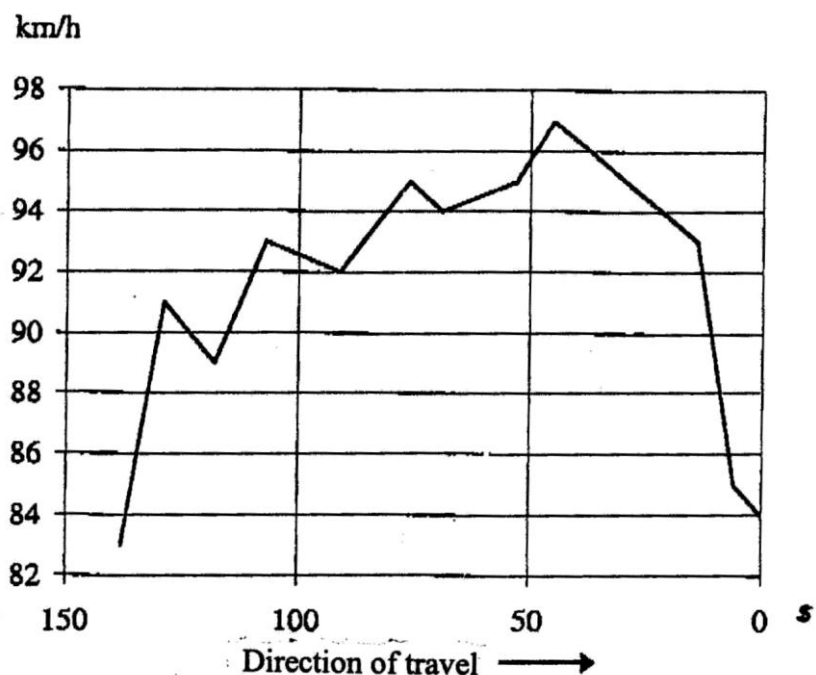
At the request of the police authority in Uppsala county, the Swedish Testing and Research Institute (SP) evaluated the tachograph diagram. In the result of the investigation it was noted that the recorded zero line for speed was approximately 0.1 mm too high. Because of this error, the tachograph had recorded approximately 1 km/h too high a speed. The speeds given below have therefore been corrected with reference to this error. The evaluation covers the vehicle's travel 3553 metres before and up to an unnatural recording which probably represents the accident. After this unnatural recording, when the bus probably overturned, the diagram sheet continued to register speeds for approximately 250 seconds.

The lowest recorded speed during the stretch above was 83 km/h but this was maintained by the driver only for a short distance. For large parts of the stretch, speed was over 90 km/h with the highest value 97 km/h for a short period. Speed varied greatly in the range 90–94 km/h.

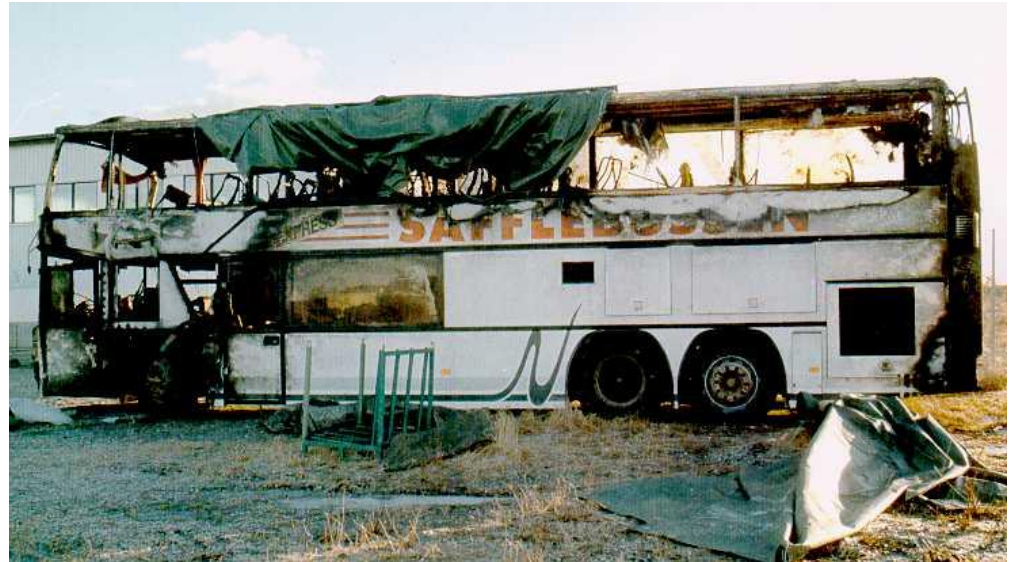
1.13.2 *Wreckage*

The forward section of the bus was pressed in on the right-hand side. Extensive fire damage arose in the engine compartment and in the upper part of the bus. Economically, the bus was considered a total wreck. More detailed report of the damage is given in section 1.17.

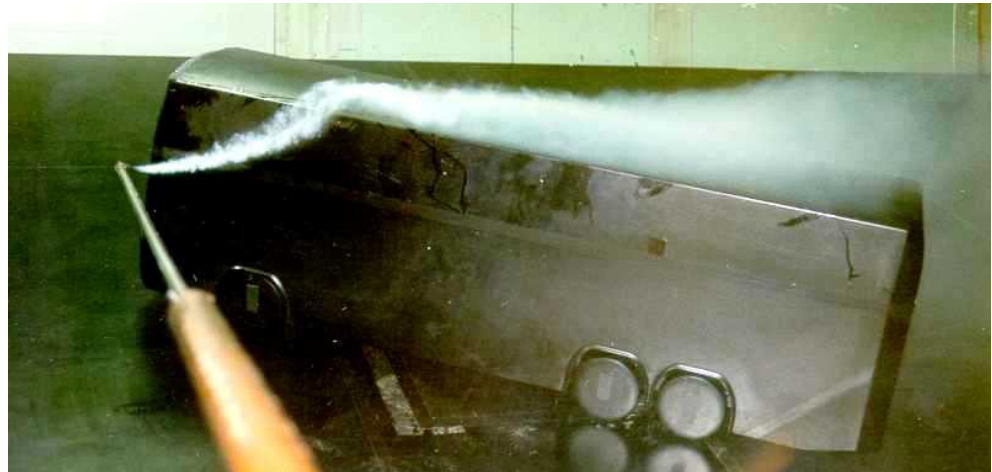
Visualised air flow for oblique relative wind direction

- For large oblique angles of wind incidence the greatest lateral and lift forces arise right at the front.
- The forces act together negatively regarding the front wheels since the lateral force there is great at the same time as the lift force reduces the already low front axle pressure.
- The angle of roll increases the lift force for certain oblique angles of wind incidence. The effect on the necessary coefficient of friction, however, is moderate.
- When the model is modified to resemble a single-decker bus, the necessary coefficient of friction is reduced more than proportionally to the side surface.
- A simple spoiler on the lower part of the front can reduce the necessary coefficient of friction by 20%.
