# Engine Malfunction on Airliner during Takeoff at Helsinki-Vantaa Airport on November 25, 2021

L2021-04

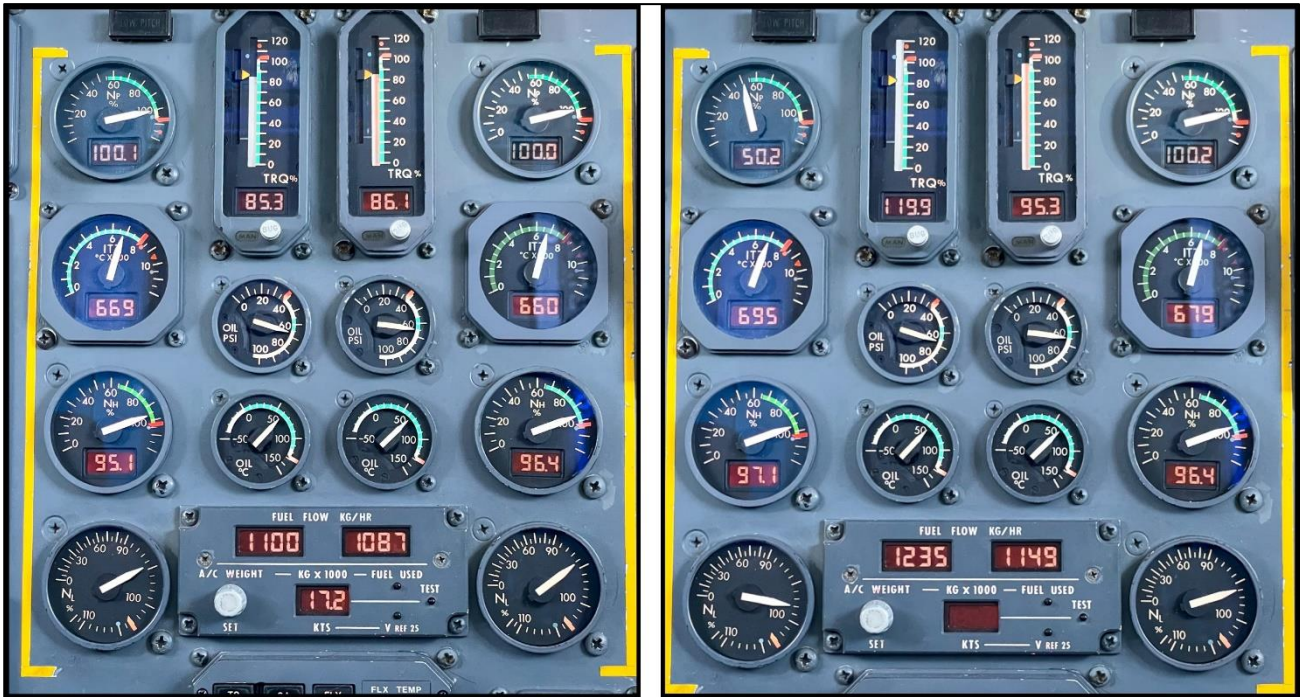
**Figure 3.** On the left, engine indications during a normal takeoff. On the right, the left propeller is feathered, but the engine is operating. (Figures: Gabriel Leigh / Fliht radar24, edited by SIAF).

After verifying the engine malfunction the pilots focused on propeller speed, which remained at 50 % Np, and concluded that the propeller had not autofeathered. They decided to feather the propeller manually by setting the fuel lever to SHUT. This cuts off fuel supply and shuts down the engine and is in accordance with the engine failure checklist.

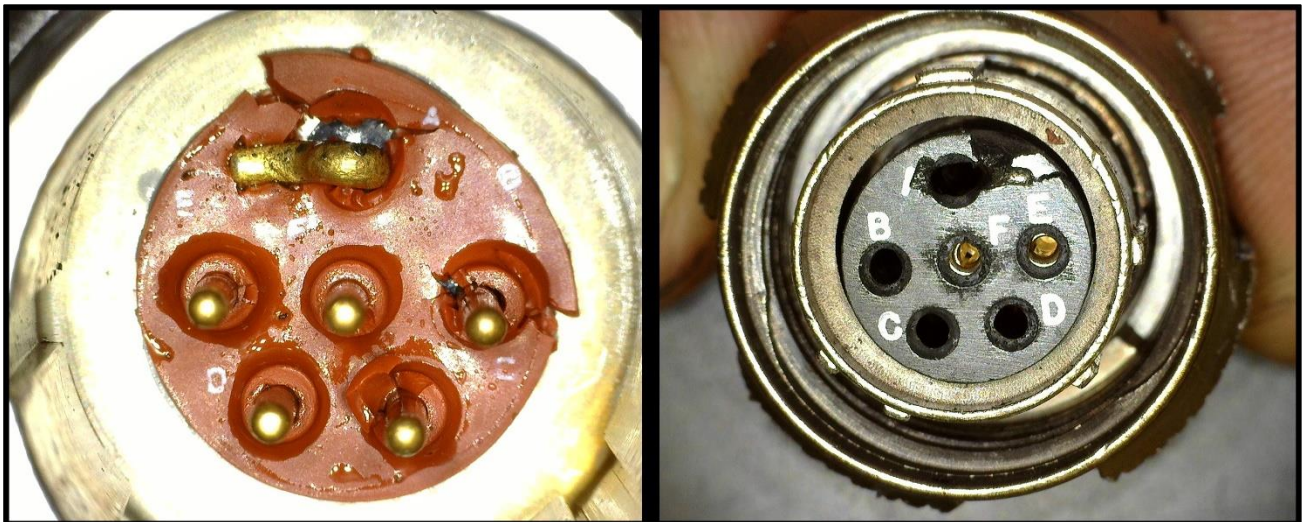
The visual inspection of the engine revealed no anomalies. The AFU was undamaged externally, and its electrical connections were secure and protected with shrink sleeving. The torque sensor connector was undamaged externally and protected with shrink sleeving. Difficulty was experienced during the removal of the connector plug. Similar connectors can normally be rotated by hand, but now tools were needed to remove the plug. Examination of the male receptacle, which is an integral part of the sensor, revealed a bent pin, while the insulator of the female plug was found damaged.

**Figure 4.** The torque sensor connector receptacle (left) and plug (right, with wiring harness removed). Bent pin and insulator damage are visible. (Photo: SIAF)

respective socket. Measurement of the height of the bent pin and the depth of the insulator damage indicated that the pin could come into contact with the socket.

On completion of the measurements the plug was installed to the sensor and the connector was tested with a multimeter. When the plug was hand-tightened using slightly higher-than-normal force, electrical continuity was created between the bent pin and the socket, but continuity was extremely sensitive to movement: even the slightest vibration or change in connector position led to a momentary or permanent loss of contact.

Damage to the sensor and the pin had occurred during installation when the misaligned pin had been subjected to bending inside the connector. Pin misalignment can be detected visually before installation, and maintenance manuals instruct to pay particular attention to the condition of connectors. The engine manufacturer has also issued amplifying instructions for the installation of engine connectors. Although the bent pin had not been visible from the outside, it is likely that higher-than-normal force had been required to rotate the plug, which later led to difficulties during its removal due to the tight fit. Shrink sleeving over the connector reduces vibration and prevents the ingress of contaminants. In this case, the sleeving had provided additional rigidity and thereby prevented an early occurrence of the fault after installation.

The malfunction was caused by electrical discontinuity that occurred during the takeoff run in a connector in the left propeller feathering circuit and resulted from incorrect connector installation during engine maintenance. The discrepancy could not be detected visually because the connector pins were covered by the connector shell, and a shrink sleeve had been fitted over the connector. The discontinuity caused an erroneous signal that commanded propeller feathering. The engine remained in operation.

**Conclusion:** *Special attention must be paid on the condition and correct installation of connectors.*

*Fokker Services as the type certificate holder and Pratt & Whitney as the engine manufacturer co-operate and look at possibilities of building system redundancy to ensure that the failure of one torque sensor will not cause uncommanded feathering. [2022-S28]*

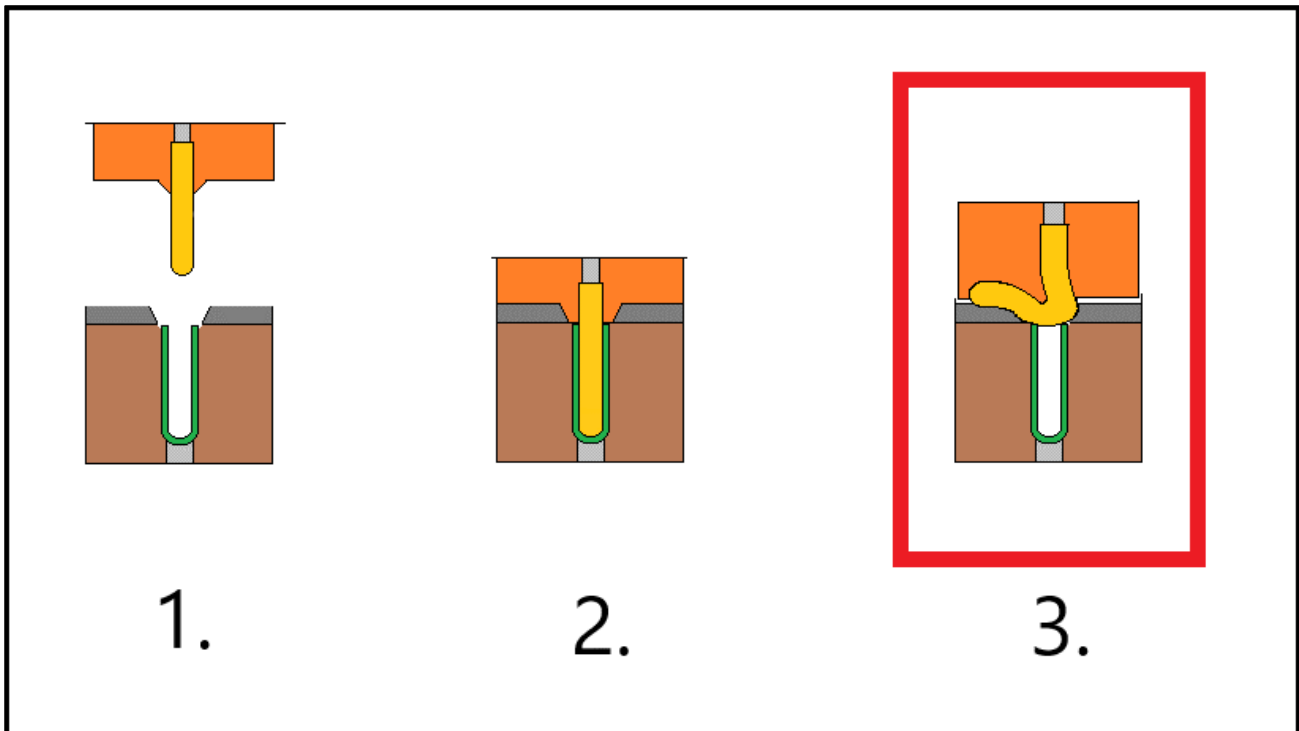
**Figure 5.** The AFU connector. 1. An undamaged connector with the plug removed. 2. An undamaged connector with the plug installed. 3. The bent pin with the plug installed. (Photo: SIAF)

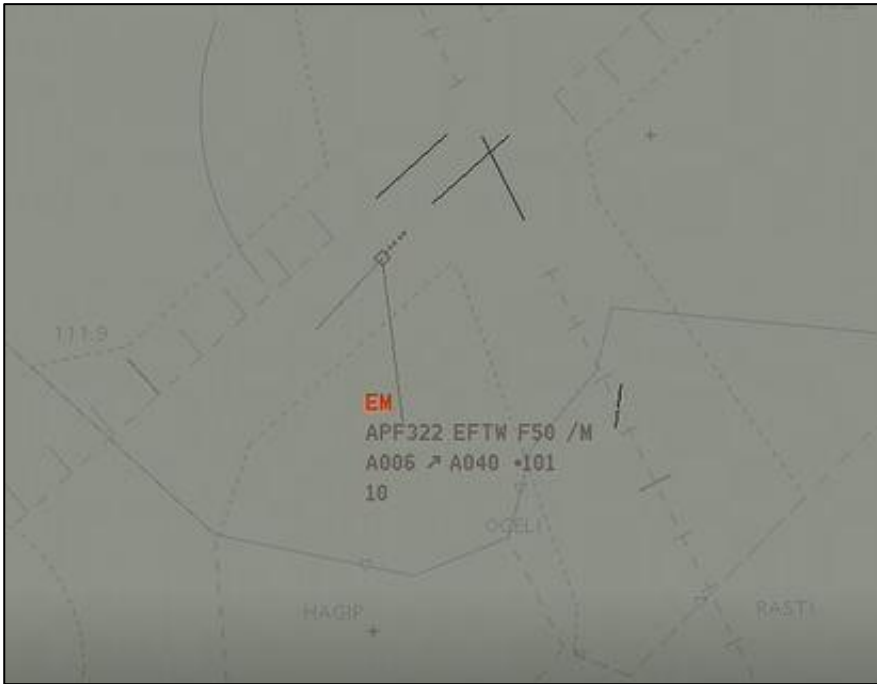
If a flight sets the emergency code 7700 on the transponder, its label will appear on the display regardless of the level of filtering and other selections, but no aural alert will be received. Code 7700 will appear on the display, and the letters EM (for “emergency”) will show on the top line of the label in red, but no aural alert will be received.

**Figure 7.** The TopSky label of the incident flight on the controller’s display. (Photo: Fintraffic)
