## **Final Report RS 2013:01e**

### **Cargo Shift on board M/V Phantom**

on 15 February 2012

**Ref. no. S-20/12**

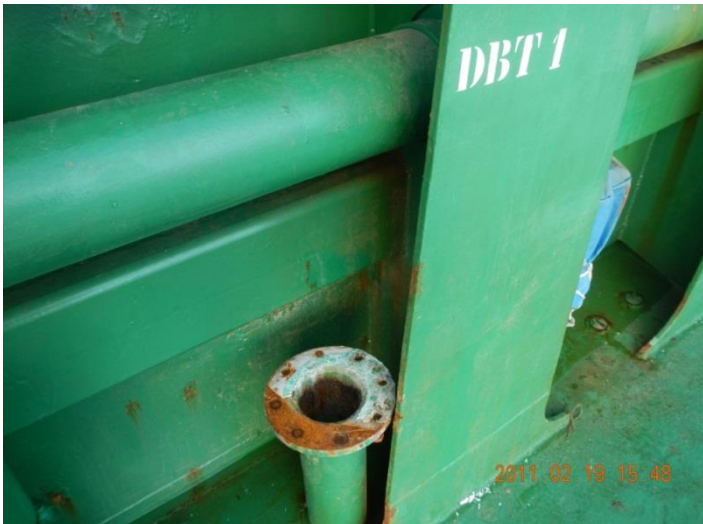
In the meantime, they experienced problems in filling the ballast as a result of either faulty valves or ice plugs blocking the pipe system, whereby they filled Bottom Tanks 1 and 2 (port and starboard sides) using the fire pump and fire hose via the air pipes on the tanks after the automatic closing devices had been dismantled (see Figure 2). These sealing devices were not remounted.

Figure 2. Air pipe for Double-bottom Tank No 1.

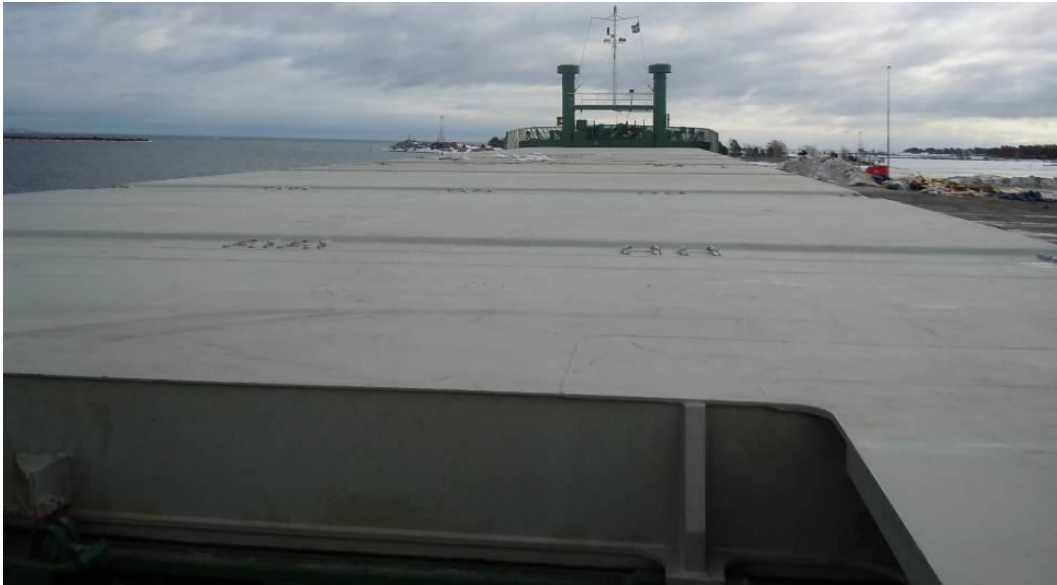
Phantom's hatch covers were completely smooth and the container fittings on top of the hatch covers were fully recessed (see Figure 3).

Figure 3. Phantom's cargo hatch with recessed container fittings.

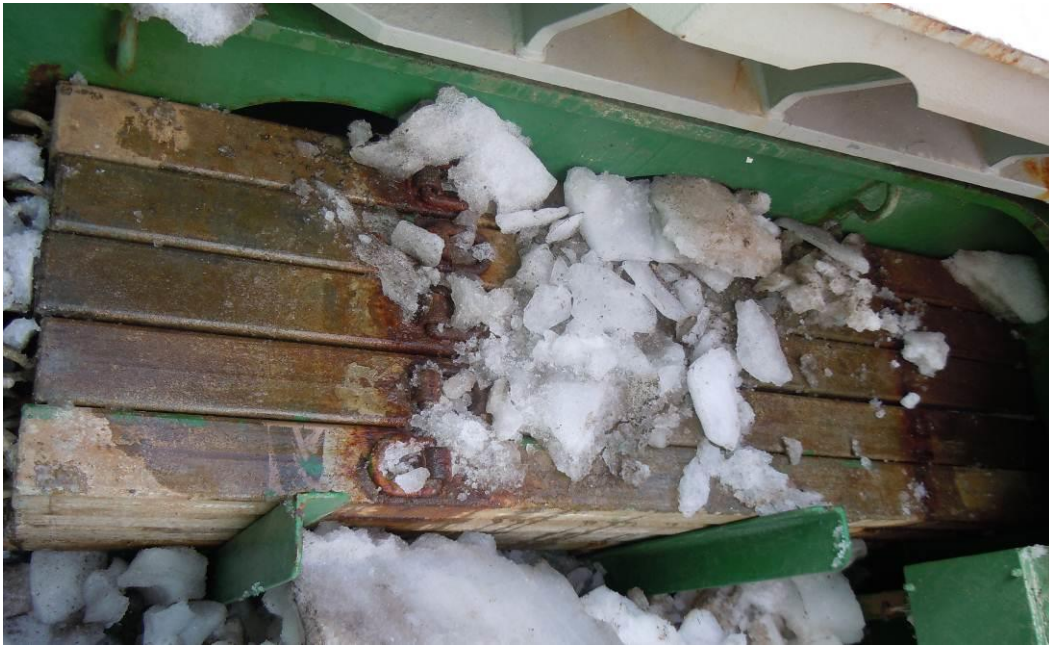
The detachable uprights (see Figure 4) each weighed approximately 30 kg and consisted of square profiles 110 x 110 mm in size with a material thickness of 5 mm. The uprights were 1.85 m high and were stored in front of the forward cargo hatch.

**Figure 4.** Detachable uprights that were available on board.

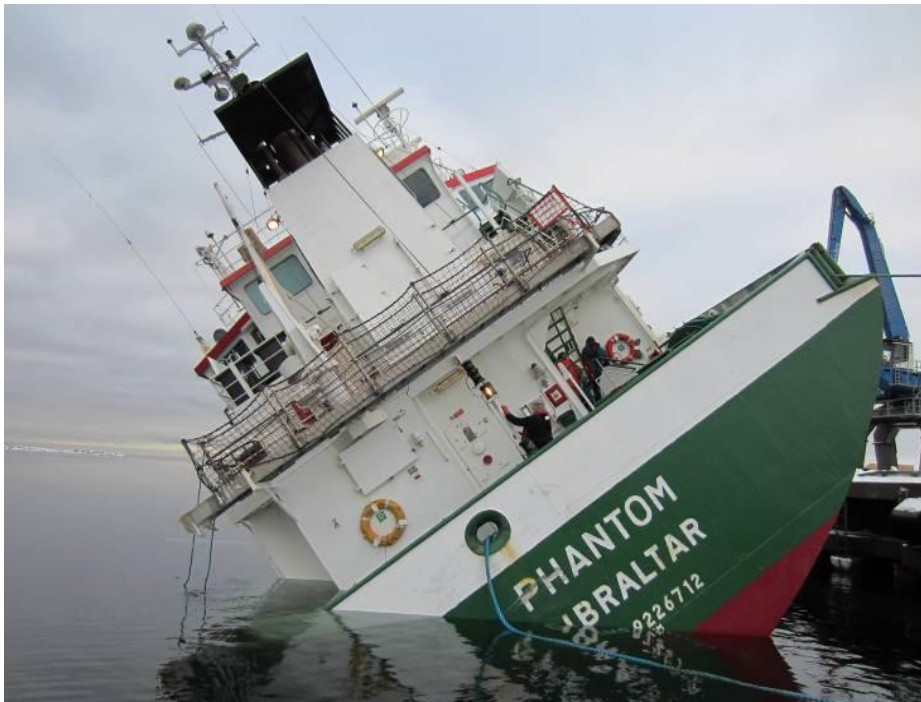
When the vessel was berthed alongside in Oskarshamn before the discharge of the deck cargo started and before the water was pumped out of the vessel, Phantom was listing approximately 40° to port, which has been possible to measure with considerable accuracy on the photograph of the vessel taken from the stern in calm water.

Figure 30. The vessel listing approximately 40° at the quay in Oskarshamn. Photo: Swedish Coast Guard.

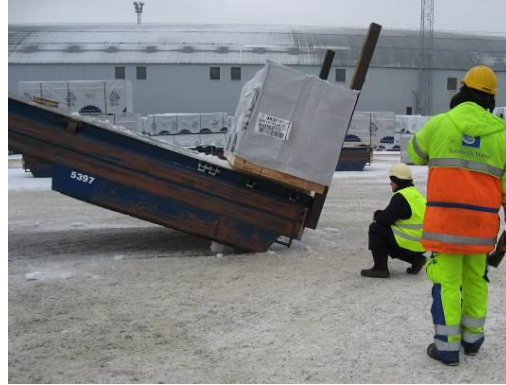
Particularly noticeable is the low friction for timber packages on painted steel plate when snow and ice has not been cleared from the underlying surface.

**Figure 32.** Angle of inclination where a timber package slides on a snowy surface of painted steel plate.

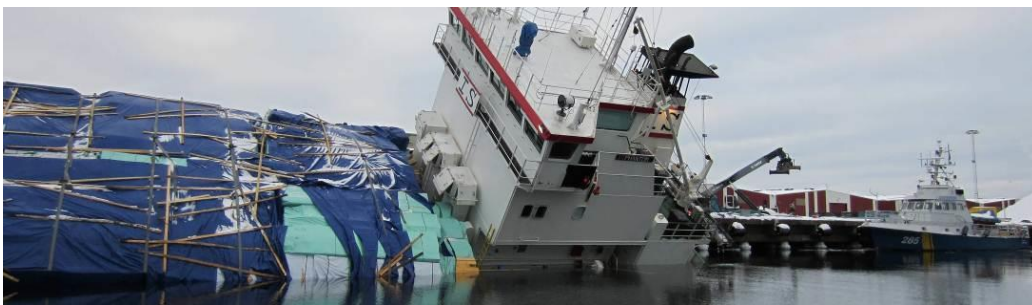
Figure 35. Photo showing that the deck cargo was stowed along the stern against the deckhouse. Photo: Swedish Coast Guard.

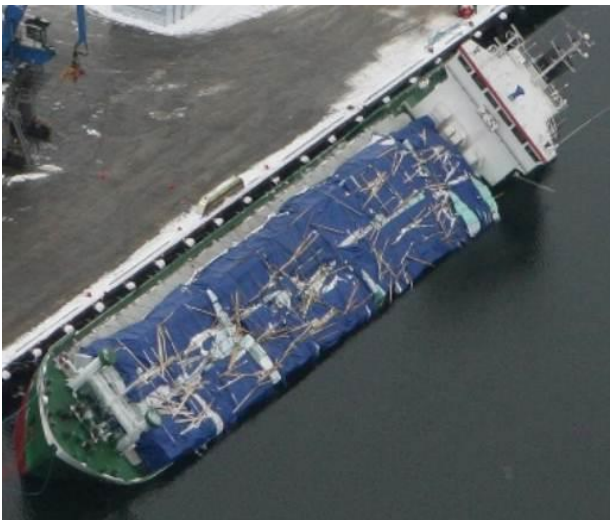
According to the master's information, the shifting of the deck cargo was 1.2 – 1.5 m. If the cargo shift in the following photo is compared with the width of the bridge beneath the window, which is 11.2 m, it can be concluded that the distance between the cargo and the outboard edge of the hatch cover on the starboard side is approximately 1.35 m. Since the cargo was stowed about 0.15 m in from the edge of the cover, it can be assumed that the deck cargo had shifted about 1.2 m, which corresponds to the cargo shift reported by the salvage company.

**Figure 36. Displacement of the deck cargo. Photo: Swedish Coast Guard.**

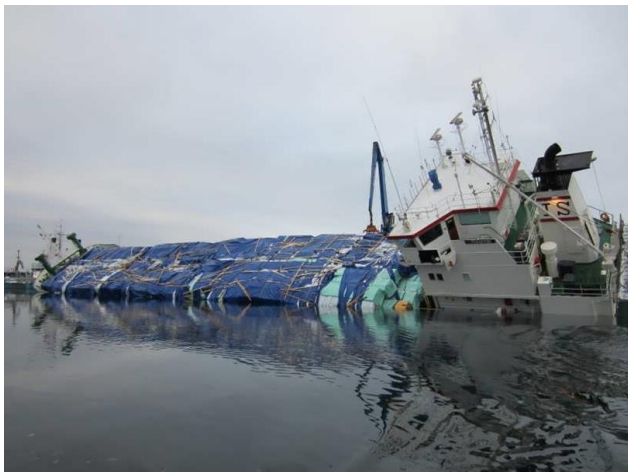
This water is not believed to have influenced the list to any great extent. In the calculations, the water in the accommodation areas, which is believed to have influenced the list somewhat, has not been included either. In the calculations, however, a lifting force from the deck cargo of 45 tons on a vertical centre of gravity of 9.80 m and a transverse centre of gravity of 6.00 m has been included. This lifting force is based on a triangle of the deck cargo, measuring approximately 1.25 x 1.25 m with a length of 58.8 m, being submerged, which is in turn based on observations from Figure 39.

**Figure 39. Displacing effect of the deck cargo. Photo: Swedish Coast Guard.**

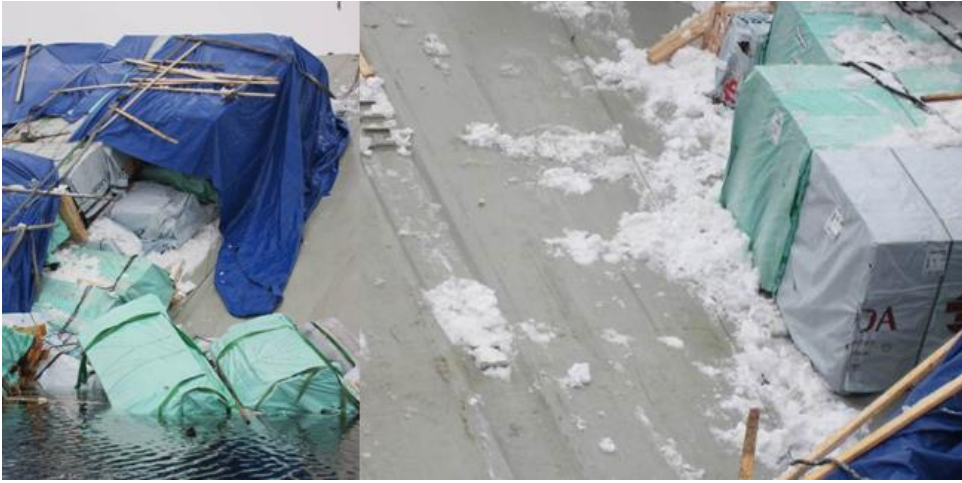
The cargo appears to have been loaded as tightly and compactly as possible in accordance with the requirements of the Code. It can be concluded from the photographic material that lower packages had been stowed on their side in order to fill voids in the cargo. However, it can also be noted that snow and ice had not been cleared from the hatch covers or from between the layers in the cargo to the extent prescribed by TDC 1991.

**Figure 41.** From the photographic material it can be concluded that lower packages had been stowed on their side in order to fill voids in the cargo, and that significant amounts of snow had been left on the hatch covers and between the layers before loading.
