# Rejected take-off involving SAAB 340B, VH-ZRC

Flinders Island Airport, Tasmania on 4 November 2022

Aviation Occurrence Investigation (Short)

AO-2022-054

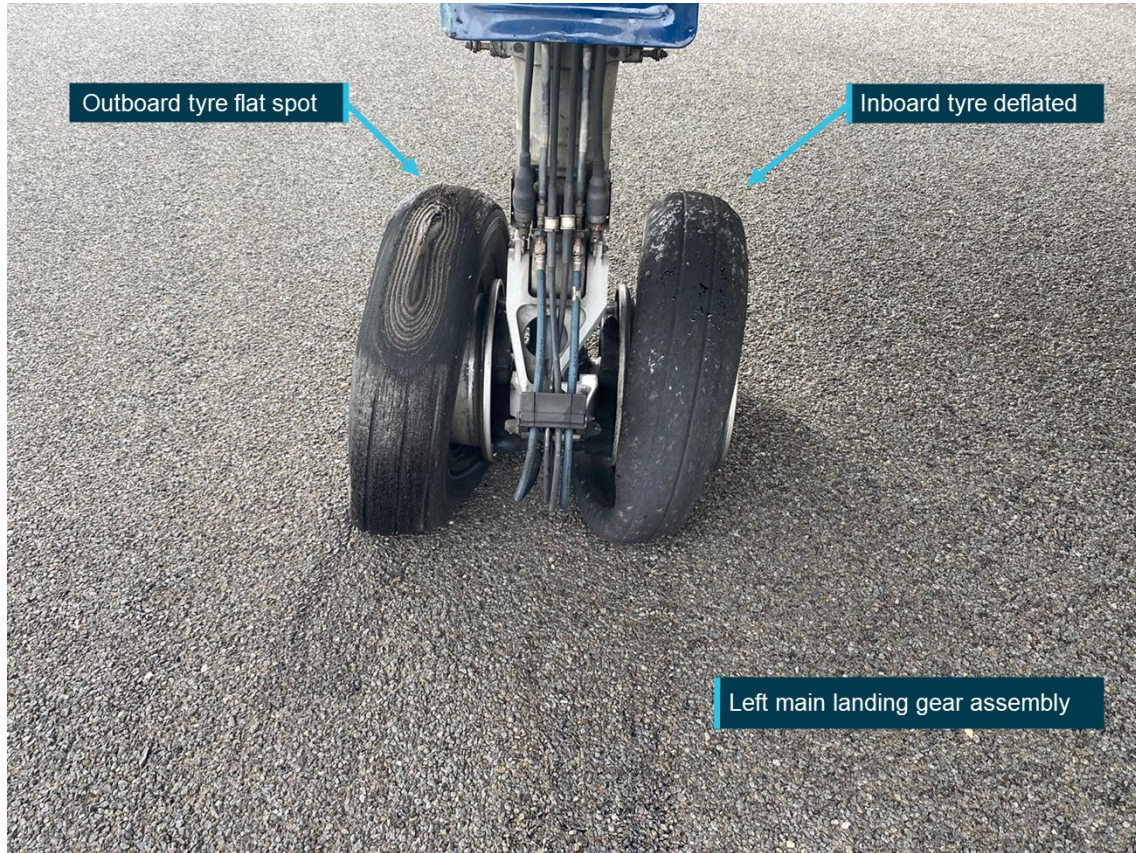
**Figure 2: Left main landing gear after occurrence**

- all 4 main landing gear wheels on both the left and right main landing gear had deflated
- the outboard wheel on the left main landing gear had a flat spot (Figure 2).

- all 4 brake assemblies were within wear limits and the brake pistons were serviceable. All 4 brake assemblies showed signs of overheating and were removed from service
- all 4 main landing gear wheel assemblies displayed signs of overheating evident with all fusible plugs blown. The wheel assemblies were removed from service for disposal.

- all 4 brake assemblies were replaced
- all 4 main landing gear wheel assemblies were replaced
- all 4 main landing gear wheel axles were visually inspected with no defects identified
- the input cables to the brake control valves were visually inspected with no binding or defects evident
- a parking brake control system test was carried out with no defects identified
- a high-speed taxi and brake test was carried out with no faults.

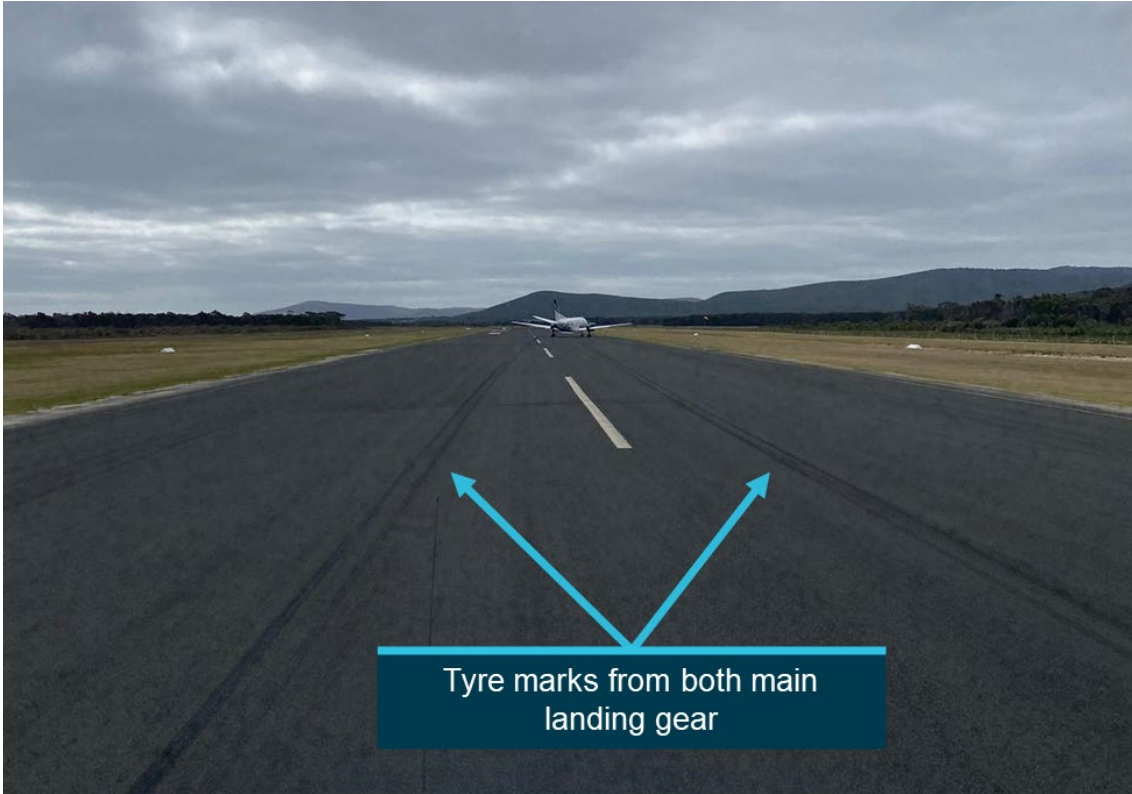
**Figure 3: Tyre marks on runway**

- tyre marks were evident commencing 300 m from the runway threshold until the aircraft came to a stop approximately 1,150 m from the runway threshold (Figures 3 and 4)
- initial tyre marks showed a veering to the left of centreline
- final tyre marks displayed a significant veer to the right with a change in tyre markings from a locked tyre to a deflated tyre prior to the aircraft coming to a stop (Figure 5).

Significant tyre marks, from all 4 main landing gear wheels, were observed on the runway after the occurrence. These tyre marks commenced early in the take-off roll and continued to the disabled

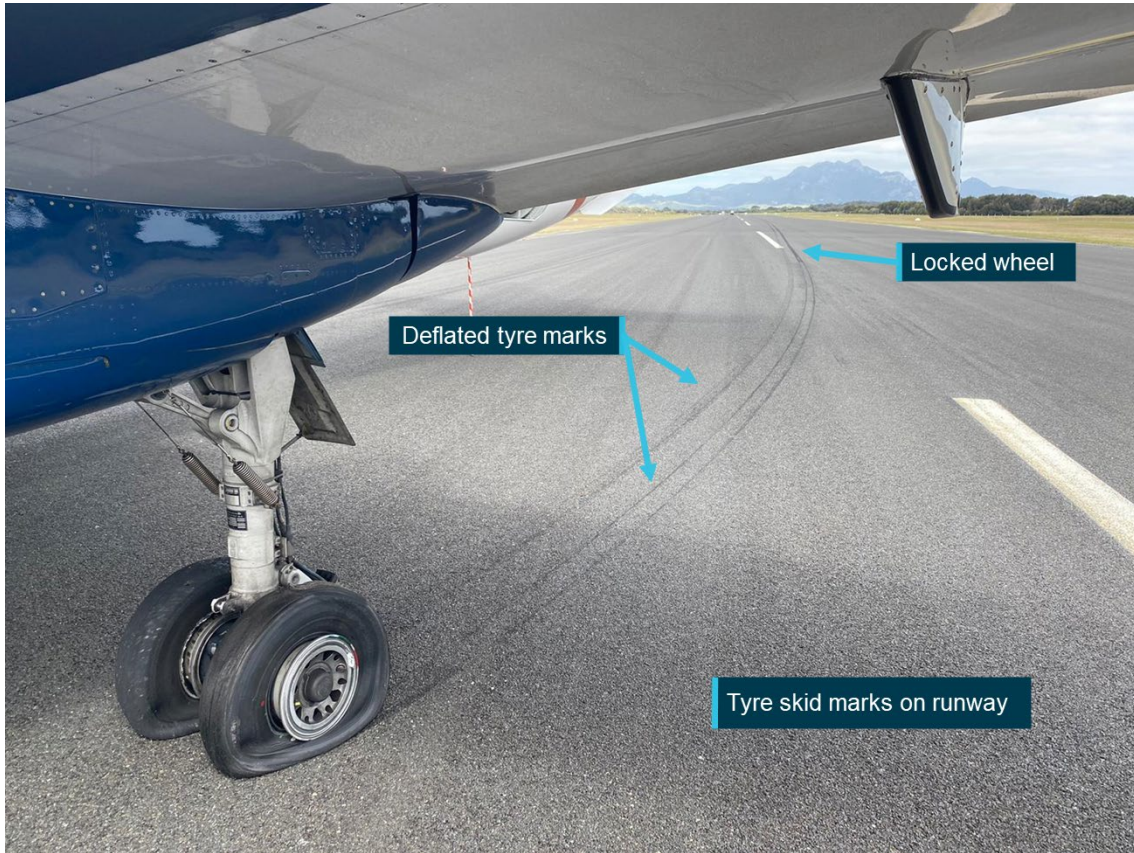
**Figure 5: Left main landing gear tyre marks**

As the aircraft commenced the take-off roll, heat from the dragging brakes increased rapidly due to the acceleration of the wheel assemblies. At 46 knots the aircraft veered to the left, likely as a result of the left tyre locking and skidding. The pilot corrected towards the runway centreline and continued with the take-off. At approximately 80 knots the pilots observed that the aircraft's acceleration rate had reduced and the take-off was rejected.

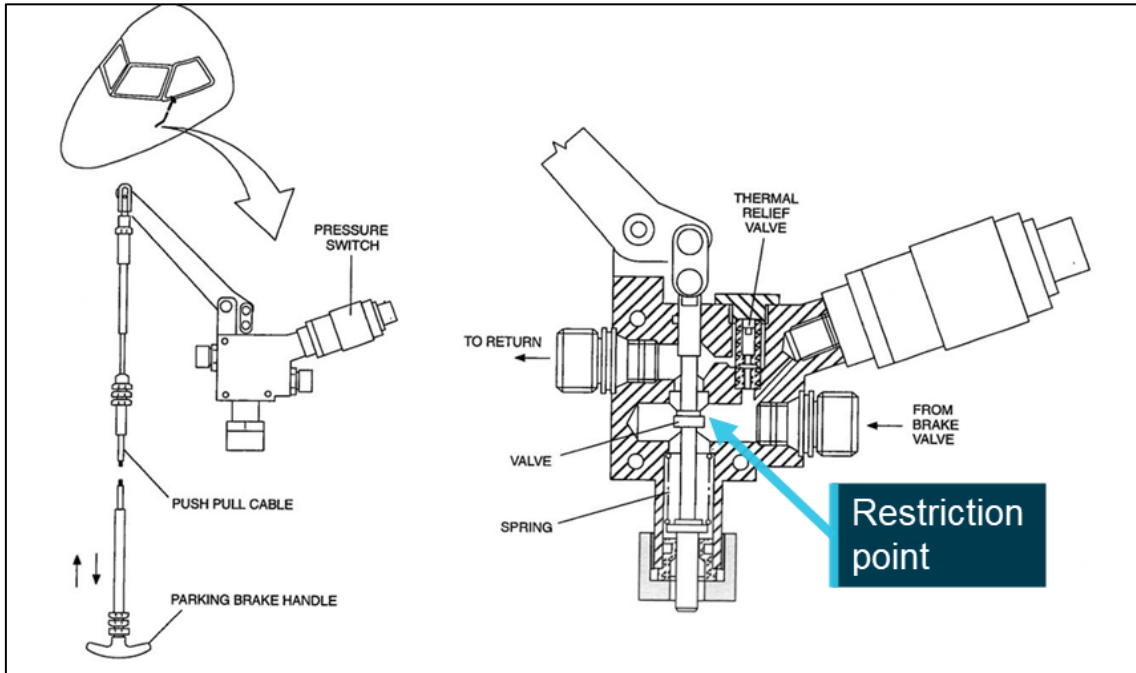
**Figure 7: Parking brake valve internal**

The brake system requires an unrestricted hydraulic fluid flow through a single return line within the parking brake valve for normal operation (Figure 7). Any restriction of this return line will increase the time required for brake pressure to be relieved, resulting in a partially applied or dragging of the brakes. A dragging brake will generate heat within the wheel and brake assemblies. This will cause all brake components, including the hydraulic fluid, to expand, further increasing the pressure in the brake circuits. In the event of a restriction, this increase in pressure will transfer directly to an increase in brake application.

If the parking brake handle is not completely seated by the pilot, the common return line from both brake hydraulic circuits will be partially obstructed within the parking brake valve. This will restrict hydraulic fluid from flowing out of the brake system, slowing down the rate at which pressure is relieved, resulting in a partial application or dragging of the brakes. During the taxi out, the partially applied brakes created heat due to friction resulting in further brake application to the restricted system as the temperature increased.
