# Cabin pressurisation fault, Saab 340B, VH-VEZ

20 km south-west of Goulburn, New South Wales on 25 March 2023

## **ATSB Transport Safety Report**

AO-2023-012

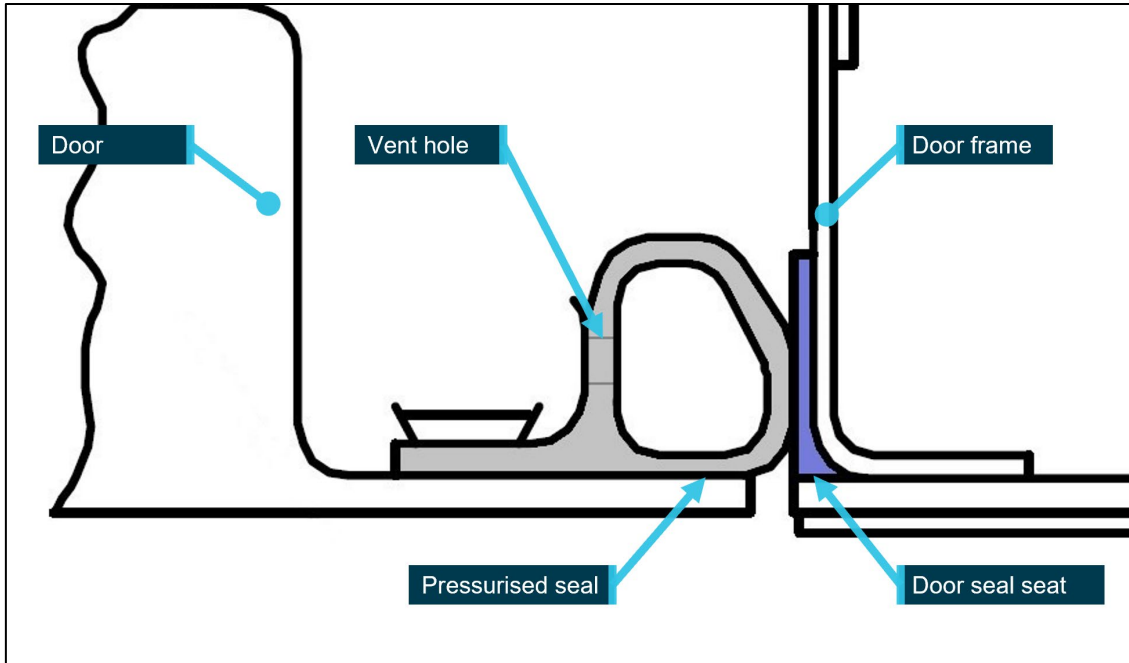
**Figure 1: Door seal system**

Pressurised aircraft use door seals to help maintain cabin air pressure in flight. The Saab 340B uses a pressurised hose-type seal which is attached to the door. The seal is compressed between the door and door frame when closed and small vent holes in the seal allow cabin air pressure to inflate the seal (Figure 1).

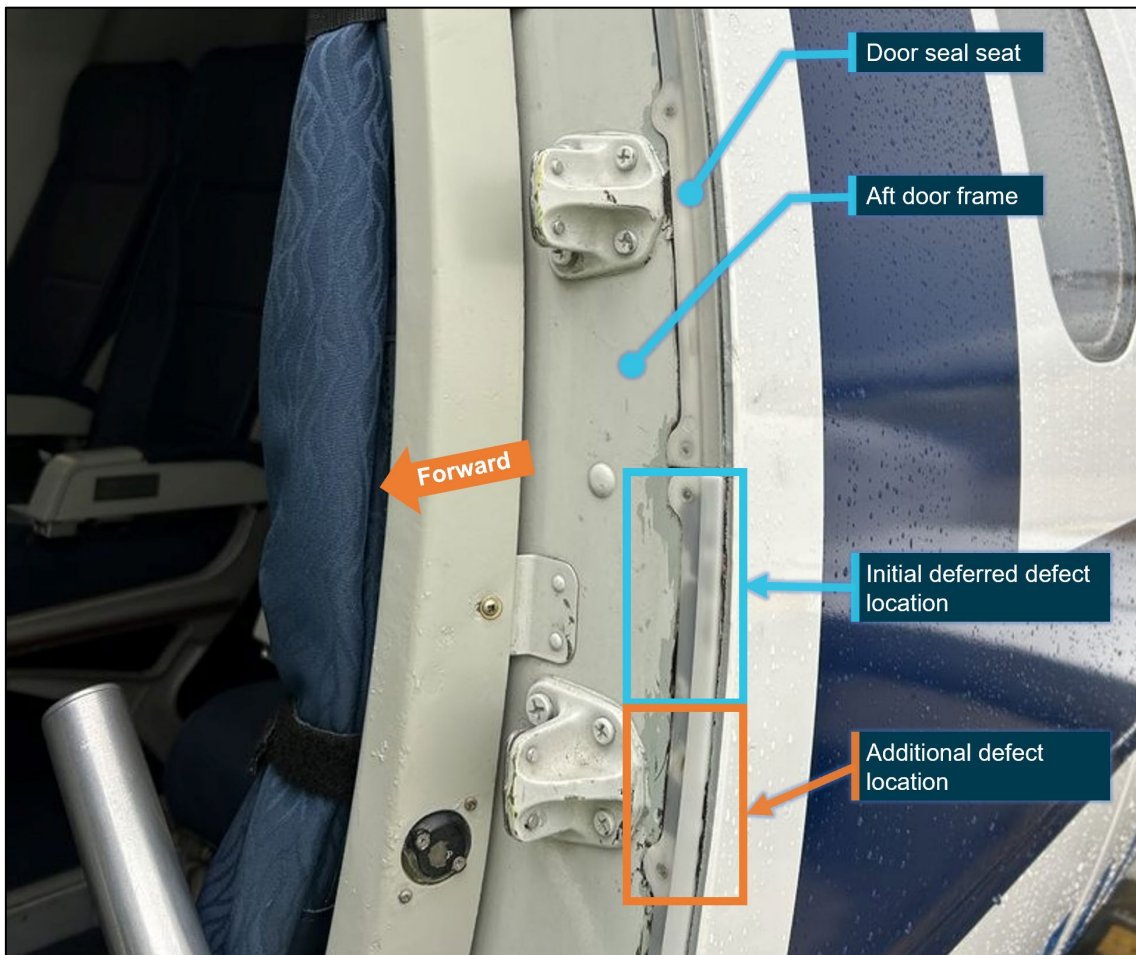
**Figure 2: Exemplar image showing the location of the door seal seat defects**

The seal seat is installed in multiple sections around the perimeter of the fuselage door frame (Figure 2). The seat provides a smooth, consistent surface for the seal to act on and assists in the sealing action of the inflatable door seal. Both defects relevant to this occurrence were in the lower, aft section of seal seat.

On 24 March 2023, VH-VEZ terminated in Canberra at about 2235. The cabin manager noticed a 15 cm section of door seal seat had broken away from its position on the aft door frame around the forward left door (Figure 2) and brought it to the attention of the terminating captain. There were no engineering staff on-site at the time to rectify the defect.

Prior to the first flight of the day on 25 March 2023, when opening the forward left door, the incident flight crew found an additional 10 cm section of broken door seal seat from the same area as the previously identified defect (Figure 2). The captain noted the NSOFD deferral in the aircraft maintenance log, assessed the second broken fragment as the previously identified and deferred defect, and therefore deemed the aircraft as serviceable for flight.

The existence of a second defect was not understood by the on-coming flight crew and was not identified until sometime after the incident flight. The specific level of contribution of each section of broken door seal seat could not be determined, however it is likely that the combined effect of both pieces of broken door seal seat was greater than either individual piece, and resulted in degradation of the aircraft's pressurisation system.

Link Airways did not have maintenance facilities in Sydney to assess and repair the aircraft. Therefore, Canberra-based engineering, having considered the crew's description of the issue, assessed that the aircraft pressurisation system was operating correctly and that the degradation in cabin altitude was due to an excessive leak from the forward left door. As such, the defect was assessed as not affecting the safety of the flight and engineering approved the return passenger flight to Canberra not above an altitude of 10,000 ft. The door seal seat was subsequently repaired in Canberra and the aircraft was returned to service.
