Report RL 2000:05 e

**Incident involving aircraft UK76824,
27 December 1998,
at the Stockholm/Skavsta Airport,
D county, Sweden**

L-125/98

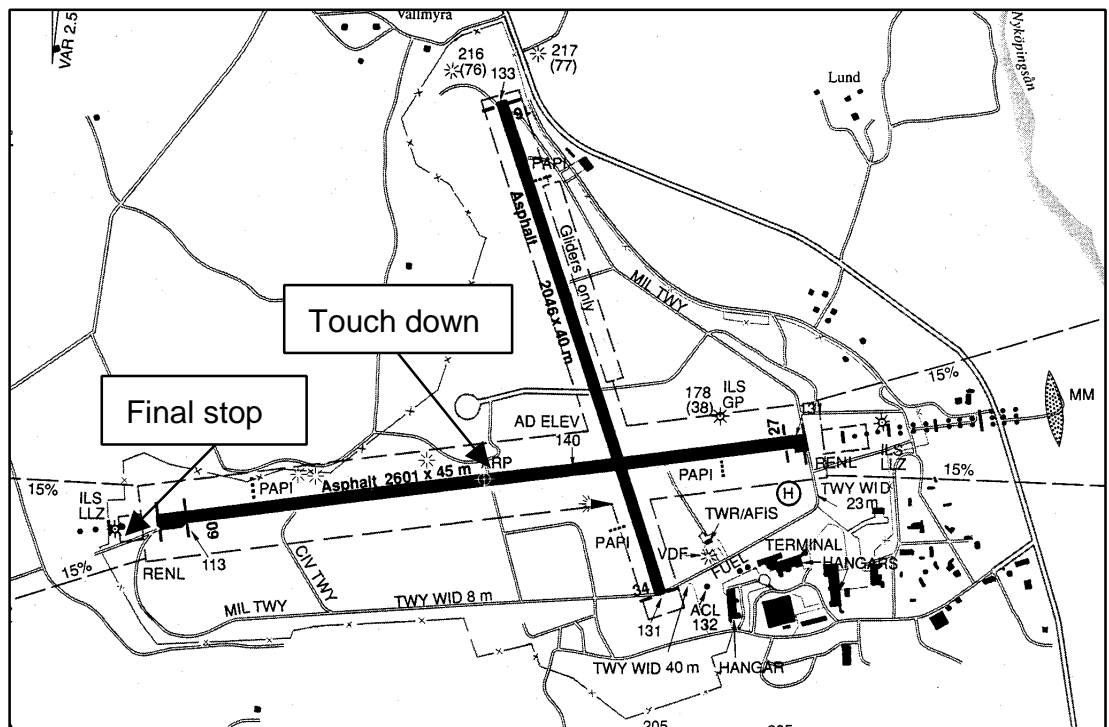
The Stockholm/Skavsta airport has full facilities as outlined in the Swedish AIP. The airport chart below shows where the aircraft touched down and where it ran off the runway end.

runway length. The runway was inspected after the incident by airport personnel accompanied by the commander. The airport personnel were able to determine that the aircraft's wheelmarks began approximately level with a road that crosses the runway at midpoint, that being 1,270 m. from the threshold.

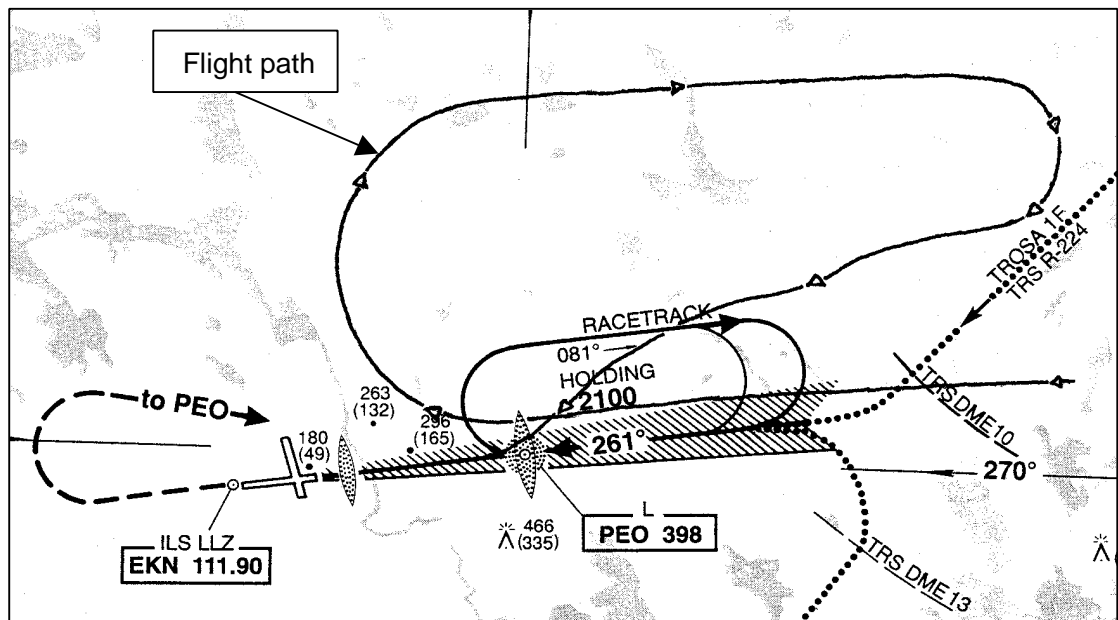
1.16.1 Radar plot

The aircraft's track in relation to the PEO NDB and the airport during the last 12 minutes of flight has been determined with the aid of a radar plot from MUST and is contained in *appendix 5*. All height information is the aircraft's altitude above sea level (QNH). The same radar plot has been transposed onto an approach and landing chart (appendix 2) in the diagram below.

The rushed and unstabilized approach is most probably the foremost reason why the aircraft passed over the threshold "high and hot", the speed being 30–40 km/h too high and the height being 60 m higher than normal. When landing on a runway with a low braking coefficient, a firm and positive touch down without delay is recommended. The commander in this case let the aircraft float for almost six seconds above the runway before smoothly putting it down. All these factors combined resulted in the aircraft touching down nearly half way down the runway, with only approximately 1,330 m remaining in which to stop.
