## **Report RL 2001: 18e**

***Accident with aircraft SE-LIR  
at the Gällivare airport, BD County,  
Sweden, on 10 November 2000***

**Case L-113/00**

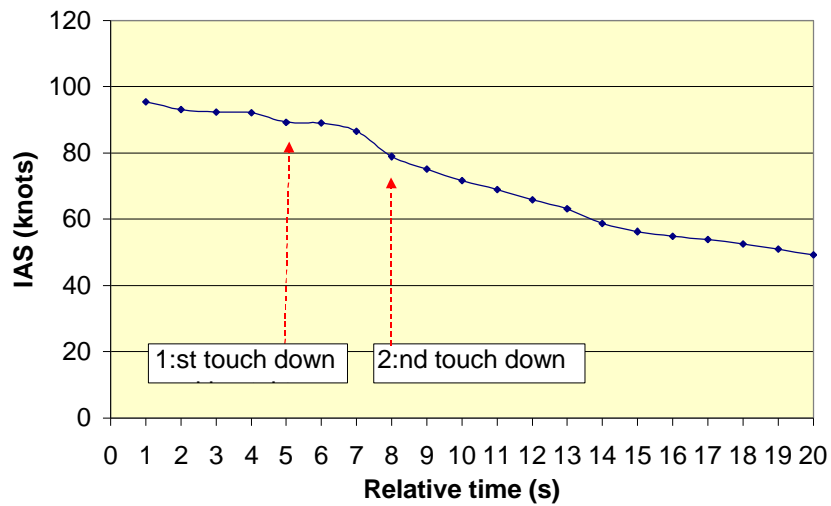
In the diagram below the relationship between indicated air speed (IAS) during the landing and the time in seconds from the first recorded data can be seen.

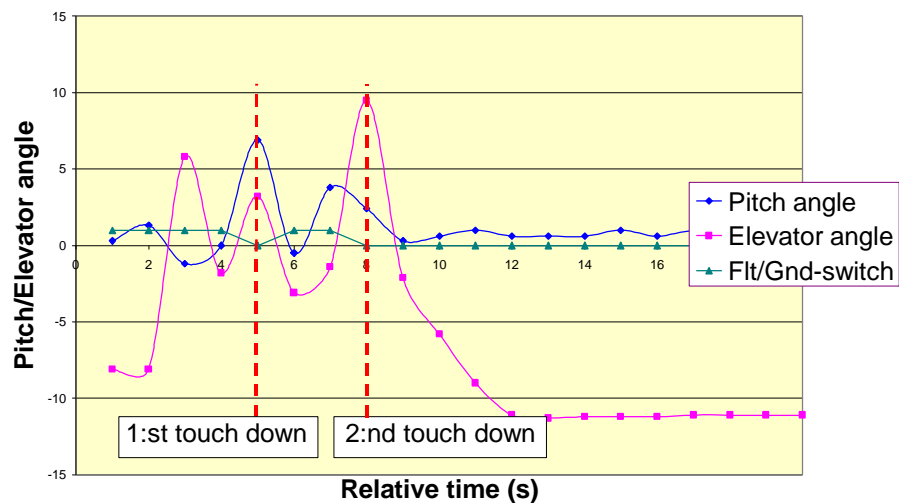
In the following diagram the aircraft pitch angle, the aircraft elevator angle and the ground contact as recorded through the flight/ground switch are compared in relation to time from the first recorded data.

The largest vertical acceleration occurred during the first touchdown and was measured by the aircraft accelerometers as follows:  
 1.692/2.855/1.792/1.103/0.838/0.769/0.719 g

As indicated in the diagram in section 1.11.1 the landing was somewhat uncontrolled. The first touchdown was made with an unusually nose high attitude. The aircraft then bounced and was airborne for about three seconds before touching down for a second time and then remained on the ground. It is reasonable to assume that it was in connection with the first touchdown that the aft section of the aircraft struck the ground and sustained structural damage.
