Report RL 2001:23e

*Aircraft incident to SE-LKB
in the Hudiksvall airspace, X county,
Sweden, on February 23, 2001*

Case L-007/01

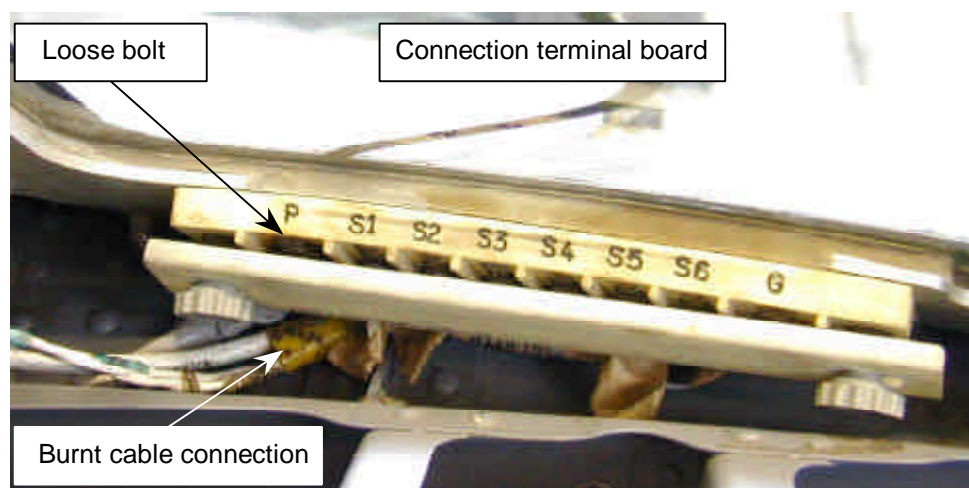
Company personnel carried out an inspection of the aircraft after the incident, which revealed a loose bolt on the terminal board for the right windshield heating system. The purpose of the bolt is to fasten one of two cable shoes that are connected to the electrical cables (W110-2834-8) that supply electrical power to the windshield heating element. Carbonization and heat damage to the cable insulation and the connection terminal board indicated that overheating had taken place.

As indicated in section 1.16 one of the bolts situated on the terminal board for the right windshield heat system was loose. The electrical cable and the terminal board in this area had suffered burn damage. This indicates that the loose connection had caused arcing, generating a heat build up and overheat the area, which in turn manifested itself in the form of a burning smell and smoke. As the electrical current in the heating element did not exceed normal values even with the system selected to maximum heating, the system circuit breaker did not trip. The arcing most probably ceased spontaneously.

The investigation has not been able to ascertain when the bolt became loose. It is possible that the bolt had been loose for quite a period of time, giving no noticeable indications of intermittent dis-connection or arcing.
