Report RL 2001:25e

***Accident involving helicopter SE-HPL
approx. 5 km north of Ockelbo, X County,
Sweden, on the 21st of February 2001***

Case L-006/01

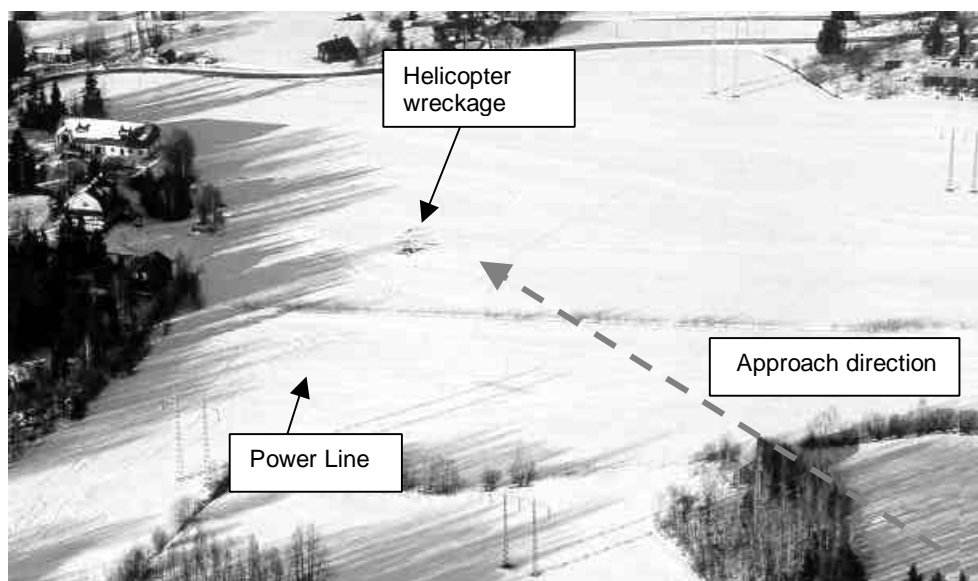
The helicopter impacted the ground on a snow-covered field approximately 50 meters from the intended landing site. Electrical power lines consisting of two phase cables 15.6 meters above the ground and two header cables 21.9 meters above the ground run about 20 meters east of the impact site. The phase cable cross-sectional area is 454 mm² and that of the header cables is 85 mm². Another set of power lines runs parallel to these about 90 meters to the east. The second set of power lines consists of three phase

cables and two header cables at about the same height as the first set of lines.

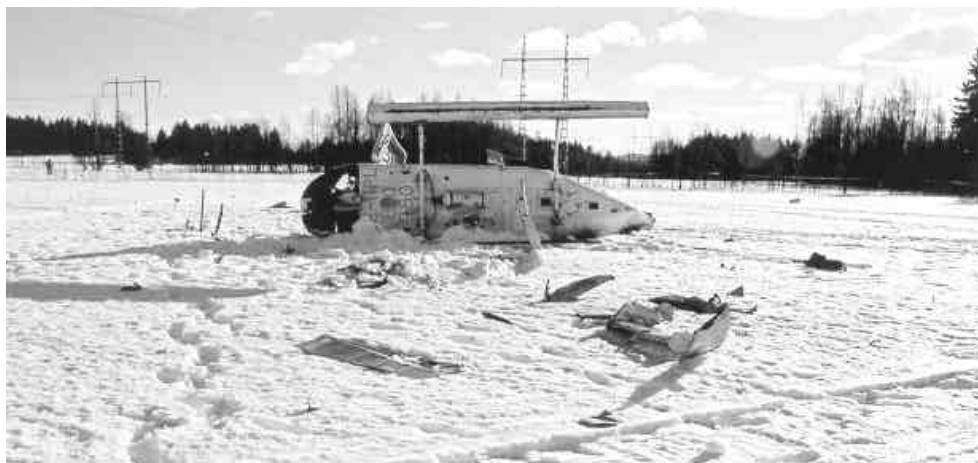
The helicopter received extensive structural damage. It was lying on its right-hand side with the nose section pointed in the opposite direction of the approach. The main rotor blades were shattered and the tail boom was separated from the helicopter. The damage to the forward landing skid legs and foot supports indicated that the helicopter had collided with a power line.

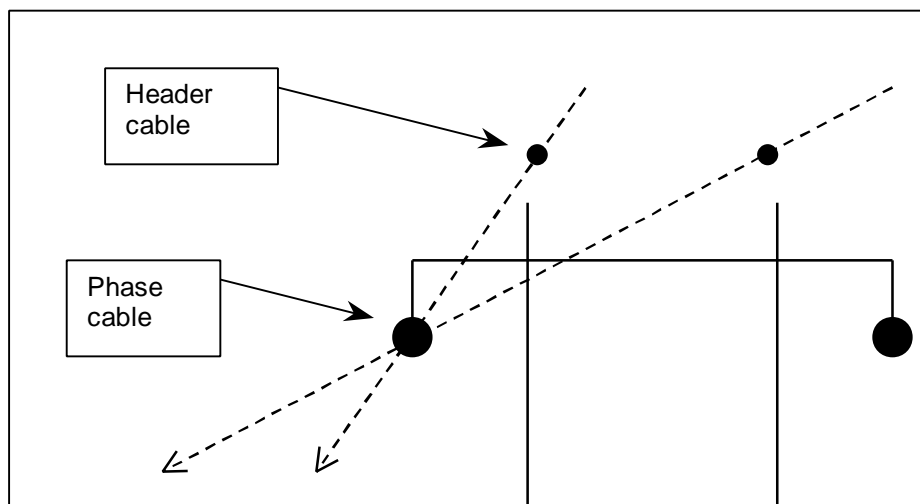
By drafting the electrical power lines in question to scale, representing the height above the ground and the distance between the cables; one is able to see from the sketch below that the thinner header cables can spatially collocate and become “hidden” in front of the thicker phase cables at certain approach angles. Critical angles of approach in this respect were approximately 30° and 65°.

- The header cables are thinner than the phase cables and more difficult to see. As depicted in section 1.16.2 the header cable in question could have been "hidden" in front of a phase cable.
