## *Final report RL 2014:08e*

**Accident 85 km north of Kiruna on  
September 26, 2013 involving the  
helicopter SE-JHH of the model EC 120 B,  
operated by Kallax Flyg AB.**

File number L-136/13

6/11/2014

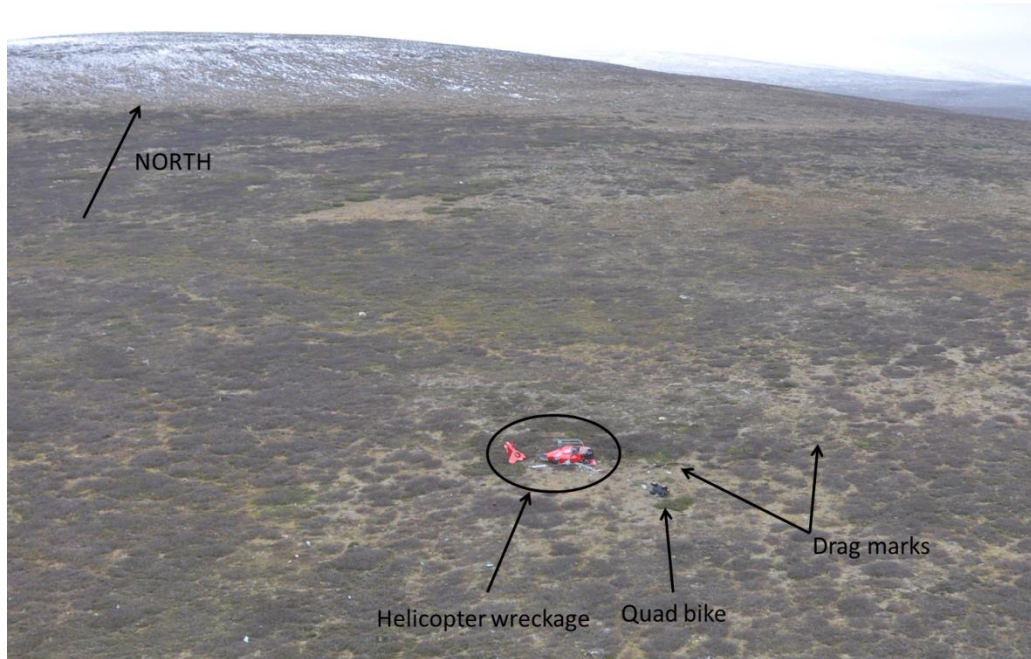
The helicopter sustained substantial damage. The tail boom separated from the fuselage and all rotor blades were broken in several places. The front part of the fuselage was damaged.

Figure 2. The accident site with the helicopter wreckage and quad bike/ATV. Photo taken the day after the event.

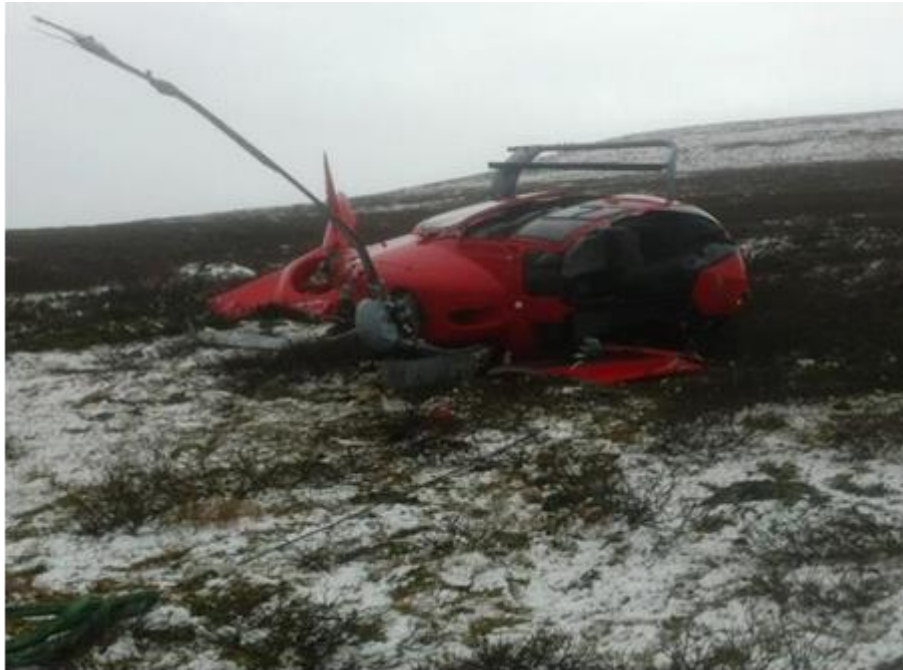
The quad bike had lighter damage and was still connected to the helicopter's cargo hook by the sling load cable and four straps. The cable was taut and ran from the cargo hook along the ground under the front part of the helicopter.

Figure 4. The helicopter at the crash site with sling load cable and straps in the foreground (Photo Kallax Flyg AB).
