Report RL 2001:21e

***Aircraft accident to D-EDVV at Beterås,
approximately 6 kilometers north, north-west
of Strömsnäsbruk, G county, Sweden,
on the 24th of June 2000***

Case L-059/00

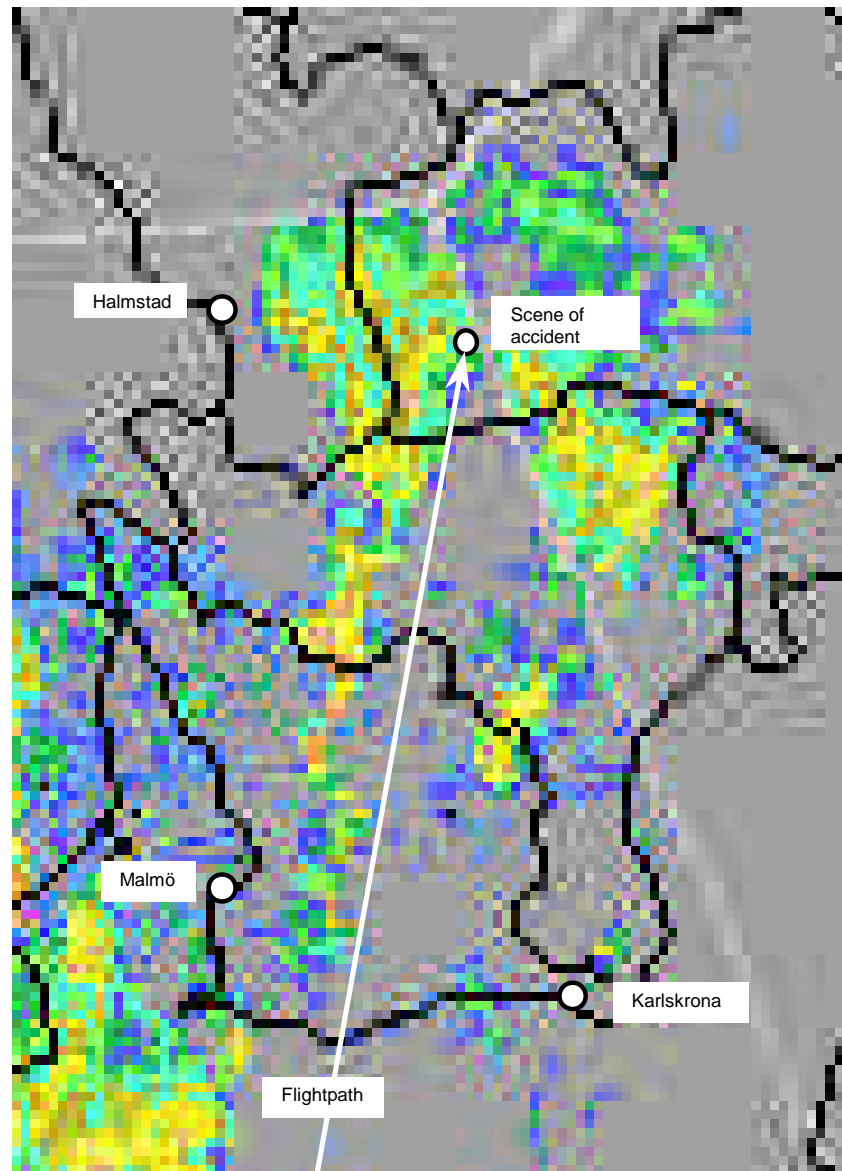
The radar depiction below over southern Sweden from 13:15 hours shows a 20–30 kilometer wide and 100–200 kilometer long echo from shower-like precipitation in a north-south direction from about Eslöv to Ljungby. The depicted echo showed light to moderate intensities, somewhat stronger in the southern sector. The flight route of the aircraft and the accident site are shown on the radar depiction.

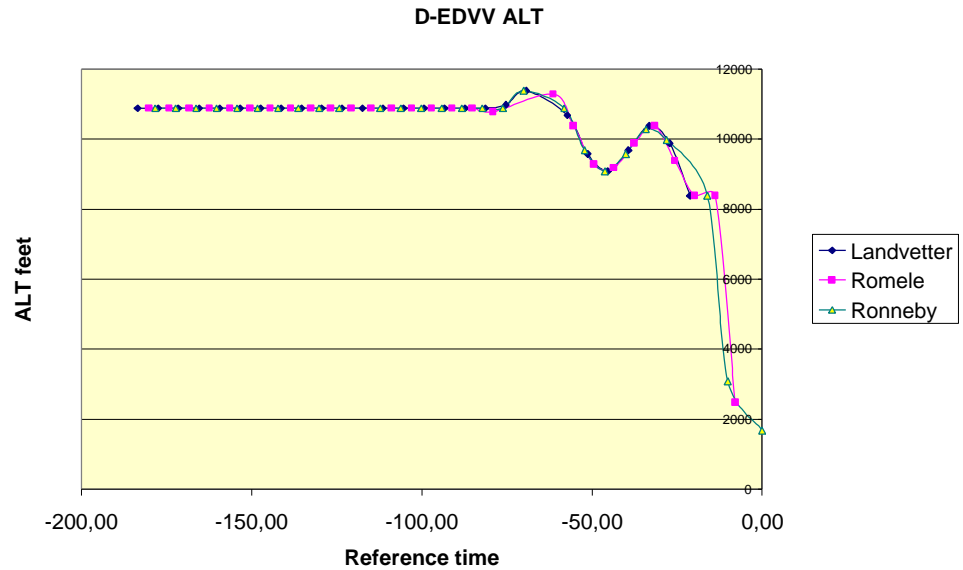
B. Altitude above sea level

Note: The transponder reported altitude has been corrected for the actual atmospheric pressure (QNH 1009 hPa).
