## **Report RL 2001: 22e**

***Incident involving aircraft SE-LIP  
in the airspace between Jönköping  
and Linköping, Sweden on the 22<sup>nd</sup> of  
December 2000***

**Case L-001/01**

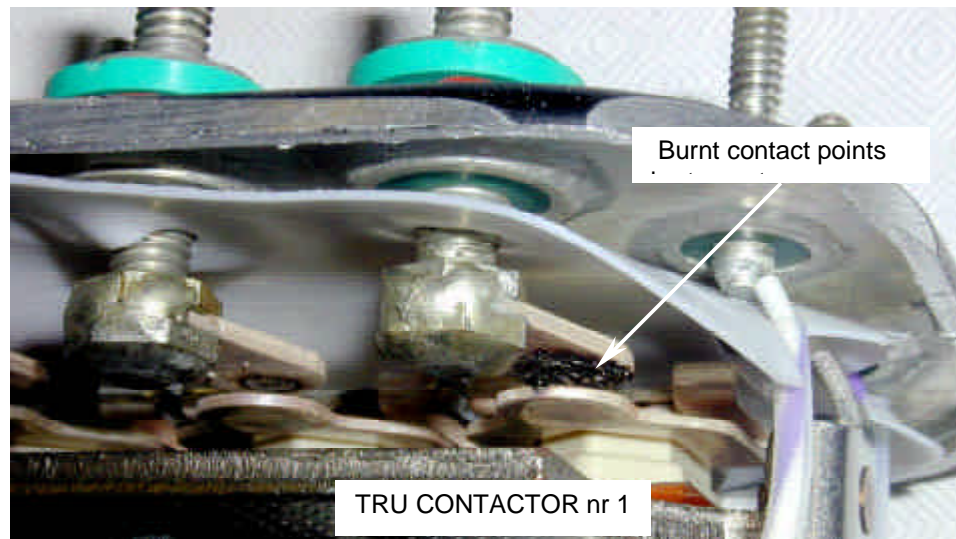
At the time of the functional test of TRU-CONTACTOR no. 1, the contact for one of the phases in the closed position was found to be sporadic. The unit was opened and it was found that the breaker points of the actual phase were substantially burnt. The consequences of this malfunction was that the subsequent component in the system, TRU no. 1, periodically was fed with only two-phase current (2 x 115/200V, 400Hz).

Tests have been performed by feeding a TRU with only two phases to ascertain what the effects of this are on the TRU's downstream direct current. During the investigation it was found that the voltage decreased and the direct current's so called ripple<sup>5</sup> increased with a factor of ten in relation to approved limits.

With the exception of breaker point malfunction, which was located in the left low-voltage system's TRU CONTACTOR, no malfunction has been found in the components that have been examined. The breaker point malfunction can not have caused the smoke or the burnt odor that the pilots experienced since the failure was isolated in a sealed box.

As is evident from section 1.16.2, the malfunction did however possibly cause the output DC-power from the system's TRU to temporarily become too low and instable. The DC-power system provides electrical power to a

Subsequent to these two identical malfunctions, the airline has introduced an operational time limit of 5,000 flight hours for TRU CONTACTORs in these locations. (The same type of relay is also placed at other locations in the aircraft's electrical system, but these have a lesser electrical load.)
