Report RL 2001:19e

***Accident involving helicopter SE-JFY
at Stockholm/Skavsta airport, D county,
Sweden, on the 28th of August 2000***

Dnr L-089/00

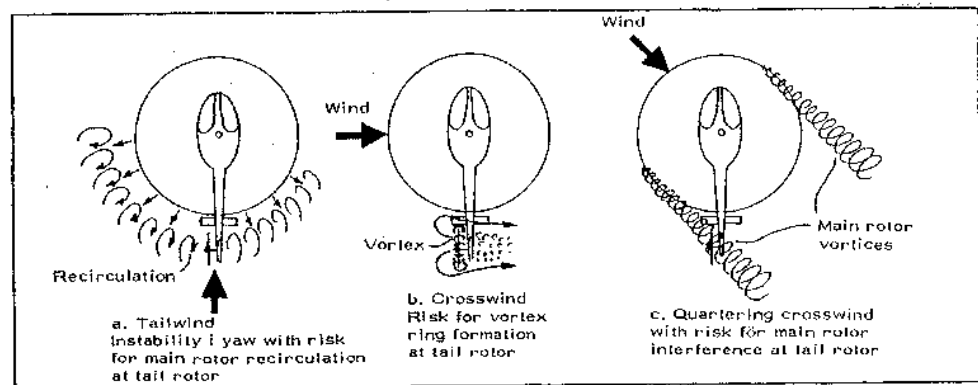
Crosswind from the left on helicopters whose main rotors rotate counter clockwise results in the airflow through the tail rotor being pressed backwards and causes recirculation of air through the rotor, which diminishes the effectiveness of the tail rotor. On helicopters whose main rotors rotate clockwise a similar risk applies with crosswind from the right.

With a quartering crosswind from the front, tip vortices from the main rotor blades can be driven rearwards to the tail rotor and cause so-called vortex interference, which diminishes the tail rotor's effectiveness. On helicopters whose main rotors rotate counter clockwise the risk of this originates principally from a quartering crosswind from the left. On helicopters whose main rotor rotates clockwise a similar risk applies with a quartering crosswind from the right.

When this occurred, instead of steering the helicopter into the wind and climbing forward or backward, the pilot hovered the helicopter above the trailer and allowed it to yaw to the left. In doing so the helicopter got the wind from the right. There is much that points towards the fact that the helicopter, during this maneuver, was placed in a flight position that according to section 1.18 entails a risk of an aerodynamic disturbance of the tail rotor function and loss of yaw control. As is evident from that section, helicopters whose main rotors rotate clockwise – as in the case of the helicopter in question – can be sensitive to wind from the right.

Aerodynamic disturbance of the tail rotor function is therefore the probable explanation to why the pilot did not get the expected rudder response when he after less than one-half of a rotation intended to stop the yaw. The disturbance may have started as a vortex interference between the main and tail rotor and continued as a recirculation around the tail rotor. This resulted in the yaw rate possibly becoming greater than what the pilot intended. Contributory to this and to his difficulty to stop the yaw could have been that at about the same time the rotor's lift was increased, which created a further yawing moment to the left. The situation worsened after a half-rotation, when the helicopter was subjected to tailwind, which normally leads to an increase in the rate of yaw. The pilot's attempt to stop the left yaw was initiated too late or with too little rudder input.
