## **Report RL 2001: 20e**

***Accident involving aircraft SE-KGH  
north of Ljungby/Feringe airport, G county,  
Sweden, on the 1<sup>st</sup> of December 2000***

**Case L-115/00**

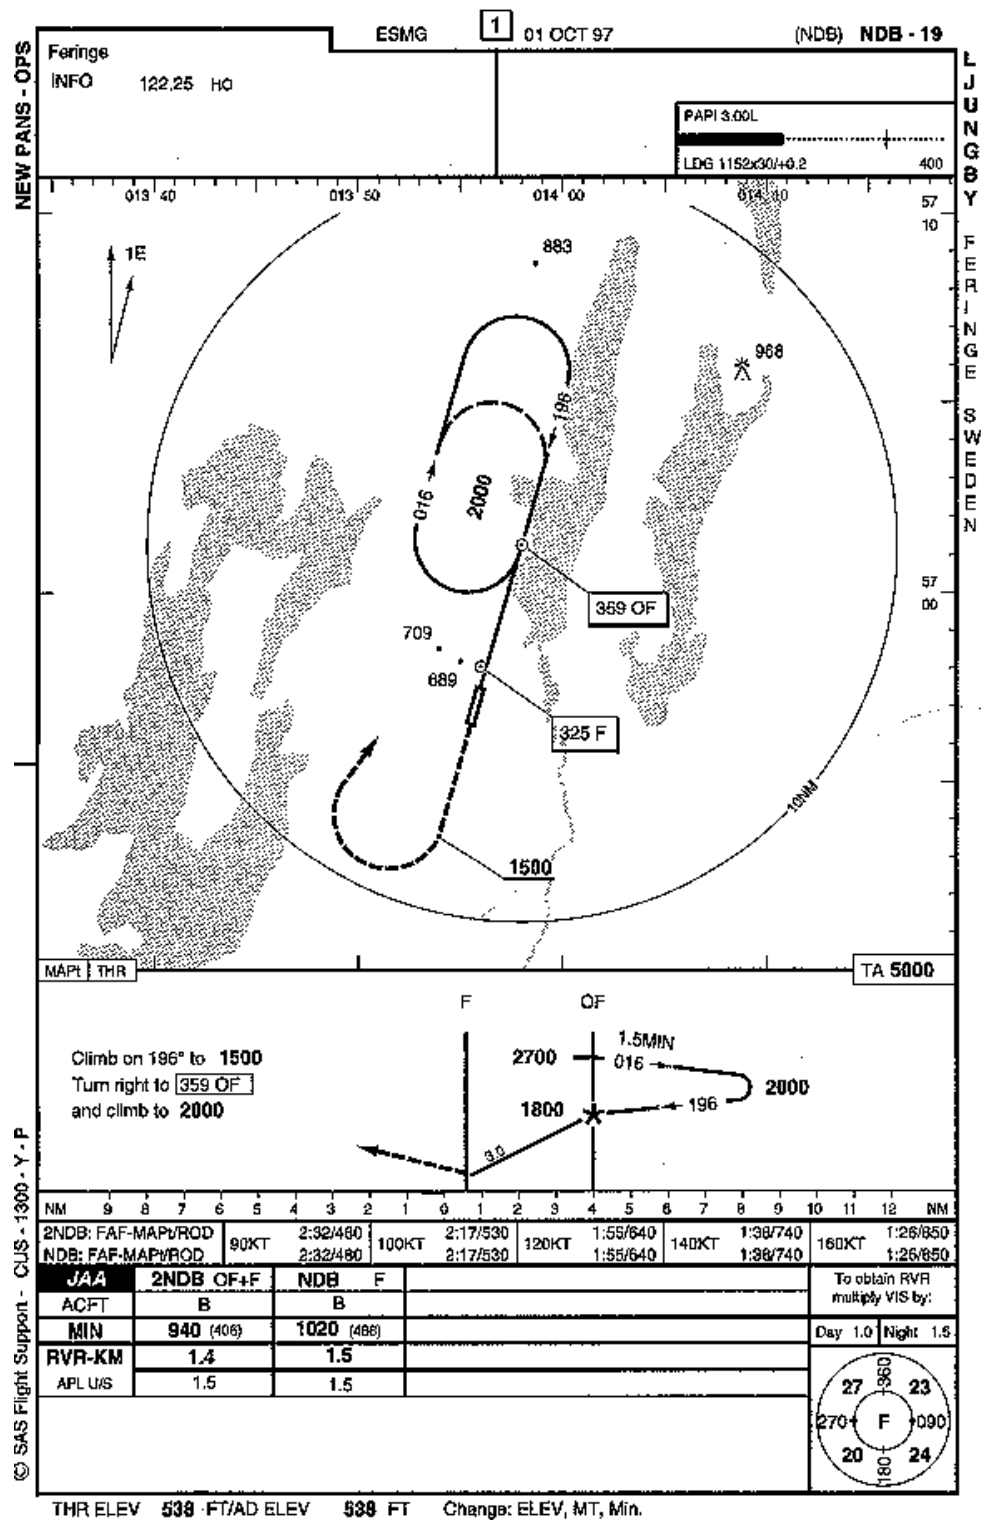
NDB procedure according to SAS-IAL-chart.

Note: The right-hand column (NDB F) should, by right, refer to NDB OF. This has been pointed out to SAS Flight Support and will be changed.

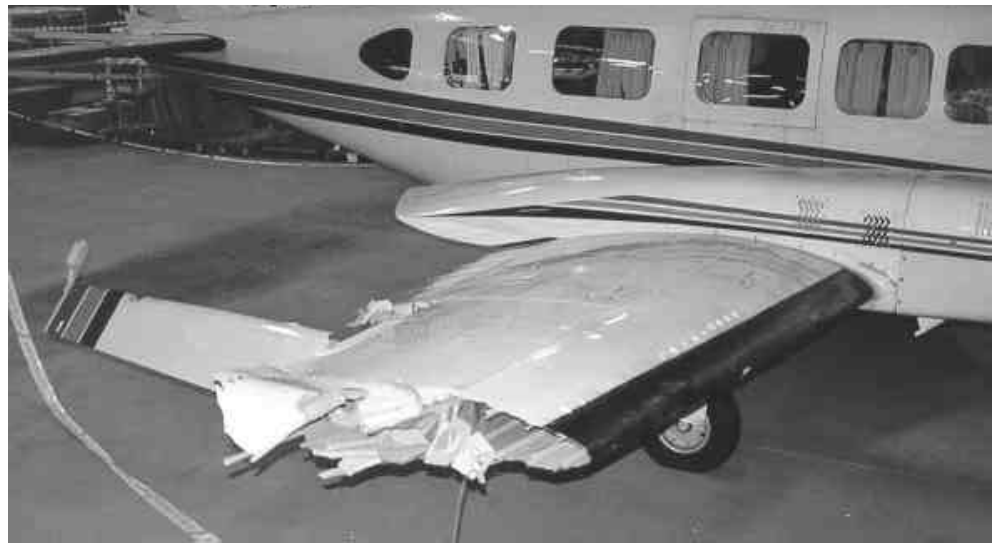
About one meter of the right wing was torn off in connection with the collision with the trees. The right-hand aileron was broken loose from its hinges but remained hanging from the wing by its supporting rod.

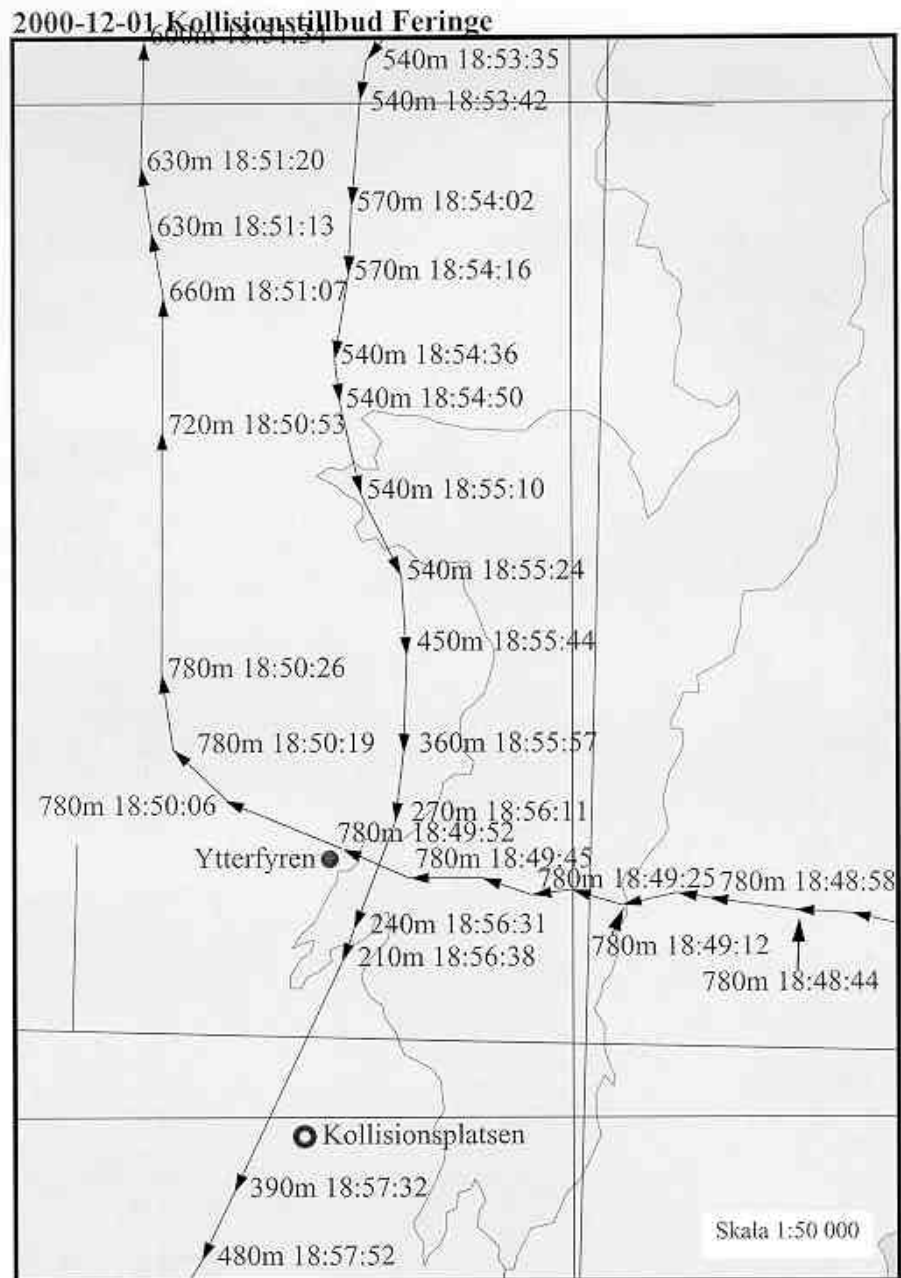
The flight path with accompanying time references for each radar echo is plotted below.

*Note. Between the time points 18:56:38 and 18:57:32 the aircraft has been at such a low altitude that radar echoes have not been noted.*

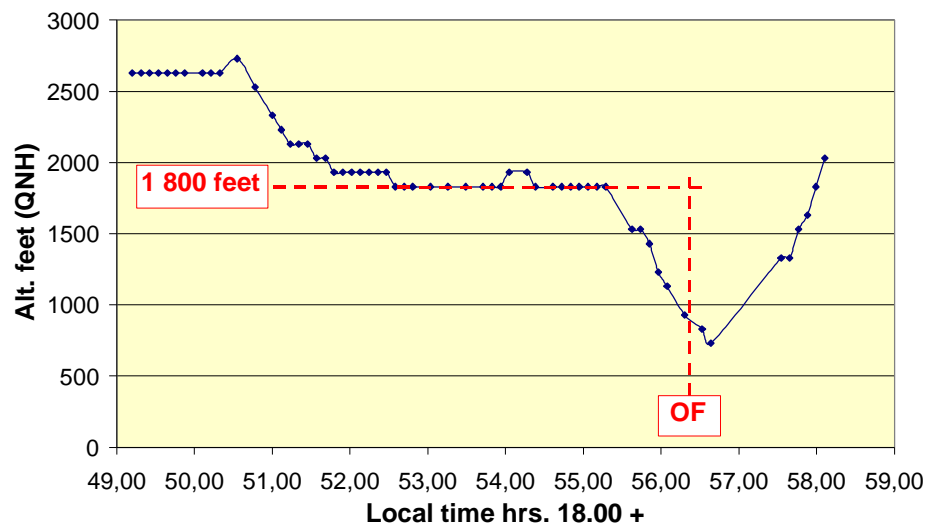
Based on the information in the above radar plot the approach altitude graph below has been constructed. The x-axis depicts local time.
