Report RL 2002:12e

***Accident involving helicopter SE-JGK
at Sör-Mesjön, northwest of Örnsköldsvik,
Y county, Sweden
on 06 January 2001***

Case L-002/01

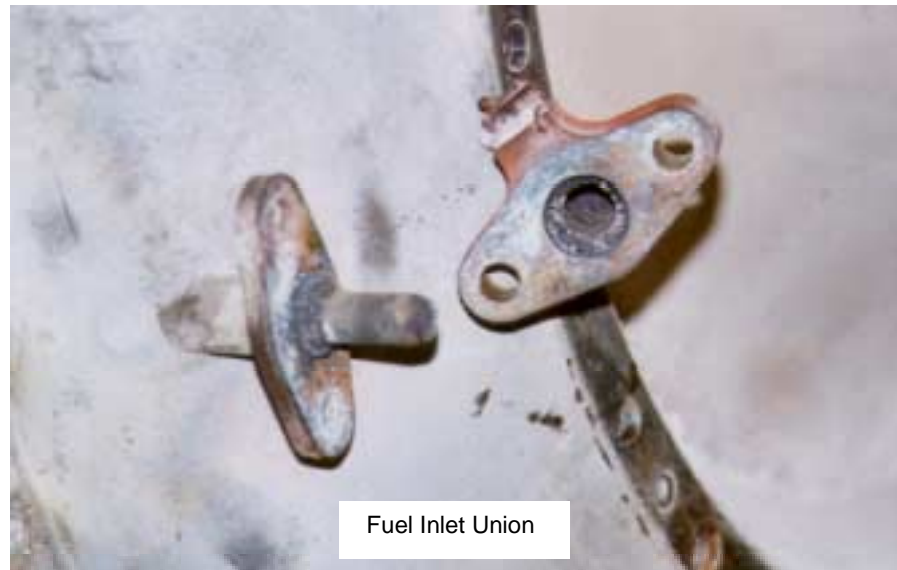
During further analysis of the fuel line connecting the fuel control unit with the combustion chamber, a fuel inlet union in the combustion chamber showed evidence of being clogged with black coke. The inlet union is situated between the Over speed and Drain valve and the Injection wheel in the

combustion chamber. Any clogging that occurs in this fuel line will either stop or reduce the fuel flow to the combustion chamber.

The coke was analysed by CSM using spectral analysis and it was determined that it contained calcium, carbon, barium, magnesium, fluorine, in addition to traces of iron, sulphur and oxygen. According to their assessment these basic elements are not derived solely from the burning of jet fuel. Their most probable source would be from the carbonised remains of spent rubber and/or plastic.

The technical investigation revealed that the fuel line between the fuel control unit and the injection wheel in the combustion chamber was clogged by coke, consisting of the carbonised remains of spent rubber and/or plastic. The only explanation for the existence of the coke is that spent rubber and/or plastic must have at some point gotten stuck in the fuel line and been carbonised by the fire. This would indicate that a small piece of plastic or rubber entering the engine fuel system and blocking the flow of fuel to the injector wheel could have caused the engine failure.

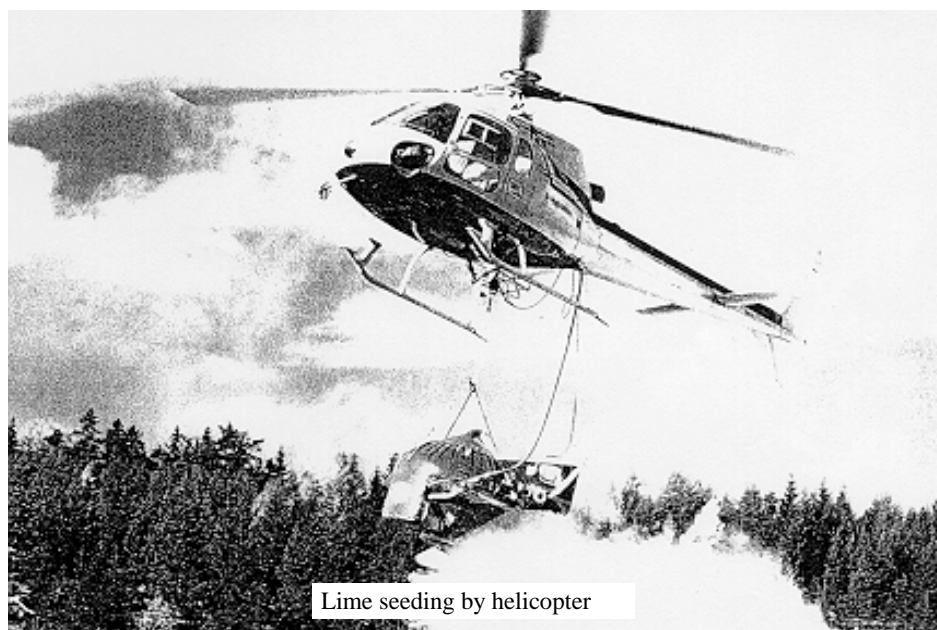
The specially designed lime spreader used in seeding operations has a cylindrical form and is made of fibre glass strengthened plastic. It is slung beneath the helicopter using two cables that are connected to the cargo hook under the fuselage. The pilot is able to open and close the lime release valve on the spreader from the cockpit
