## Report RL 2002:11e

***Infraction of minimum separation  
between the aircraft SE-KOL and SE-ISV  
at Stockholm/Arlanda airport, AB County,  
Sweden, on 28 November 2001***

Dnr L-085/01

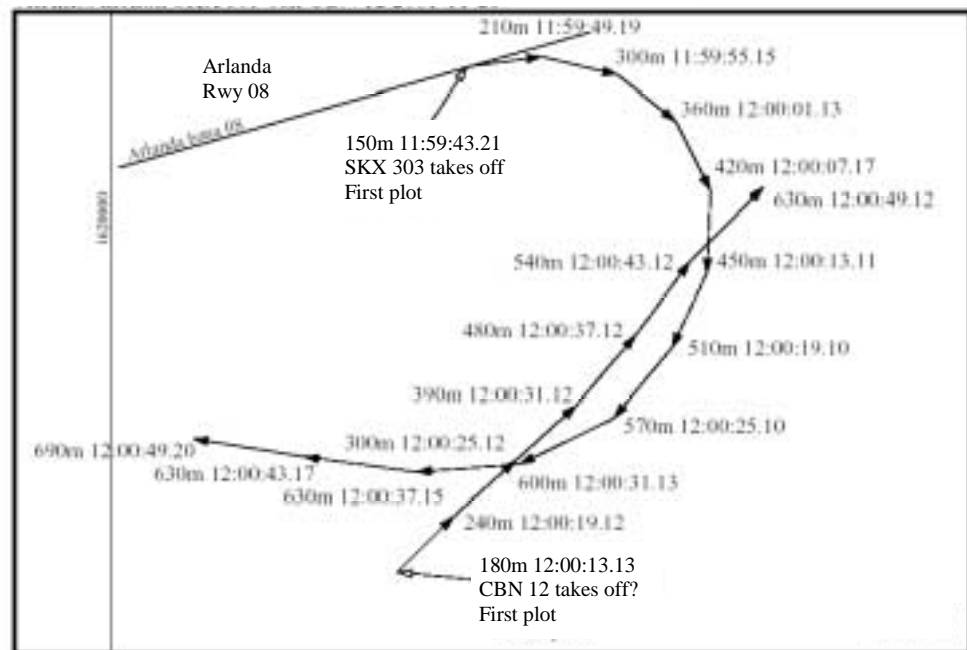
#### Airmiss between SKX 303 and CBN 12, 2001-11-28

Through analysis of the radar data from Arlanda's MSSR<sup>8</sup> radar, the following relative positions/correlations have been ascertained.

<i>Time</i>	<i>Event</i>	<i>Alt. SKX303</i>	<i>Alt. CBN12</i>	<i>relative range</i>
11.59.45	SKX303 is initially observed on radar	500 feet	–	–
11.59.56	SKX303 is observed to initiate right turn	1,000 feet	–	–
12.00.14	CBN12 is initially observed on radar	1,500 feet	600 feet	1.28 nm
12.00.19		1,700 feet	800 feet	0.83 nm
12.00.26		1,900 feet	1,000 feet	0.33 nm
12.00.32	The aircraft have passed each other	2,000 feet	1,300 feet	0.23 nm
12.00.38		2,100 feet	1,600 feet	0.77 nm

According to the radar information that exists and the fact that the pilots in CBN had visual contact with the on-coming aircraft, there was no risk of a collision. The aircraft were closest to each other at time 12:00:32, horizontally at a distance of 0.23 nm (425 meters) and with a vertical separation of 700 feet (213 meters). Nevertheless it was a very unpleasant experience for the air traffic controller, who did not have visual contact with the aircraft from the position she was in, but only observed the radar echoes overlap on the radar screen.

- i) A violation of minimum separation ensued between aircraft CBN and SKX 303. The closest they came to each other was 0.23 nm (425 meters) with a vertical separation of 700 feet (213 meters).
