Report RL 2002:05e

*Incident involving aircraft SE-KUT
in the airspace above Umeå, AC County,
Sweden, on the 6th of March 2001*

Case L-009/01

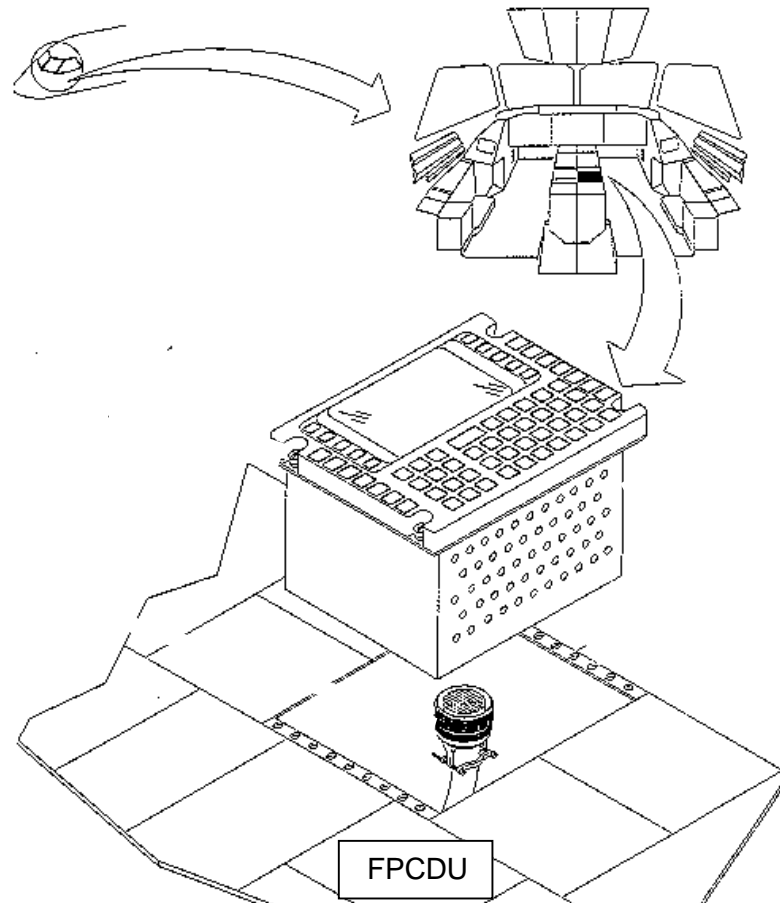
However, later the burnt smell was localized to a control unit called the FPCDU⁴, which is installed in the center console placed between the pilot seats. The FPCDU is an electronic control unit for a number of the aircraft systems. The unit was replaced and sent to the manufacturer, Universal Avionics, for trouble shooting. Subsequent to this replacement no burnt odor was experienced and the aircraft was returned to service.

As is evident from section 1.16, a type-related fault existed within the control unit (FPCDU) at the time of the incident, which could cause the odor of a fire. After this unit was exchanged no smell of fire has been evident in the aircraft. This therefore confirms that the odor of fire was caused by a failure within the FPCDU in the aircraft. In view of the fact that the problem has been attended by the manufacturer and measures have been taken in order to overcome the problem, SHK sees no occasion to issue any recommendation.

The incident was caused by overheated electronics in the control unit FPCDU.

On the 11th of June 2001 Universal Avionics issued a non-compulsory Service Bulletin on the FPCDU (SB No 1117.XX-34-2698) that recommends retrofit of the unit with a latter version (Model 8). The stated intention with this is to diminish the risk of a component failure within the unit.

On the 29th of June 2001 Universal Avionics issued a compulsory ("Alert") Service Bulletin on the FPCDU (SB No 1117.XX-34-2699) that prescribes specified periodical functional testing of the unit. The stated intention is preemptive identification of a possible component failure in the unit which can result in the ("--- odor characteristic of hot electrical equipment").
