Statens haverikommission
Swedish Accident Investigation Board

Report RL 2003:47e

***Incident involving aircraft LN-RPL
and a tow tractor at Stockholm/
Arlanda airport, AB County, Sweden,
on the 27th of October 2002***

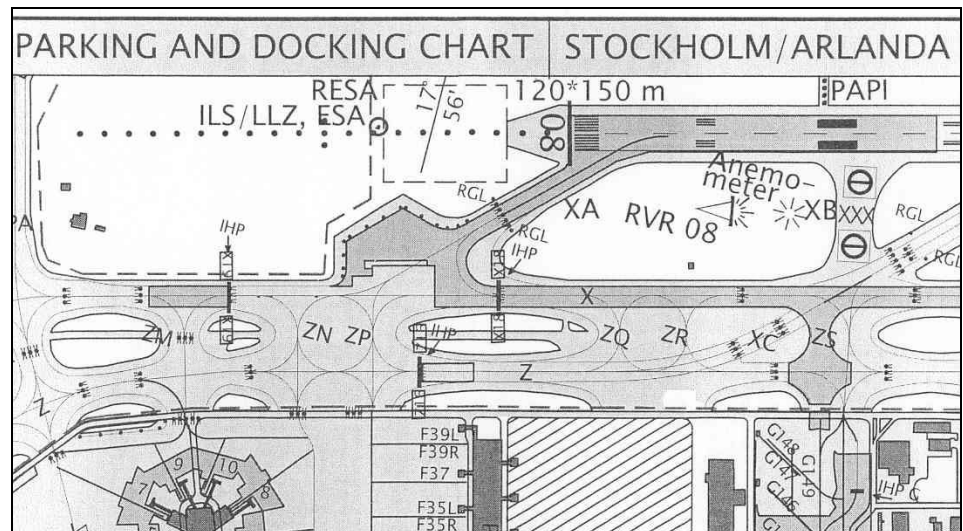
Shown below is the area of the airport in question according to the AIP Sweden dated 15 July 2002, which was applicable at the time. All depicted taxiways have centerline lighting. The areas between taxiways X and Z that are depicted on the chart as white fields consist of grass surfaces.

At the time of the incident the pilots were using these visual references, depicted on the taxi chart they were using, in order to follow the taxi route they had been cleared for. As mentioned above, all of the grass areas between taxiways X and Z were depicted on the chart they were using, but not the "roundabout" between ZN and ZP.

The Swedish Civil Aviation Administration is recommended to revise the present regulations concerning the design of taxi charts in the Swedish AIP and that of information signs, with respect to the risk of misinterpretation (*RL 2003:47e R1*).

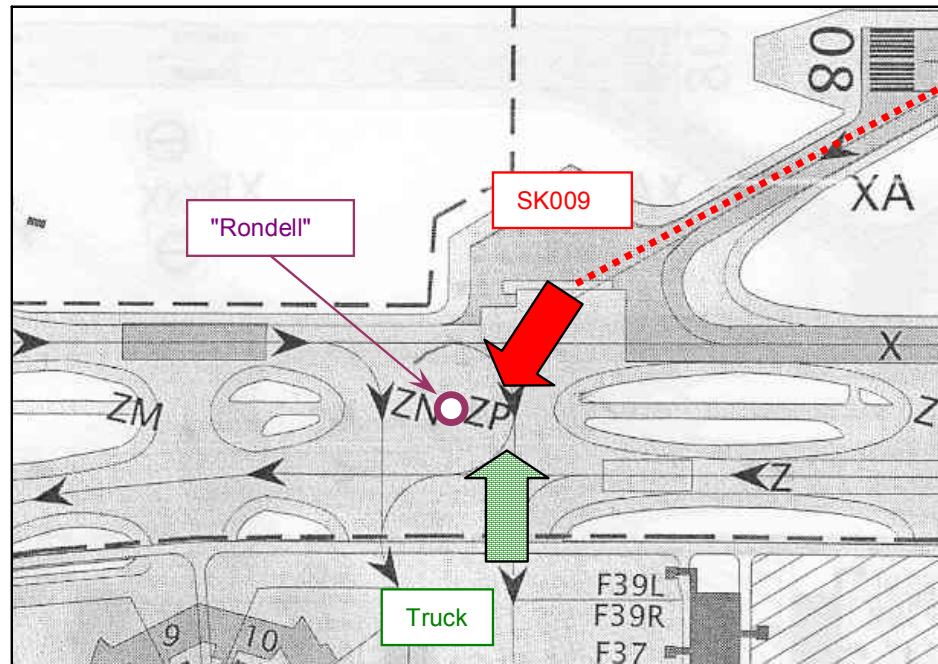
The incident occurred at ZP. Between ZP and ZN there is a "roundabout", which was marked with colored stakes at the time. The "roundabout" was not depicted in the AIP. The taxiways around the roundabout" have concentrated centerline lighting. According to the airport personnel, the lighting was on at the time on all of the taxiways in the area. On the chart depicted below from the AIP/ARRIVAL, the "roundabout" has been drawn in as a circle. The approximate positions of the aircraft and the tow tractor at the time of the incident have been marked with arrows.

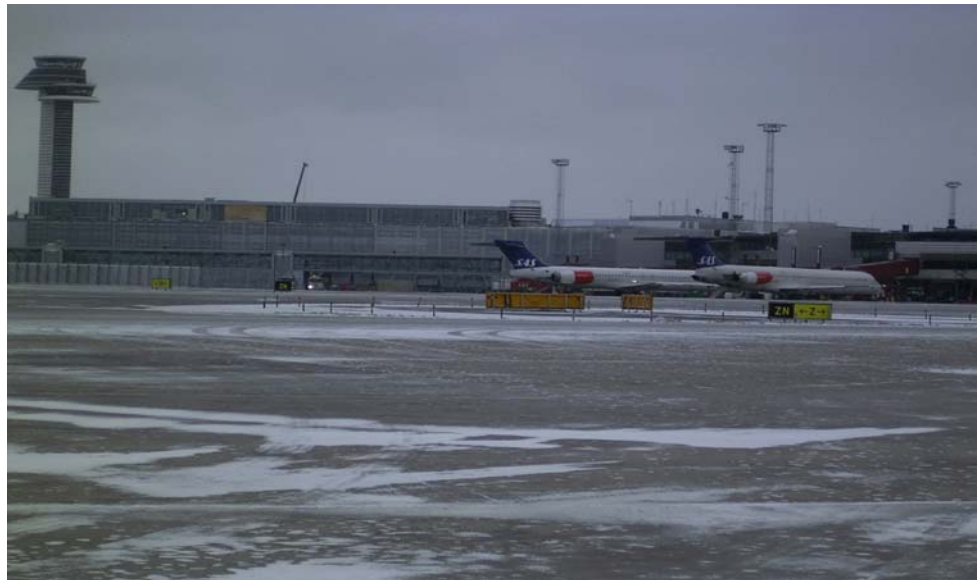
The "roundabout" consists of a circle with a diameter of approximately 20 meters that is painted onto the asphalt surface between ZN and ZP. There are three illuminated information signs within the circle. One of these, with the appearance depicted below, is facing north and is readable from XA. This is a combination type sign, where the letters "ZN" are supposed to show that the aircraft is on a specific taxiway as viewed from the left-hand pilot position (pilot in command) and the symbol "<- Z ->" is intended to show directions to taxiway Z, behind the sign.

The photo below shows the "roundabout", as seen from XA, a few months after the incident.

Taking into consideration how the "roundabout" appeared from the viewpoint of the pilots (see chart and picture in 1.13.2-3), it is understandable that they mistook it for the grass area that is situated immediately to the right of ZN in the direction of travel.

Even the combination sign that the pilots observed within the "roundabout" lends itself to misinterpretation.

It is true that the sign is situated to the left of ZN, according to the instructions in BCL-F 2.2. However, because the letters "ZN" on the sign itself are placed to the left of the symbol " $\leftarrow Z \rightarrow$ ", it may be very likely to interpret the sign as indicating that ZN lies to the left of the sign and also on the left side of the "roundabout", which in this case is erroneous. Even the symbol " $\leftarrow Z \rightarrow$ " can be considered to be ambiguous, as taxi way Z, which lies behind the sign is a "one-way" taxiway to the right from the viewpoint of the observer.

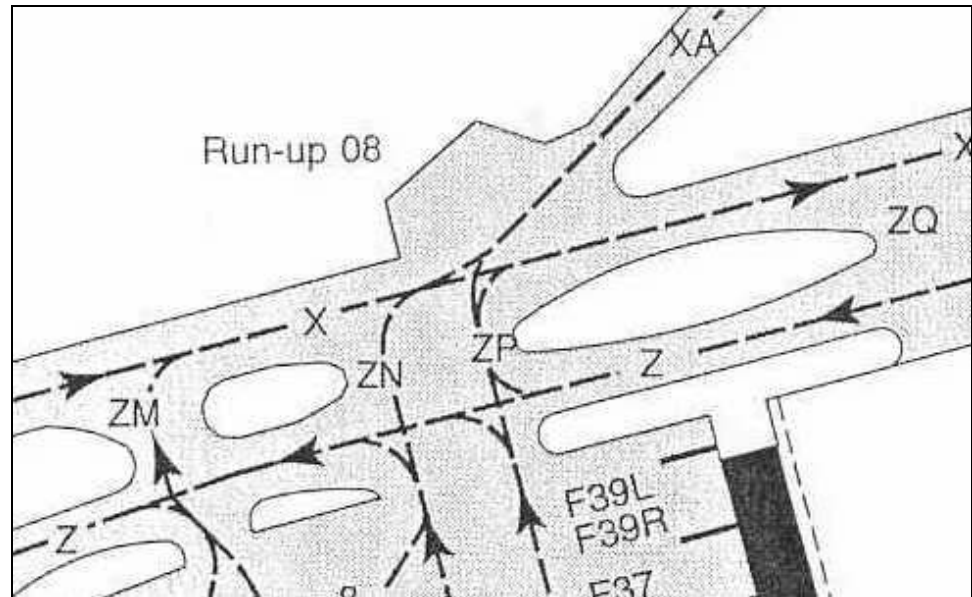
SAS Route Manual

On the taxi chart in the SAS Route Manual, which the pilots used during the in taxiing, the "roundabout" between ZN and ZP was not depicted (see below). The chart was based on the AIP dated 15 July 2002. According to re-

The pilots have stated that they believed that the area between ZN and ZP consisted of an open surface without any "island" in between. Subsequent to the incident the "roundabout" (island) has been drawn-in in both the AIP and the SAS Route Manual.
