Statens haverikommission
Swedish Accident Investigation Board

Report RL 2003:05e

***Accident involving helicopter SE-JUV
at Stockholm/Bromma airport, AB County,
Sweden on the 28th of August 2002***

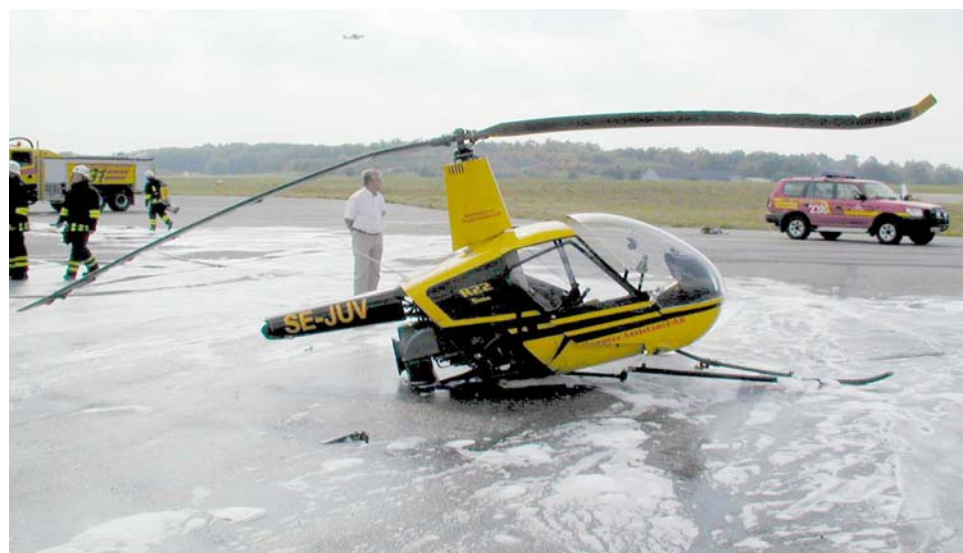
The helicopter's landing gear was broken and the cabin was deformed. The main rotor transmission had been partially broken loose from the structure of the helicopter. The main rotor blades were bent and chafed from having come in contact with the ground. One of the rotor blades had severed the tail boom. Parts of the tail boom and the tail rotor and its 90-degree gear-box were spread around an area at a distance of from 10 to 50 meters from the helicopter wreckage. The damage that could be observed on the tail rotor and the tail rotor spur has been determined to have occurred subsequent to the tail boom being torn off.
