Report RL 2001:24e

***Accident involving helicopter SE-HPO
at Kåsjön, Partille, O County, Sweden
on the 17th of January 2001***

Case L-012/01

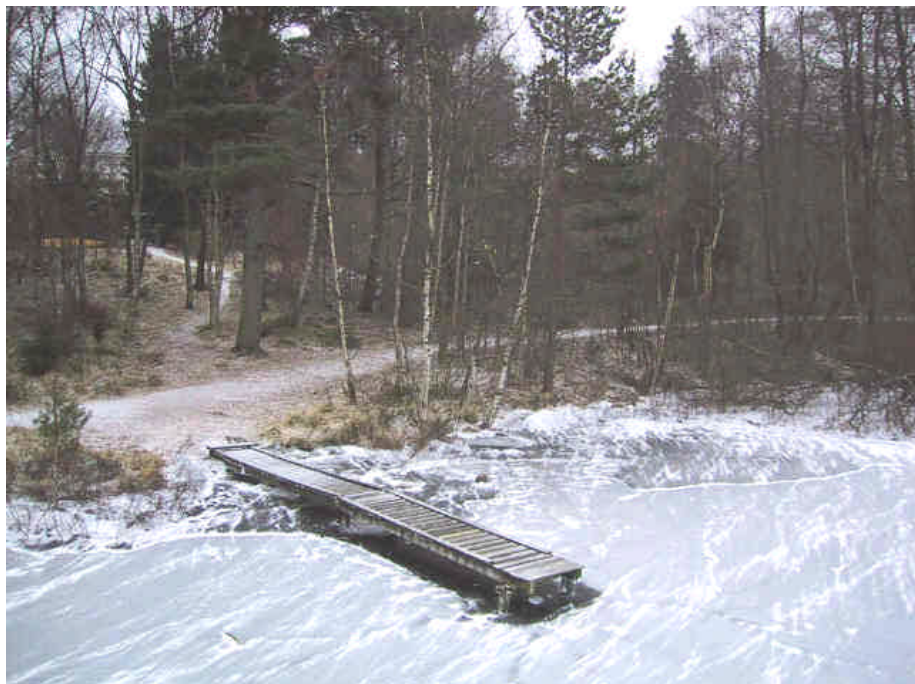
The collision with the tree occurred by a bridge at the southern shore of the lake. The picture below is taken from the direction of approach a few days after the accident. The tree in question was a birch that stood close to the water's edge. Its bark was darker than that of the surrounding trees and it was leaning out over the water. The diameter of the tree was three centimeters.

The collision with the tree by the bridge at the time of the hovering maneuver shows how difficult it is to judge distance in the dark. In this case the actual distance to the nearest tree was most likely less than a meter. Contributing to the misjudgment could have been that the bark of the actual tree was darker than that of the trees nearby and that it was leaning out over the water.
