## **Report RL 2001:26e**

***Accident involving helicopter SE-JUZ  
in Tierp, C County, Sweden  
on the 24<sup>th</sup> of March 2001***

**Case L-013/01**

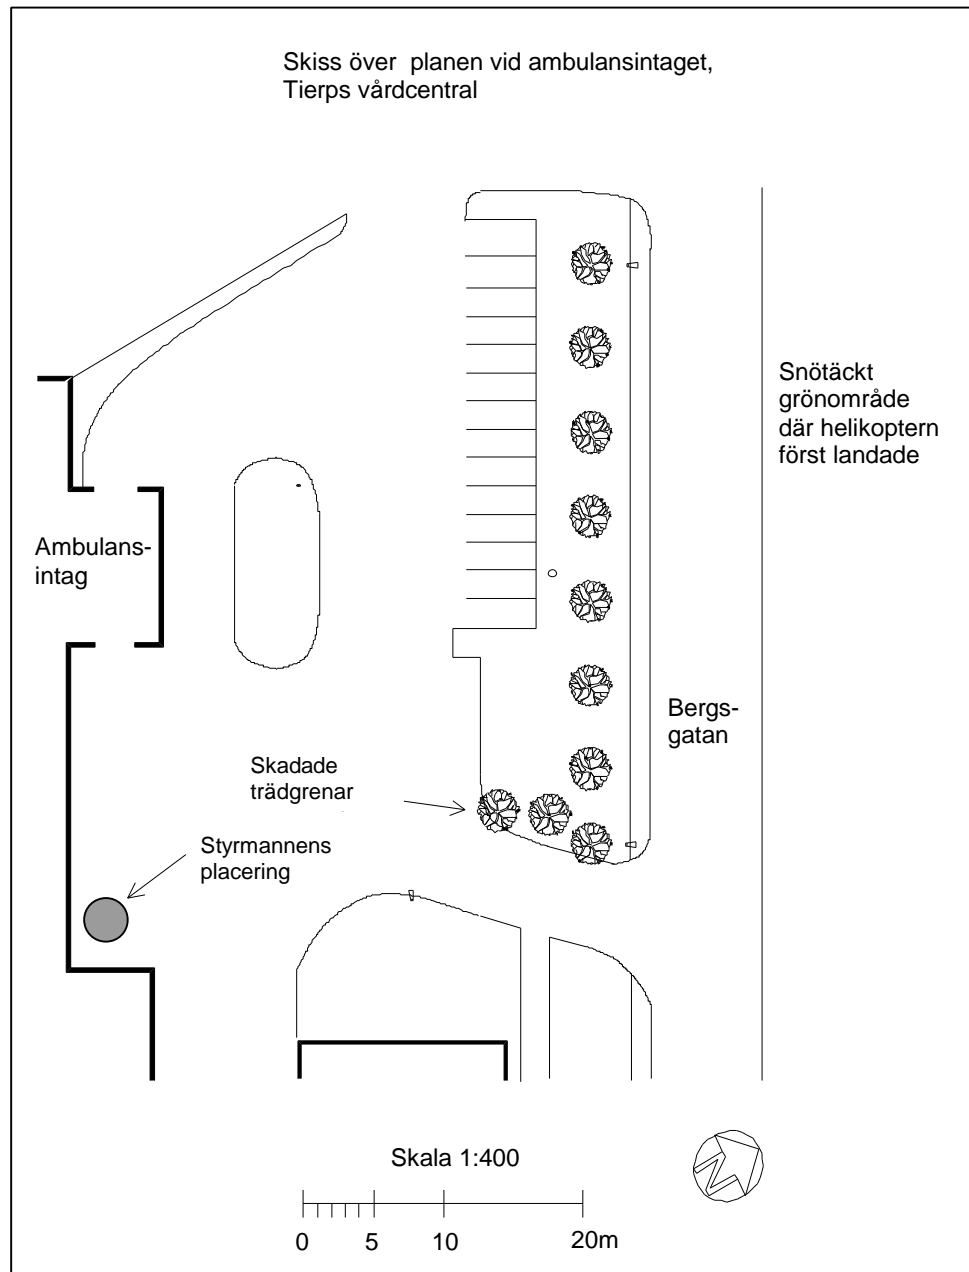
The tail rotor collided with some branches of a tree that stood at the very edge of the car parking lot as depicted in the police survey sketch below.

According to the company manual, landing with this type of helicopter may only be carried out with an obstacle-free landing area larger than 32 meters in all directions. As shown in the police survey sketch in section 1.12.1, the actual parking lot width was only approximately 29 meters and therefore did not fulfill the minimum distance requirement for a temporary landing site. SHK is aware of the fact that it can be difficult to judge the distance to stationary objects with an accuracy of a meter or two. Therefore one should— in those cases where a crewmember is located on the ground— step-off the distance if it is not obvious that the margin of safety is sufficient.
