## **Report RL 2001:42e**

***Incident involving aircraft SE-DUP in  
the airspace above Jönköping, F county,  
Sweden, on 2 February 2001***

**Dnr L-005/01**

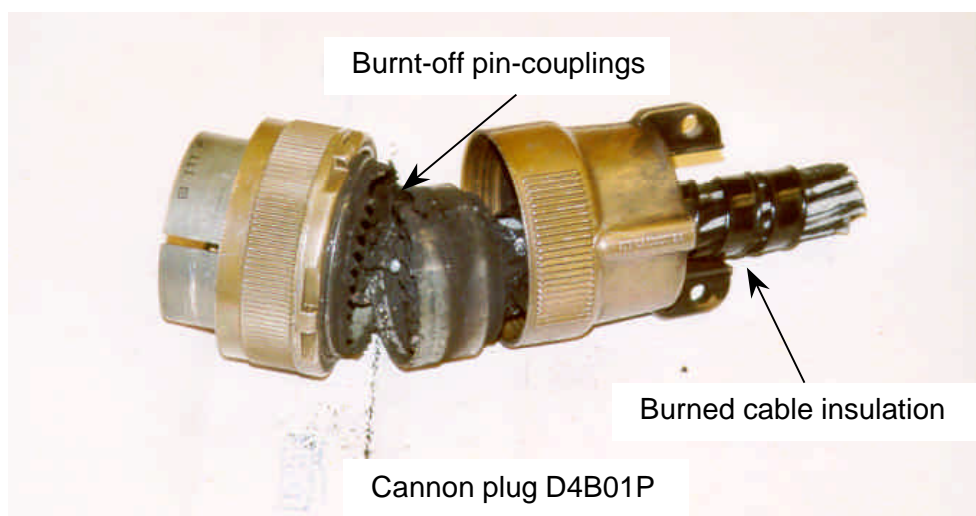
The burned cannon plug has been examined at a technical materials laboratory. The investigation showed that all but one of the electrical conductors within the connector were burned-off adjacent to the pin-clamp couplings. The internal area was completely burned-out and the heat generation had been so high that the copper in the electrical cables had melted.

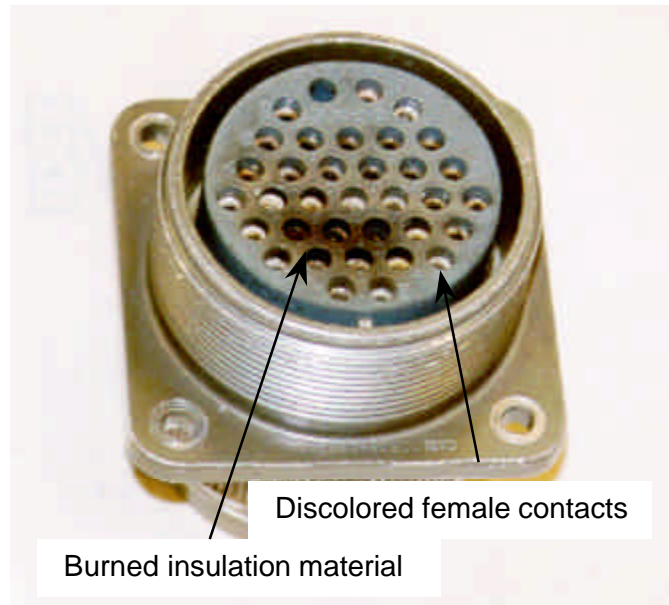
The investigation also showed that several of the contact pins were discolored due to the overheating and that the insulating material between the pins in the cannon plug had been affected by high temperature and had also been discolored. This all points to the fact that the source of heat generation was not external in connection with the fire but took place within the electrical pin couplings during an extended period of time.

No manufacturing defect of the cannon plug that could explain the flash-over has been identified. The technical investigation of the cannon plug showed however that internal overheating had taken place in the connector over an extended period of time. The rubber material between the contact pins in the male portion had “aged” so that its insulating ability had been impaired.

All the evidence therefore indicates that the electrical short was initiated by a flash-over between two contact pins. The electrical arc and heat that was hereby generated caused further shorting between other contact pins in the cannon plug. Finally an electrical arc was produced that short circuited all the electrified pins simultaneously, thereby creating an explosion and local fire within the cannon plug, resulting in the smoke generation.

This occurrence and the previous incidents that took place involving the overheating and fire in the same type cannon plug indicate that the cannon plug was under dimensioned. The design of the cannon plug was such that the cooling ability of the surrounding air was not sufficient to dissipate the heat that was generated on the surface of the conductor pins when all ovens and water boilers were turned on to full rated effect.

The final modification that the manufacturer has introduced with regards to the cannon plug, and that has obviously solved the problem, entails larger contact surfaces and better cooling. As this modification is obligatory, SHK finds no reason to issue any recommendation.

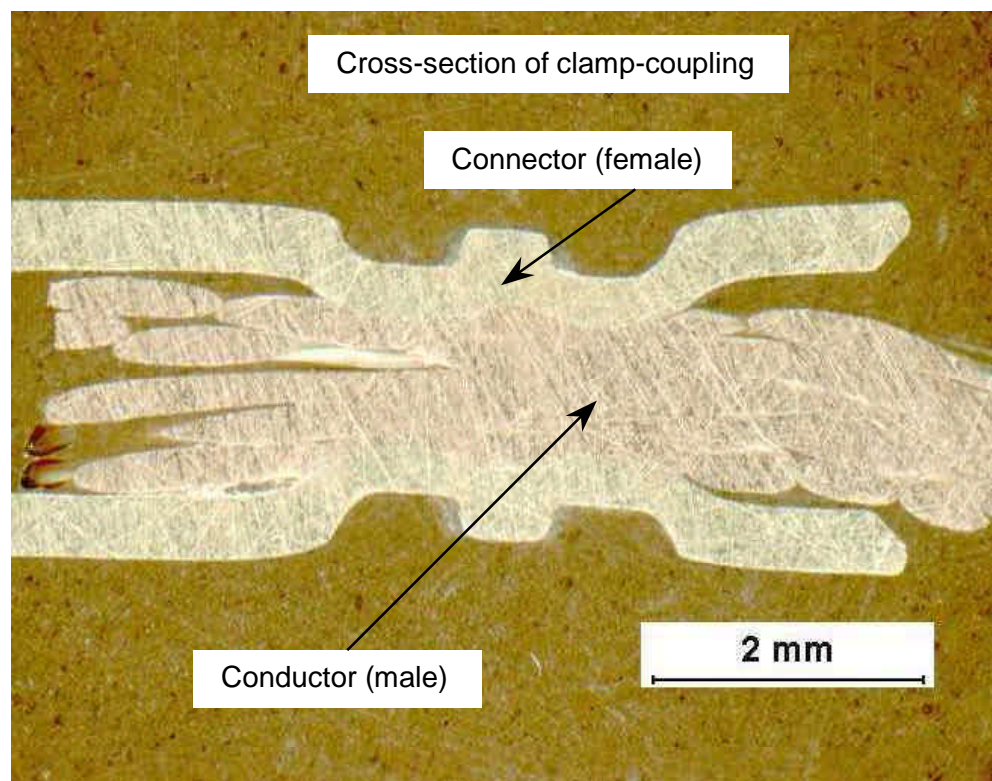
Metallurgical examination of the burned pin-clamp couplings indicates that they were manufactured correctly and that there was no presence of contamination on the contact surfaces.
