## Report RL 2001:41e

***Incident onboard aircraft SE-DRE  
during flight between Stockholm and Malmö,  
M county, Sweden, on 12 November 1999***

Case L-102/99

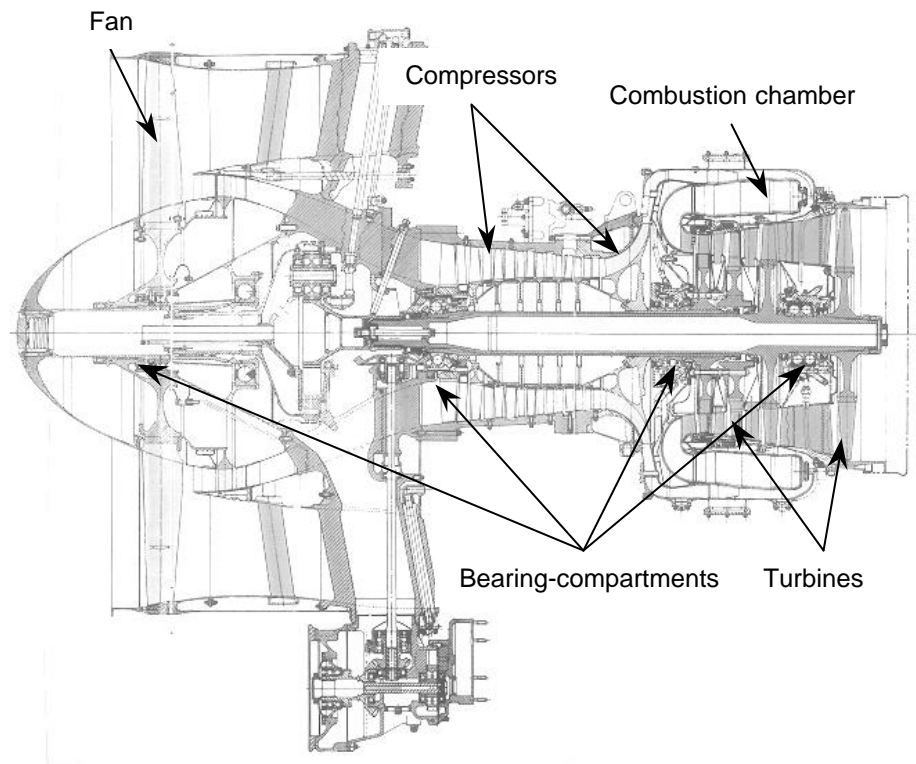
**Engine schematic**

This engine type does not have so-called knife-edge seals to back up the carbon seals at the number one bearing compartment (inlet to high-pressure axial compressor). Knife edge seals are found in many engine types and are a non contact method of maintaining the desired pressure distribution within an engine, one function of which is to reduce oil and oil mist entering the gas flow.

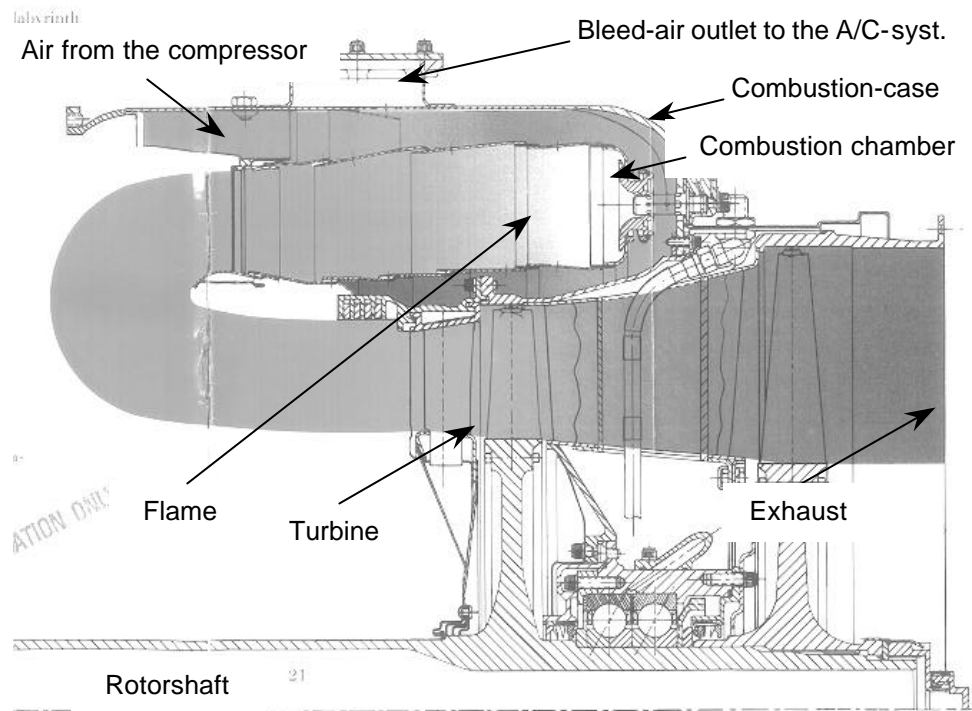
**Burner section**

- The air extraction takes place unusually far back on the engine. The drawing off takes place directly from the combustion case shroud that is mounted aft of the compressors. As depicted in the figures in section 1.6.2 the combustion chamber is situated in the combustion case. Inside the combustion chamber the temperature can reach up to approximately 850 °C.
- The seals for the engine bearing compartments do not all have knife-edge seals that are supposed to take care of the possible oil that normally can leak out in small amounts from oil lubricated carbon-seals after a certain time of operation.

The combustion case and the combustion chamber are designed so that air that is bled off to the air-conditioning system shall not be able to contain any combustion gases or air that has been in contact with hot surfaces in the combustion case. In the engine that the SHK has investigated no physical fault was found in the combustion case that could indicate that this had taken place.
