## **Report RL 2004:30e**

**Accident involving aircraft SE-RDL  
at Londonderry/Eglinton Airport, U.K.,  
on 18 July 2003**

Case L-32/03

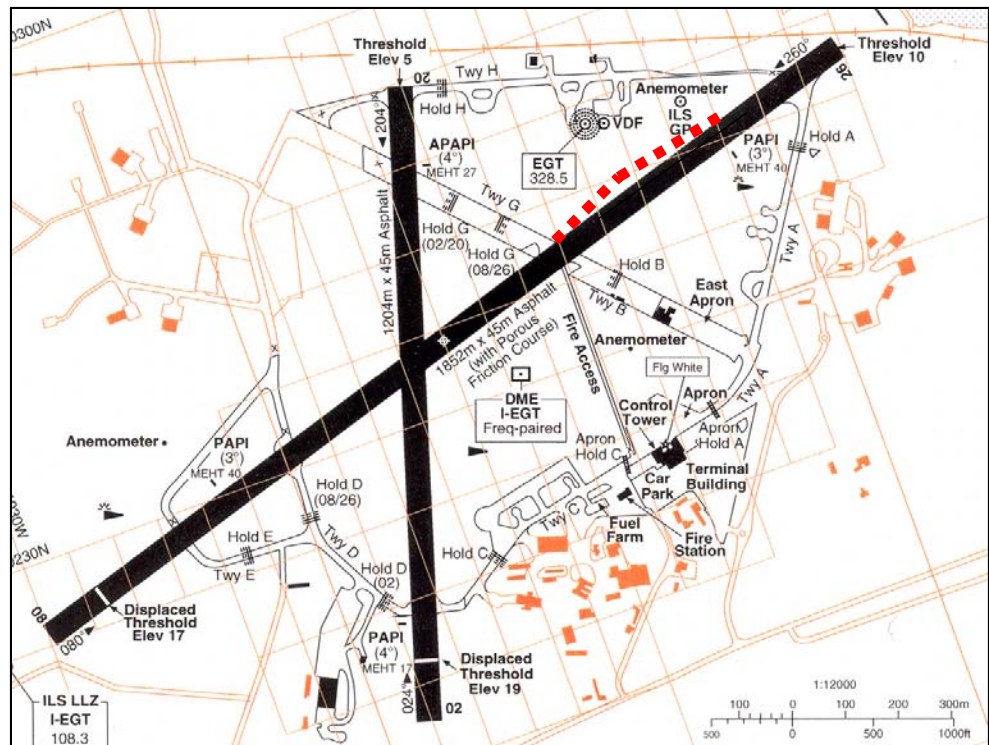
The accident occurred during landing at Londonderry/Eglinton Airport, runway 26. Approximately 270 m from the runway threshold the aircraft's

right main wheels ran off the edge of the runway. The aircraft then rolled with the right undercarriage on the grass alongside the runway and the nose wheel on the gravel surface for approximately 370 m before all the main wheels had returned to the runway (see below).

Runway excursion

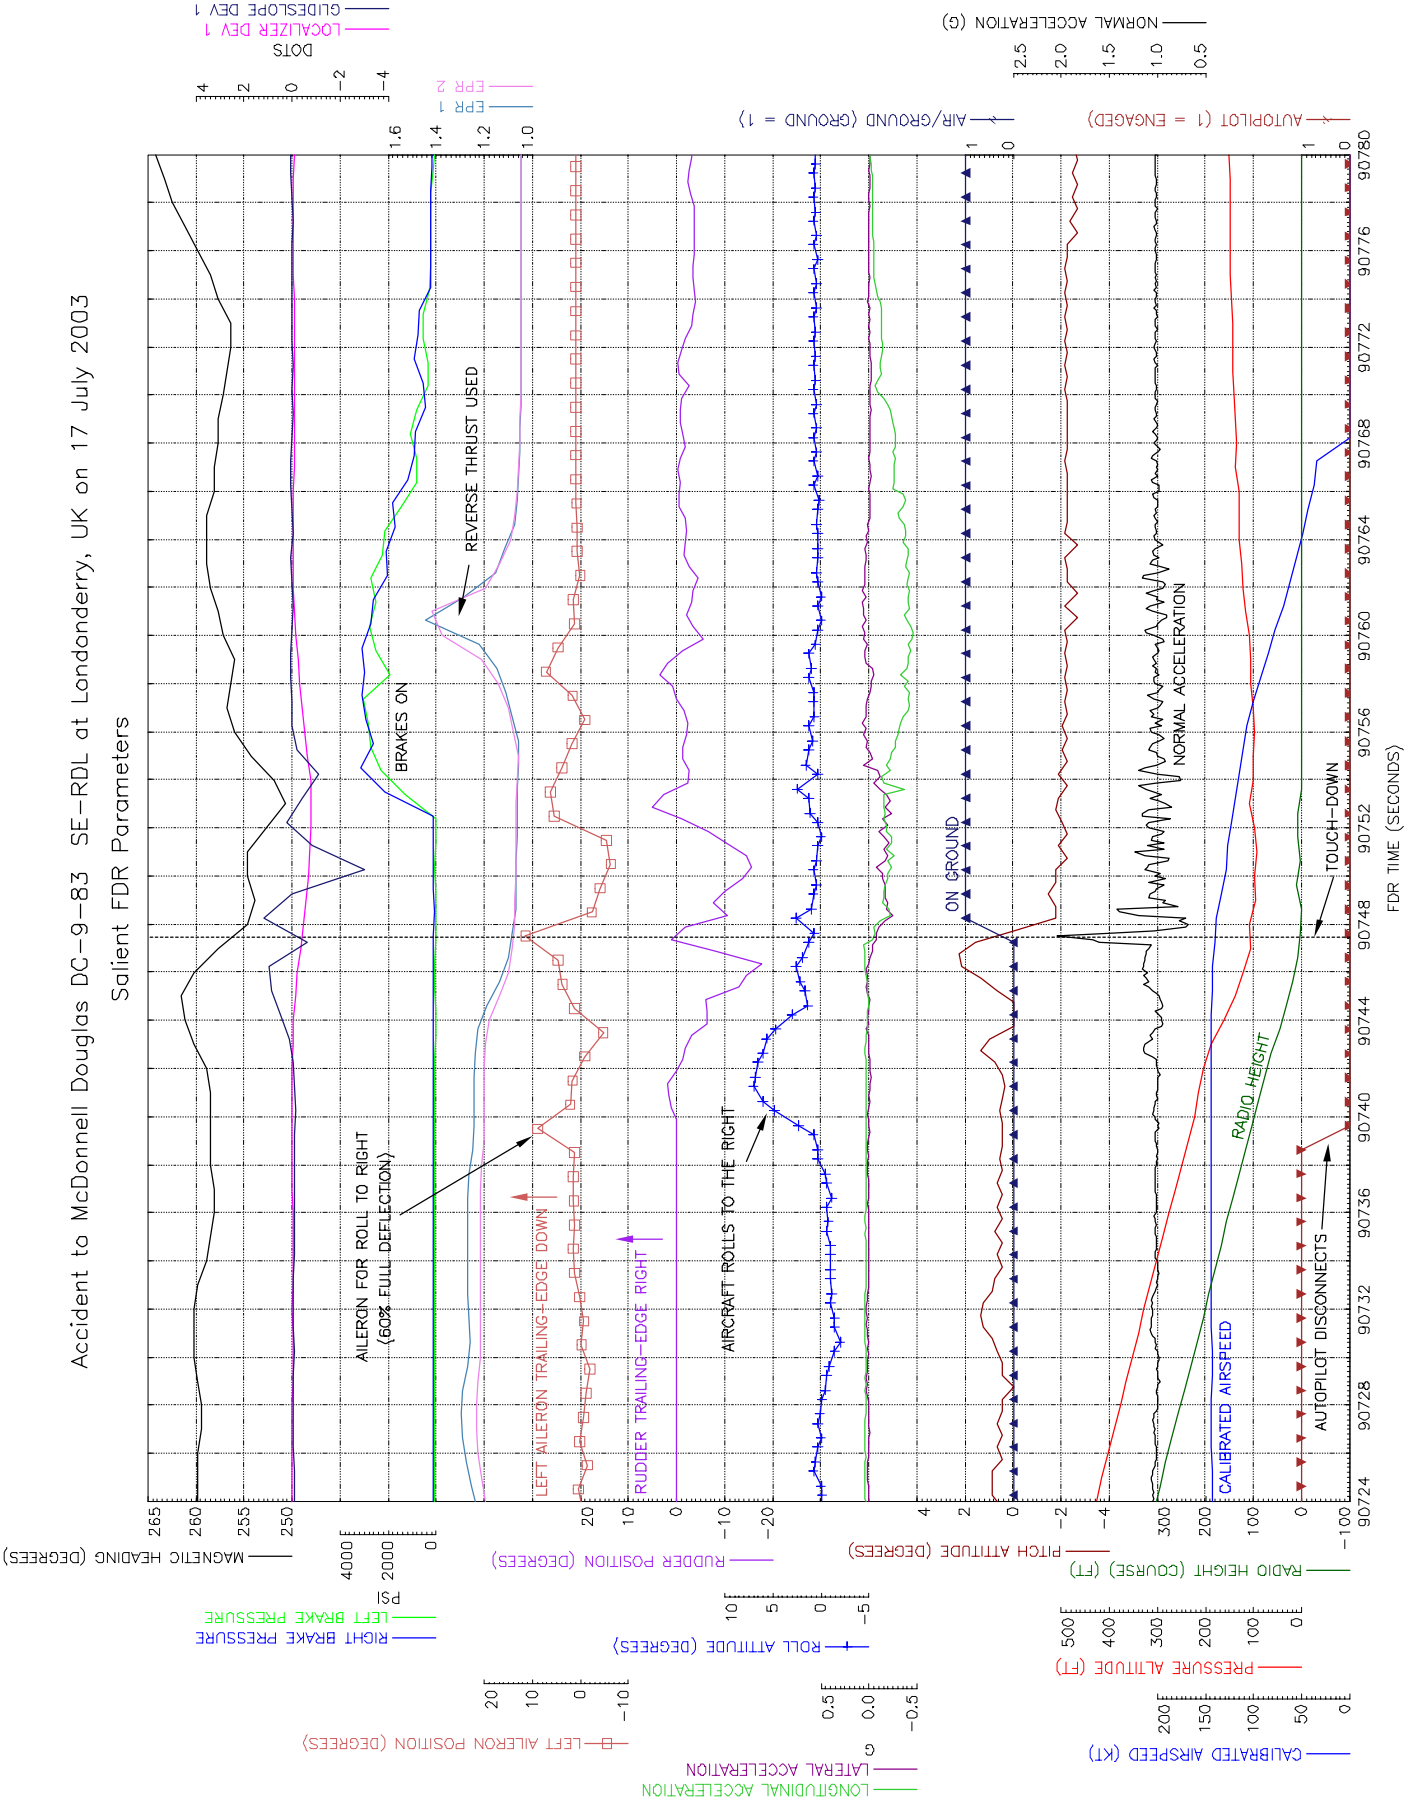
Salient FDR Parameters

The DFDR data shows that the calculated speed on touchdown was approximately 140 knots and that the course was 256°. The stretch along which the right main wheel was outside the runway was measured as 370 m. Using recorded G forces in the horizontal plane and assuming that the touchdown was with the right main wheel 18 m to the right of the centre-line, it was calculated that, on touchdown, the aircraft had a lateral speed (at right angles to its length) of about 13 m/s.

As the course of events shows, the pilots were surprised that, just before touchdown, the aircraft "drifted" to the right and that touchdown was thus well to the right of the runway centreline. It is further shown at Section 1.16.1 above, that the aircraft's course on touchdown was four degrees to the left of the runway orientation, and that it had a lateral speed to the right of about 13 m/s. On touchdown the aircraft skidded to the right, a movement the pilot in command was unable to correct until the nose wheel and the right main wheel had run onto the runway edge. A contributory cause may
