Statens haverikommission
Swedish Accident Investigation Board

Report RL 2004:26e

Incident involving aircraft SE-LGZ in the air space over Mariehamn, Sweden on 31 January 2003

Case L-03/03

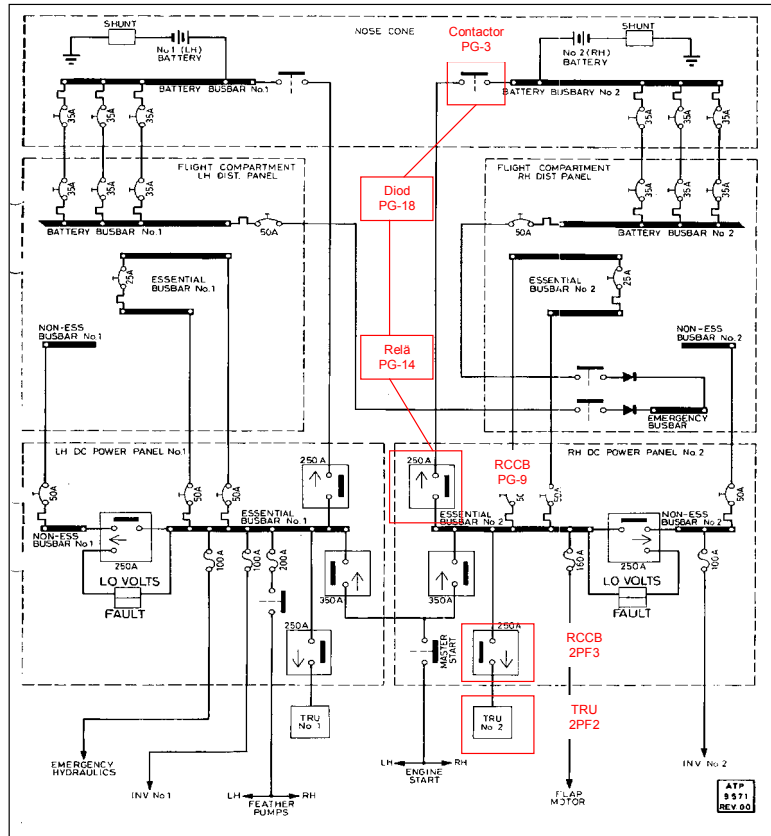
Portion of wiring diagram

Current is supplied to the 28V DC- system, both from the TRUs and from the batteries, via a special type of relay, the Reverse Current Circuit Breaker (RCCB) which, apart from breaking and making the connection, also acts as a diode. The RCCBs are controlled in their turn by switches, contactors, relays and diodes included in the aircraft's electrical system. One of these contactors is the battery main switch.

SHK was informed by the aircraft company of the incident on the same day that it occurred, since the SHK was already investigating a similar incident with the same aircraft type that had afflicted the company just under three months previously. Further investigation of the aircraft was conducted by technicians from the aircraft company in consultation with SHK. During the fault-finding and putting in order of the aircraft selected components were replaced and checked separately. At functional tests of these components the RCCB (2PF3) was found to be unserviceable.

For the 28 V DC-system to become ‘dead’, it is necessary that the current supply from both generators/TRUs and batteries is interrupted. The technical fault detected in the RCCB explains the power cut from the TRU side. Regarding the power cut from the battery circuit, several explanations are possible. It has however been impossible to produce any definite conclusion.

- replacing all RCCB “Mod A” with RCCB “Mod B”,
- introducing operating time limitations for RCCBs
- shortening the operating time interval for batteries.

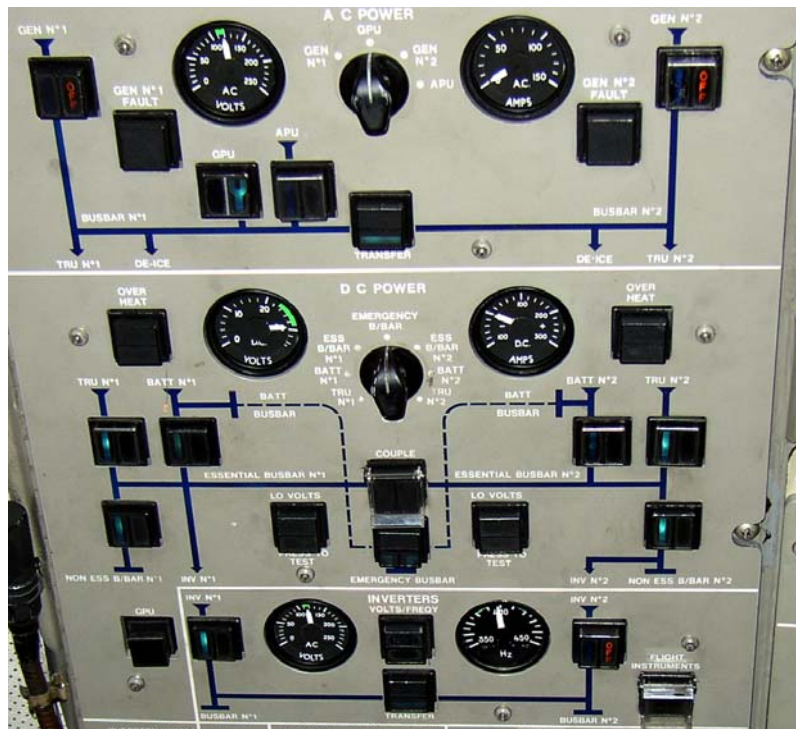
Control panel

In the ceiling above the left pilot’s seat there is a control panel for controlling and checking the status of the aircraft’s electrical system. Switching on and off is effected on the panel with press-buttons that light up with a blue line if they are ‘on’ and show a lighted OFF symbol if they are ‘off’, see photograph below.

Interruption of the power supply from the battery does not normally trigger any warning but is shown only by the blue line on the switch for battery contactors to extinguish. Thus the power supply from the battery may have been interrupted for some time before the incident without the pilots noticing it.

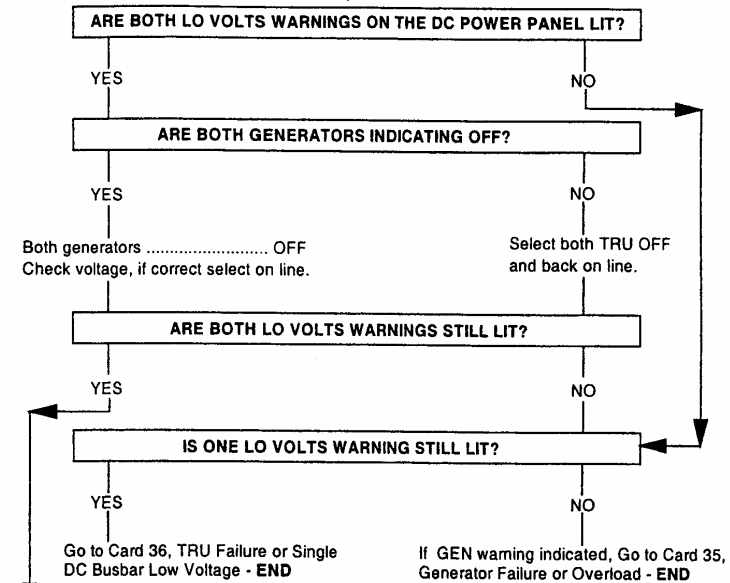
DOUBLE GEN/TRU FAILURE OR DC BUSBAR LOW VOLTAGE

As mentioned above, the emergency checklist should be the natural aid to pilots to identify a possible fault and take the most suitable action from the point of view of flight safety. It should be easy to understand and very user-friendly. In SHK’s opinion the present emergency checklist does not meet these demands. It is complicated, the logic is not self-evident, the typeface is small, the text on the emergency panel is not given as headlines for steps to be taken, etc.

Apart from the present incident and that mentioned in 1.18.1, SHK has noted in earlier investigations that pilots have refrained from using emergency checklists for the same reasons as in these cases. The checklist is felt to be too complicated and there is no time to attempt to follow it. This is understandable but unfortunate since the checklist frequently contains measures that are essential for flight safety but are perhaps not self-evident to pilots attempting to solve a serious problem in what may be a stressful situation.
