## ***Report RL 2004:21e***

**Accident involving aircraft LN-ALK at  
Malmö Sturup Airport, M county, Sweden,  
on 14 April 2004**

Case L-07/04

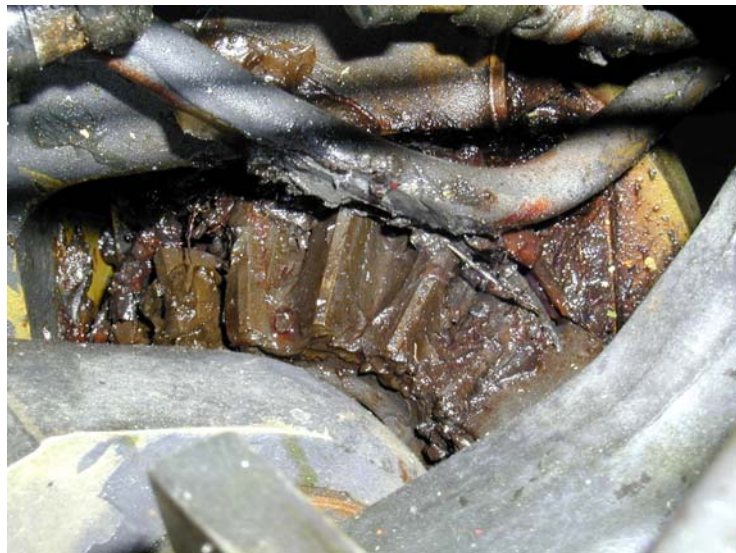
The hydraulic line to the "down lock actuators" pass close to the operating cylinder of the undercarriage in a relatively cramped position under the cabin floor. After the accident the aircraft was moved to a hangar for inspection. Here it was found that its underside was covered with hydraulic fluid and that the hydraulic fluid reservoir was empty. It was further noted that the hydraulic line serving the left down lock actuator showed abrasion damage clearly caused by the gear of the right-hand undercarriage leg. See illustration below.

Rack segment and damaged hydraulic line

The abrasion was deeply lined and the lines had a "coarse" appearance. It was also noted that that the bracket supporting the line was faulty, giving

the line two rest positions: one well clear of all moving parts and the other up against the gear.

The damage to the hydraulic line was "coarse", which suggests that the line had not rested up against the gear for any length of time. A check of the aircraft's log book showed that all the hoses in the hydraulic system, including that to the main undercarriage operating cylinder, had been replaced on 2 February 2004, approximately ten flying hours and seven lowerings and raisings earlier. Since this hose can scarcely be replaced without affecting the position of the line in question it appears probable that while the hose was being replaced the line came into its second resting position against the gear. Here the line was damaged in connection with the subsequent lowering and raising of the undercarriage.

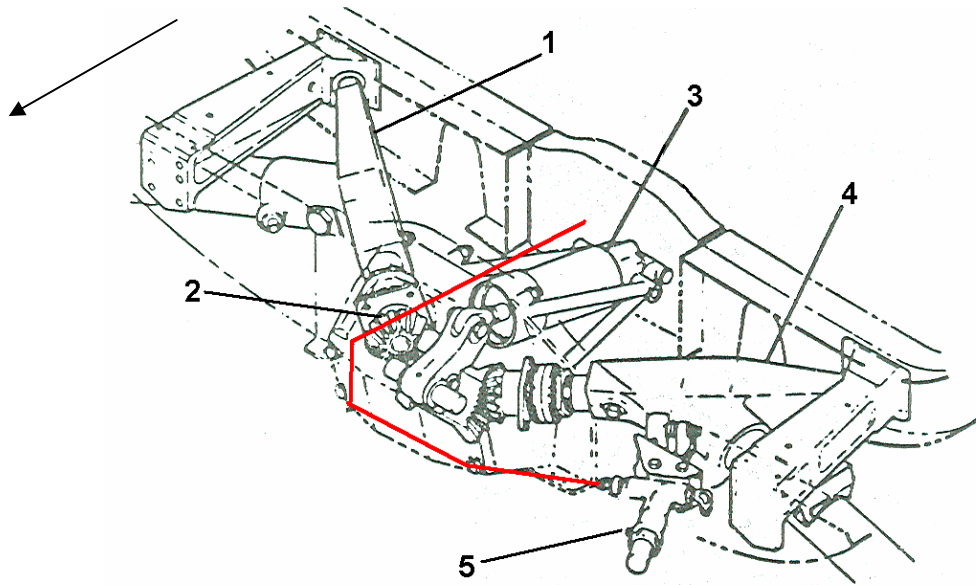
1. Right undercarriage leg assembly
2. Gear
3. Main undercarriage operating cylinder
4. Left undercarriage leg assembly
5. Left "down lock actuator" with hydraulic line drawn schematically.
