Statens haverikommission
Swedish Accident Investigation Board

Report RL 2005:14e

**Incident involving aircraft SE-DNU
at Ängelholm Airport, M county, Sweden,
on 15 April 2004**

Case L-06/04

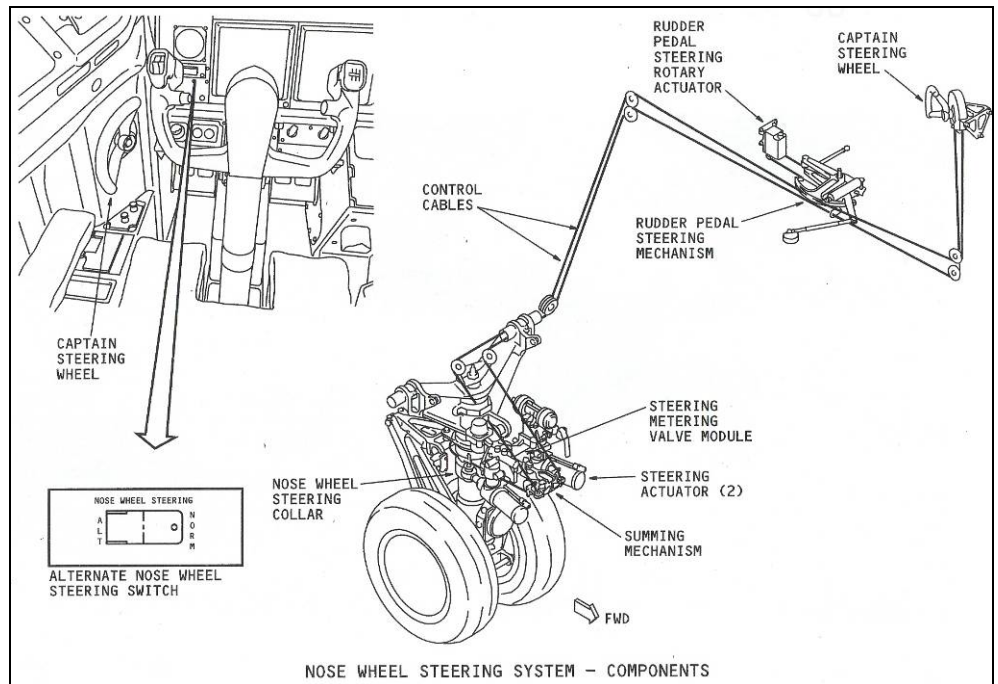
Nose Wheel Steering System

The manufacturer's view is that these cases, including the present incident, were caused by a momentary jam in the nose wheel steering control system, the "steering control loop". The example given is that a very small debris in the hydraulic system can cause a 'pilot valve' in the Steering Metering Valve Module to jam momentarily, whereupon the nose wheel turns. The fault disappears of its own accord during further steering or in connection with troubleshooting, when it is assumed that the debris is washed away. The system then functions without remark.

Despite extensive troubleshooting of the aircraft's nose wheel steering system it has been impossible to establish any technical fault that could explain the malfunction. As stated in 1.18.3, according to the manufacturer there have, since December 1991, been nine reported malfunctions of the nose-wheel steering system for which no technical fault has been found. The manufacturer's view that these errors have been caused by some small debris in the hydraulic system that has become randomly wedged fast in an unfortunate manner, leading to a valve in the steering system momentarily jamming and causing an uncontrolled swing, appears reasonable.

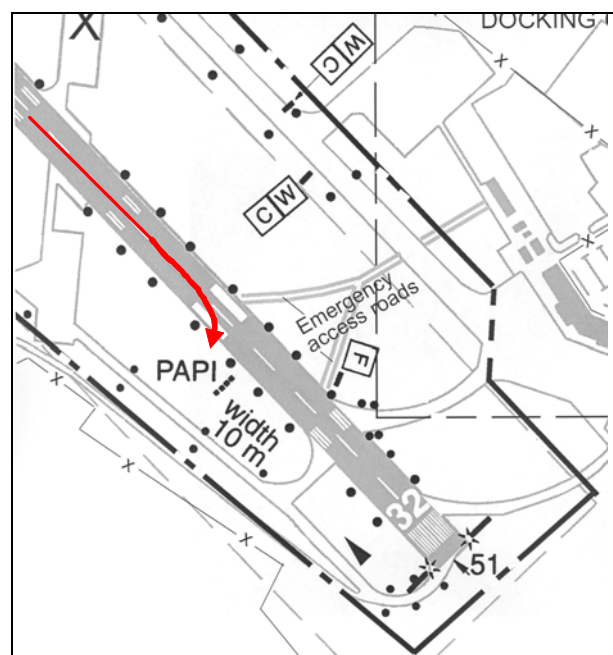
Site of occurrence

The aircraft left runway 14 to the right about 300 metres from the further threshold. From the centre of the runway, approximately 120 metres from where the aircraft finally ended up, rubber skid marks from the nose wheel and left main wheel can be clearly seen.

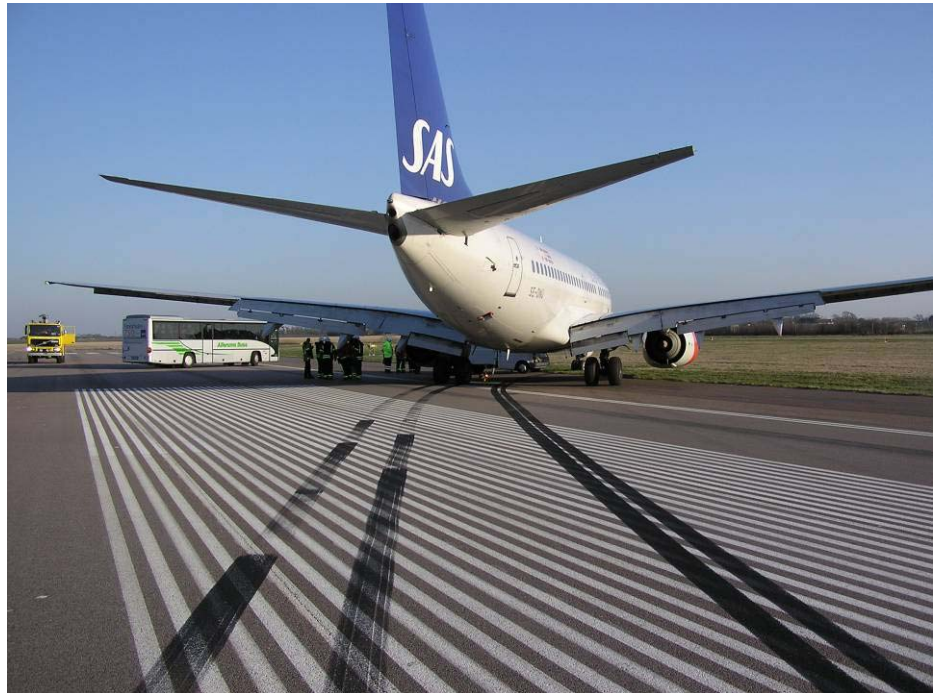
The aircraft was undamaged. It stopped with the nose wheel on the grass about one metre from the runway verge and the main wheels approximately on the verge.

Wear marks on the nose wheel and left main wheels showed that they had been subjected to strong lateral forces and braking forces in connection with the aircraft's leaving the runway.

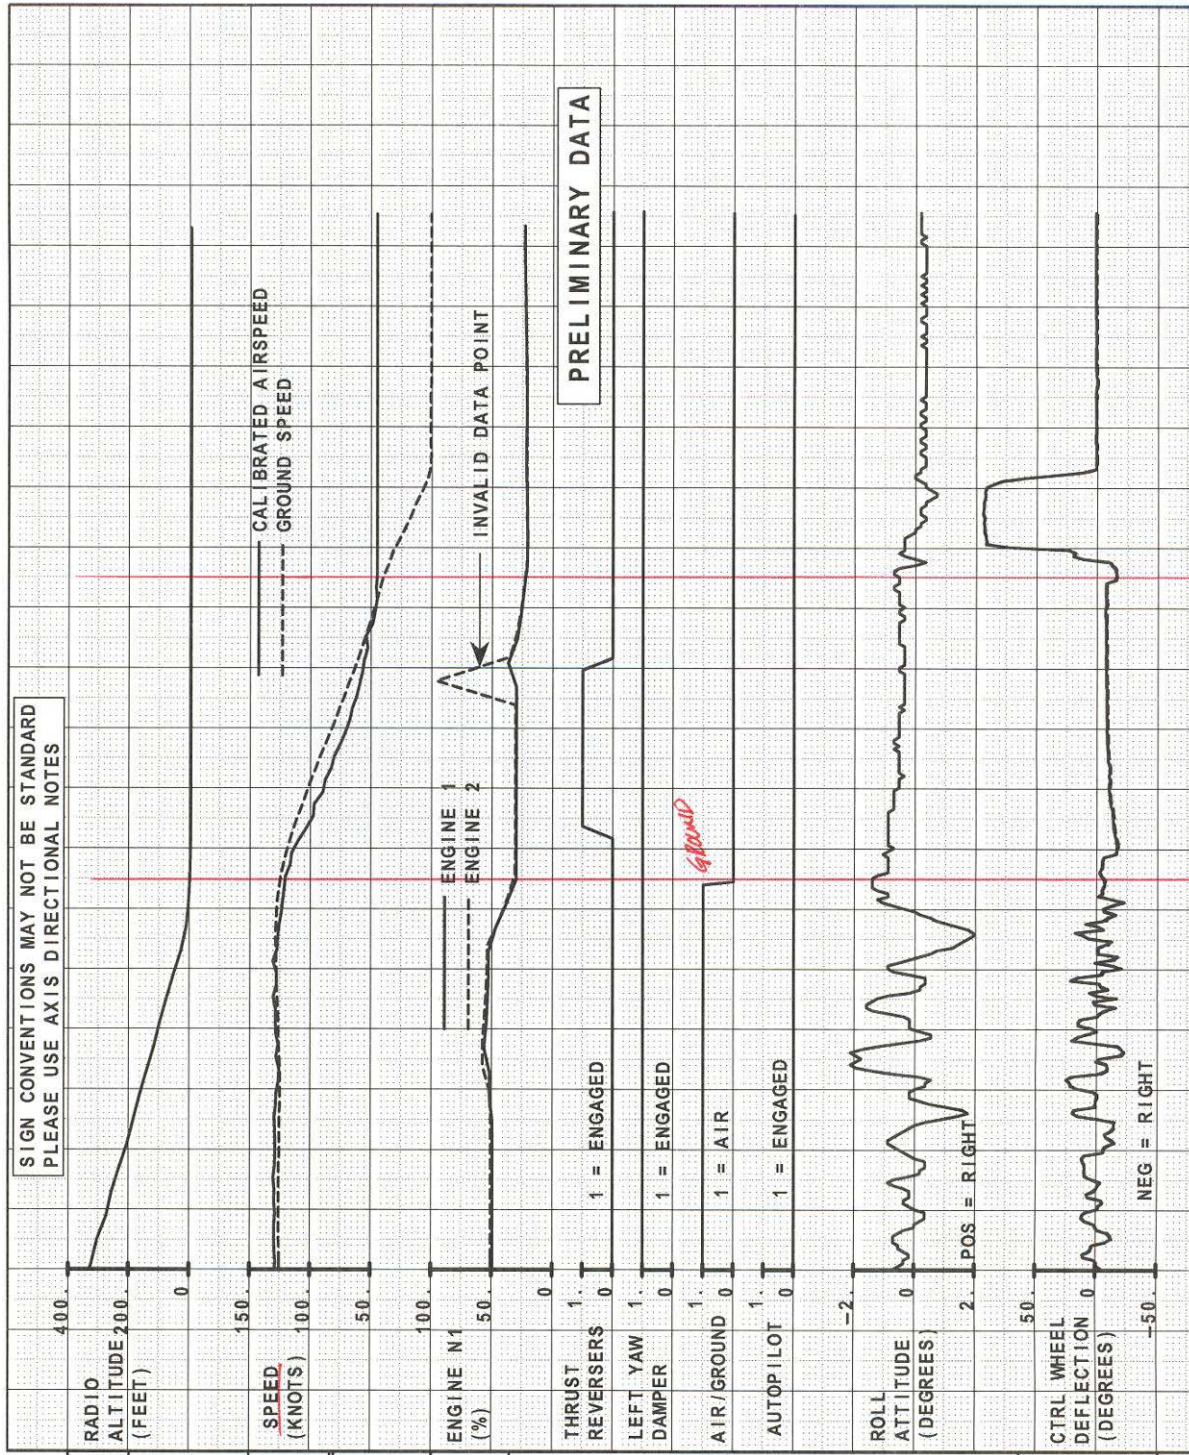
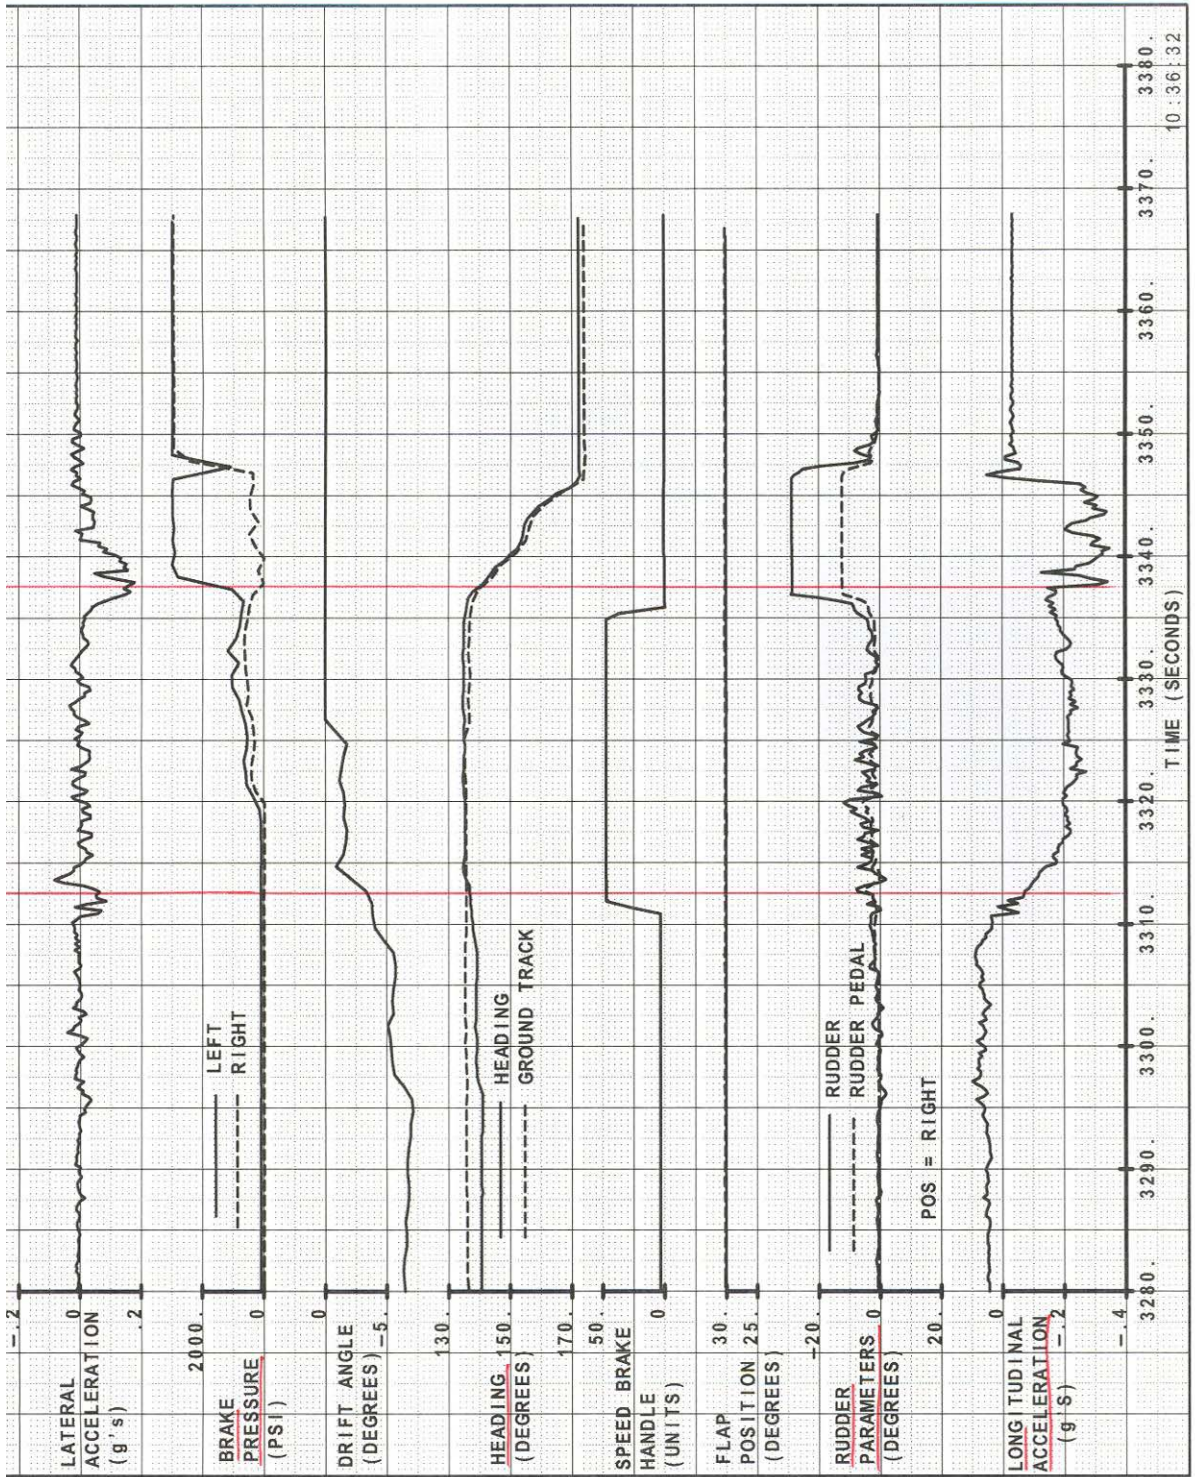
FDR diagram

It can be seen from the diagram that, about 25 seconds after touchdown, the aircraft started to yaw markedly to the right. Calculated speed was then about 40 knots. Shortly thereafter the rudder was turned to the left and heavy braking was applied to the left main wheel. The yaw to the right continued and stopped when the aircraft came to a standstill on a magnetic course of about 174 degrees.
