Report RL 2005:15e

Accident involving paraglider Gin Boomerang III in Valle de Bravo, Mexico, on 22 January 2004

Case L-01/04

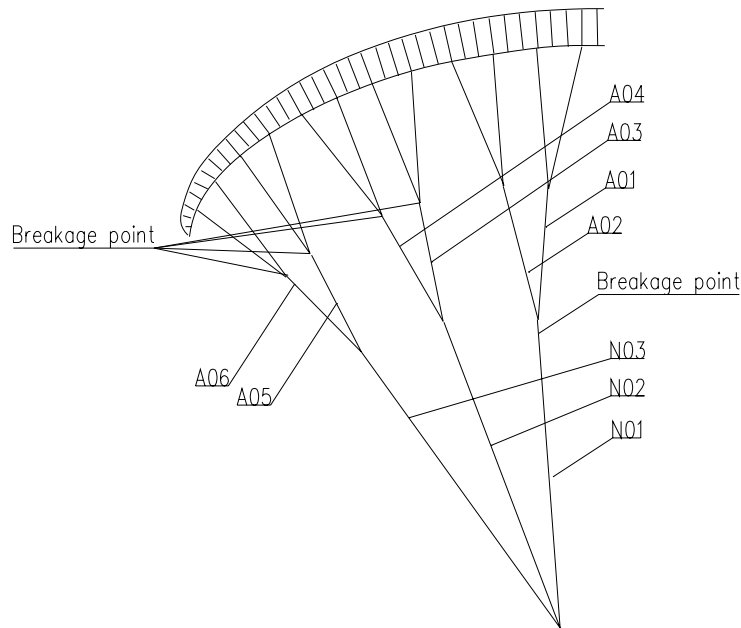
The paraglider and its lines were examined by the Board together with staff from the Swedish Paragliding Association, SSFF. The examinations showed that all A, B, C and D-lines on the left-hand side were broken, most

at the last branch nearest the canopy. A majority of the lines on the right-hand side had also broken.

The left-hand A lines showing numbering and breakage points.

It will be seen that the test values are considerably lower than those stated by the manufacturer.

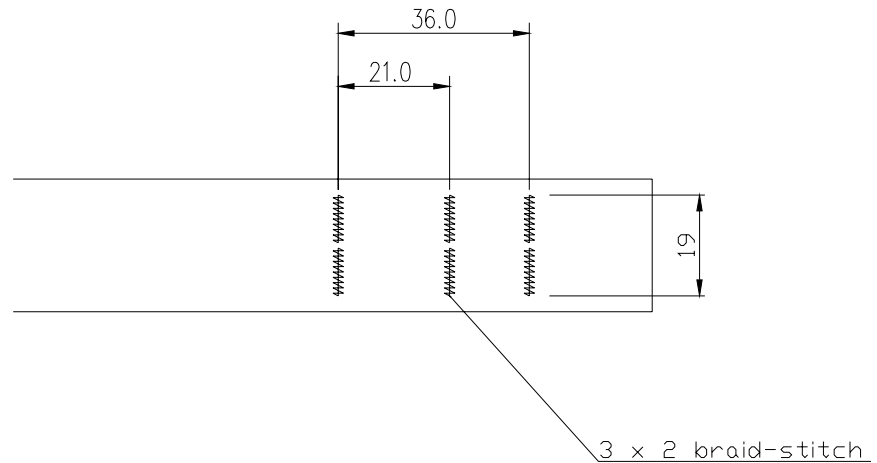
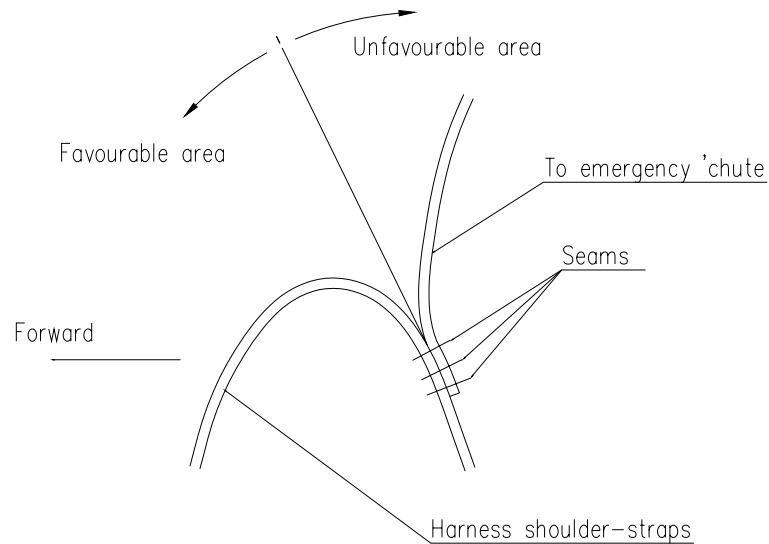
The harness was examined by the Accident Investigation Board. It was noted that the seams between the harness and the strap connecting the harness and the emergency parachute had ruptured.

The connection between the harness and the strap to which the emergency parachute is connected is effected by placing the strap over the harness shoulder straps and then fixing it with three rows of braid-stitch, as illustrated below. This arrangement means that the seams are subjected to tear loads if the strap is loaded within the unfavourable area in the lower illustration. Tear loads cause one row of stitching at a time to take up the load, dramatically reducing the strength of the joint.

Calculated tensile strength in the favourable area was approximately 9300 N, while in the tension test the strap broke at 9 200 N. On tearing (tension within the unfavourable area) the seams gave at approximately 1 900 N.
