**Statens haverikommission**  
Swedish Accident Investigation Board

## ***Report RL 2006:14e***

**Aircraft accident involving SE-DYX  
at Stockholm-Arlanda Airport, AB county,  
Sweden, on 1 December 2004**

Case L-50/04

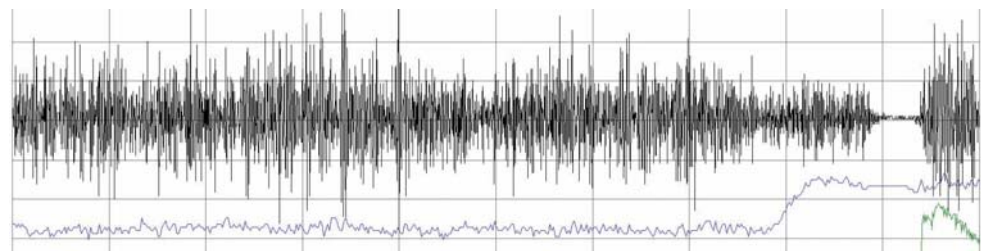
*Taxiing out at Plovdiv*

By the graphic print out it appears that as well amount and frequency on the vertical g-force are remarkably high at out taxiing at Plovdiv compared to Bromma.

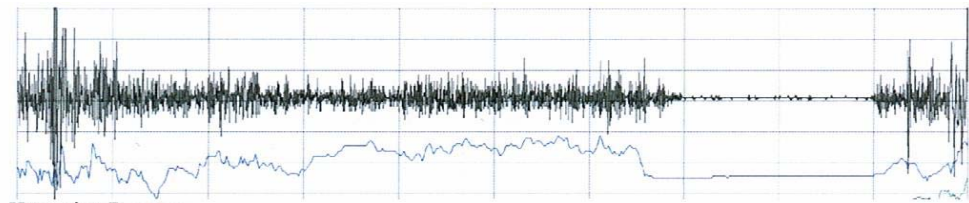
*Taxiing out at Bromma*

In this comparison Bromma is considered to be at, or shortly below, the normal level regarding smoothness according to European standard. (Definitions for this are not established, see 4.1).

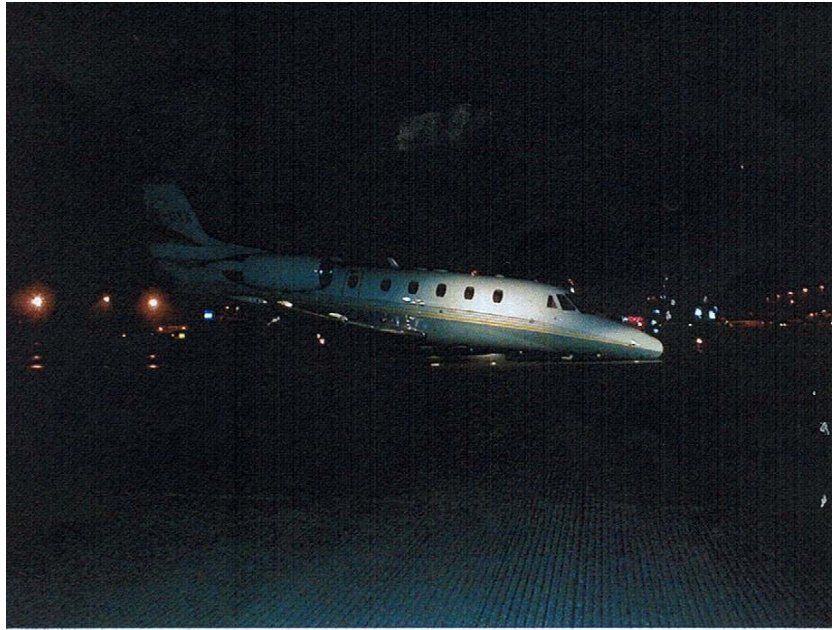
The accident occurred at Stockholm-Arlanda airport (ESSA) runway 26. Touch down took place about 500 m in on the runway. After about 1700 m the nose of the airplane touched the runway and after about further 200 m

the airplane stopped, 1-2 m left of the centerline of the runway. This was about 600 m from the end of runway 26.

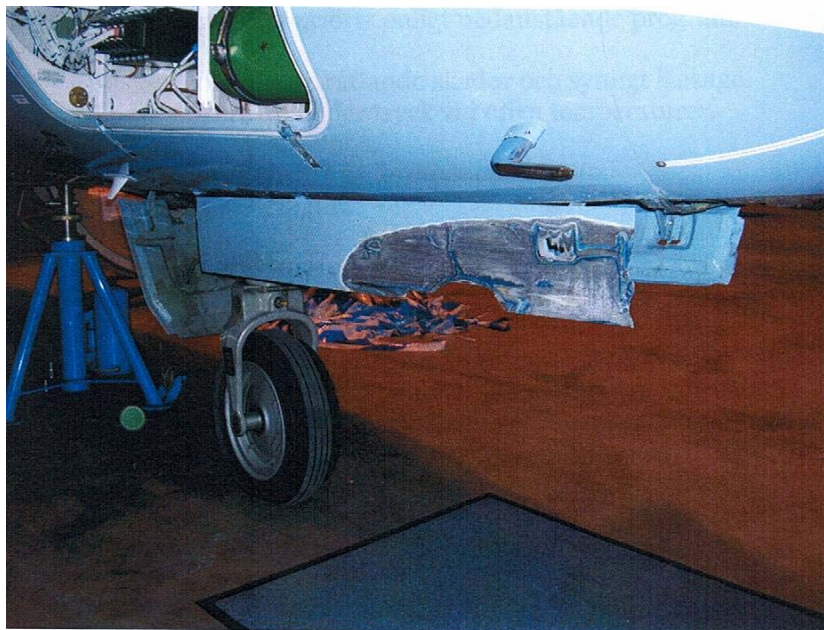
Considerable damage occurred at the nose part of the aircraft.

- Structural damages to sheets and inside frame.
- Friction- and impact damages on the front landing gear doors.
- Damages on suspension.
- Damages on landing gear and wheel.

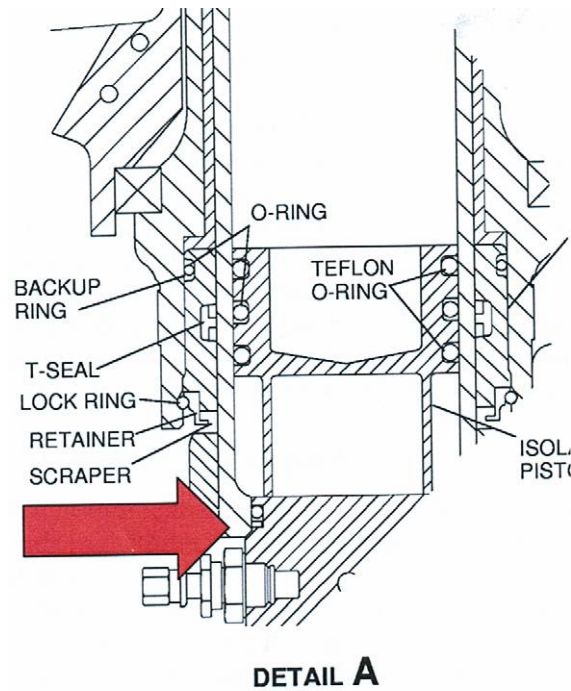
After the last test series it was decided to bring back the piston to room temperature. After heating up in 45 minutes the material had a temperature of  $+5^{\circ}\text{C}$ . At the check of the nitrogen pressure it was verified that a substantial loss of pressure had occurred.

Repeated tests showed the same results. The piston was submerged in a bath of alcohol and again was cooled down to ascertain where the leakage appeared. Tests showed that the leakage mostly occurred at temperature changeovers, from warm to cold and vice versa. The leakage was located to an o-ring between the lower landing gear piston and its piston plug.

The damages could be verified to two o-rings, (part number NAS 1611-331 and NAS-1611-226). The damages were longitudinal and sharp, and were found as well on outer side as on inner side of the o-rings. The damages have probably come up through mechanical influence/wear. According to the investigation the tests indicate that one of o-rings could develop leakage, partly under time in cold environment and partly at transition from cold to warm environments.
