**Statens haverikommission**  
Swedish Accident Investigation Board

## **Report RL 2003:26e**

***Infraction of minimum separation  
between the aircraft SE-LHB and  
SE-EKW in the airspace east of  
Norrköping/Kungsängen airport,  
E County, Sweden, on the 12<sup>th</sup> of  
September 2002***

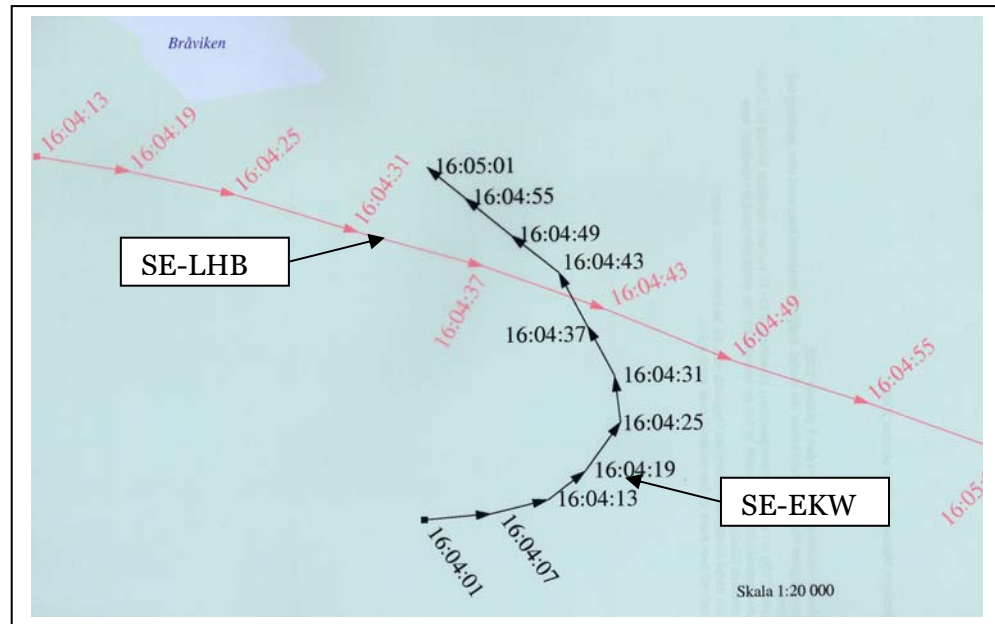
The flight paths of the two aircraft have been registered by MUST. From the registration it has been calculated that the minimum distance between the aircraft was approximately 500 meters horizontally and approximately 180 meters vertically. This occurred at time 16:04:41 as seen in the illustration below.

According to the registration from MUST the two aircraft came as close to each other as approximately 500 meters horizontally and 180 meters vertically, which indicates that this was a serious infraction of minimum separation with regard to safety of flight.
