Statens haverikommission
Swedish Accident Investigation Board

Report RL 2005:27e

Accident involving aircraft SE-LTP in Värnamo, F county, Sweden, on 16 November 2004

Case Dnr L-48/04

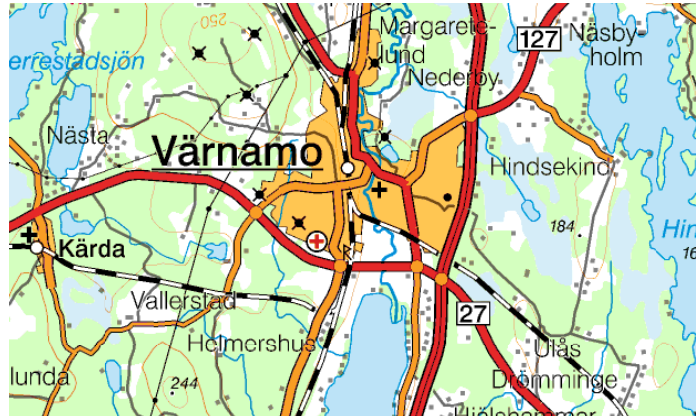
When the engine stopped smoke penetrated the cabin and sparks and flames were seen under the engine cowling. These went out after a few seconds. The instructor took over control of the aircraft from the student and initiated a forced landing on a plot on an industrial estate. The landing was successful and the aircraft sustained only negligible damage. The crew and the passenger left the aircraft unharmed. There was no fire, nor any leakage of fuel; nor was there any effect on the environment.

After the landing it was found that the underside of the fuselage was covered with engine oil. In addition a connection rod had failed and made a hole in the crankcase.

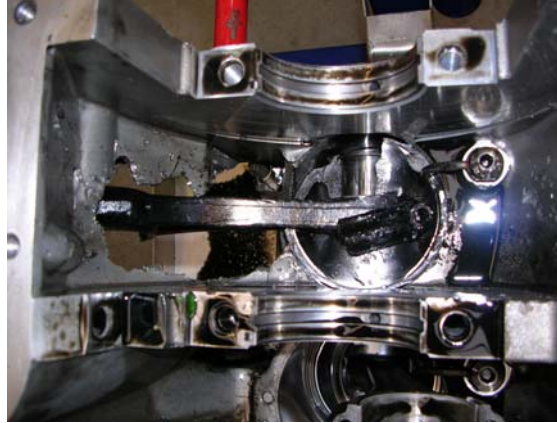
Following arrival at the factory the engine was dismantled by Thielert and SHK staff. It was found that it contained very little oil, that the rear connecting rod bearing had seized and that the connecting rod was broken off. Also, the connecting rod had made a hole in the crankcase, as shown in the illustration below.

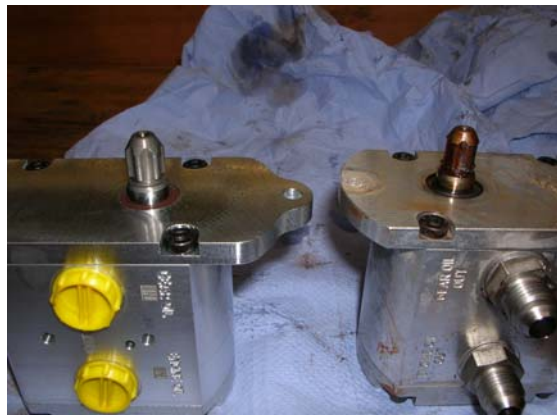
The double oil pump proved to have an extremely worn input shaft, see illustration:

(To the left, a new pump and shaft.)

The engine failure was probably caused by the input shaft of the double oil pump having become so worn that the pump was no longer being driven. When this occurs there are two consequences. One is that the propeller is no longer supplied with oil pressure for varying blade pitch. It moves to fine pitch, whereupon engine revolutions increase. The other consequence is that oil is no longer emptied from the turbocharger but, since the engine pressure oil pump is still functioning and delivering oil to the turbocharger, the latter's oil sump overflows. The oil makes its way out of the supercharger wherever it can: out onto the underside of the aircraft instead of into the engine oil sump. After a minute or so the latter is empty and a bearing in the engine overheats and seizes up because of lack of oil.

The factory has also redesigned the oil pump drive.

Following the event the oil pump drive has been redesigned and the original pumps will be replaced successively, whereafter operators will meet the requirements of the airworthiness directive mentioned above. The Swedish Board of Accident Investigation makes no recommendations.

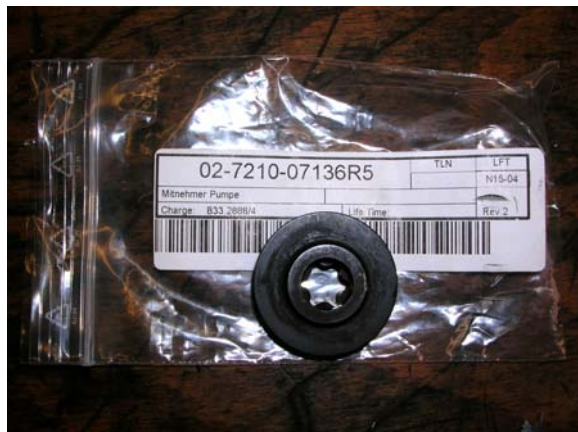
The input shaft is driven by a driving plate, see illustration, pressed into the splined end of the gearbox intermediate drive. No visible damage to the driving plate was noted. The connection between the driving plate and the oil pump input shaft is designed to have a small but noticeable play.

In addition, the Board considers that the design of the oil pump drive is doubtful at several points. For one thing the carrier, as mentioned earlier, is only pressed into its shaft with no secure locking arrangement. Secondly, the play between the carrier and the oil pump shaft, together with unavoidable changes in radial position between the two, entails wear.
