**Report RL 2005:26e**

**Accident involving helicopter SE-JHJ at  
Orremossen in Vättlefjäll, north-east of Göteborg,  
O County, Sweden, on 11 September 2004**

Case L-45/04

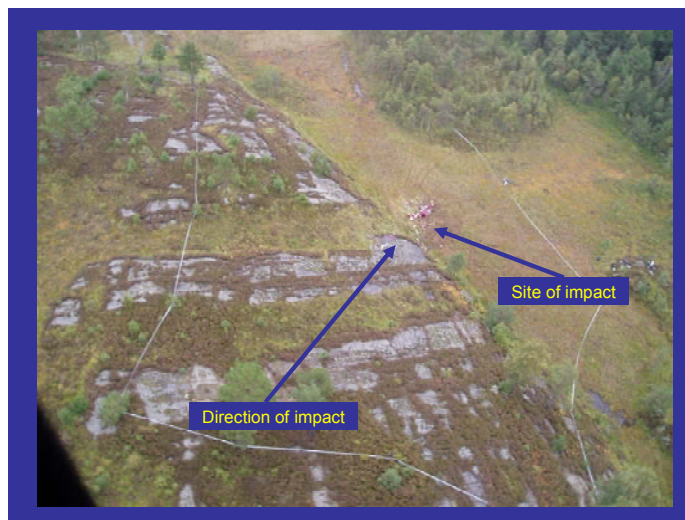
*Main wreckage*

The main portion of the wreck had first crashed into rock, whereafter it slid down, ending up on moorland about 10 m from the rock. Marks on the ground show that the impact occurred in an approximately easterly direction and was steep. Within an area under the path of impact, about 100 m long and 200 m broad, wreckage was found from the forward part of the cabin and the main rotor. This included numerous centimetre-sized pieces of plexiglass, fibreglass and parts of the pneumatic flight instruments over 100 m from the main wreck.

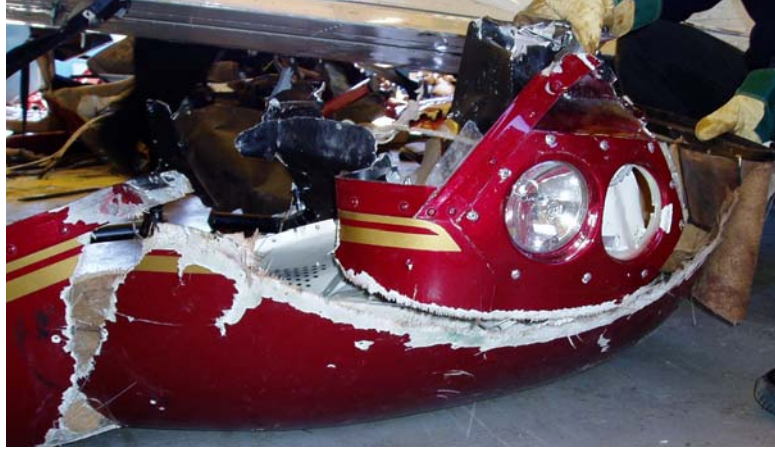
Damage to the forward part of the cabin shows that it was cut through at right angles to the longitudinal direction of the helicopter, in two places. The cuts were inclined steeply backwards in the direction of the helicopter's travel and the distance between them was approximately 30 cm. The forward cut ran through the instrument panel and the cabin structure forward of the pedal support. The rear cut ran rear of the front screens and the pedal support. (See photo below).

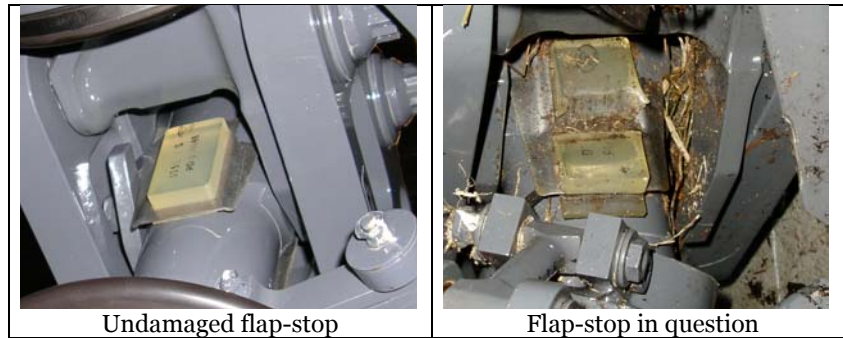
Both flap stops on the rotor hub were squeezed right through, showing that violent mast bumping – see 1.18.2 – had occurred. See illustrations below.

Heavy wear damage was noted to the droop stops of both main rotor blades and their corresponding support heels on the rotor hub. The damage indicates that the blades were bent downwards with great force.

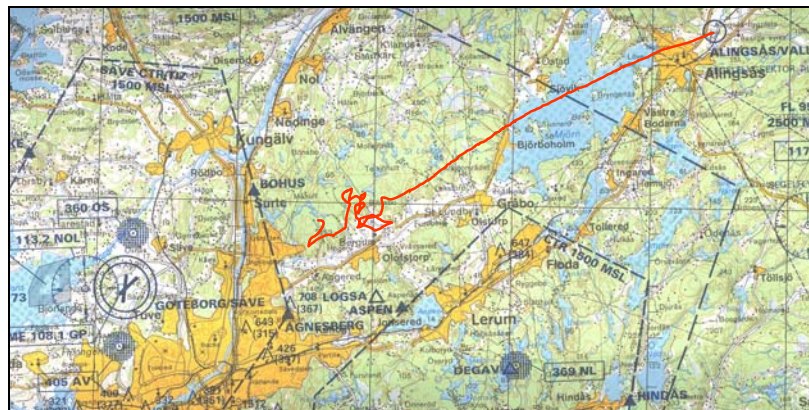
*Radar plot*

The radar plot shows that the flight was initially on a direct course to Göteborg. Speed was steady and altitude above sea level approximately 1,000 feet. As the helicopter approached Vättlefjäll just north-east of Göteborg, where the terrain is hilly and somewhat higher, the helicopter started to turn and fly in tight circles, at the same time greatly varying its speed. At 11.51 hrs the pilot contacted Säve tower and asked about the weather. He stated that he would try and fly through some rainy weather. The last radar plot was 20 seconds before impact, when the helicopter's altitude above sea level was 1460 feet.
