Statens haverikommission
Swedish Accident Investigation Board

Report RL 2003:27e

Infraction of minimum separation between the aircraft G-KATA and OY-CNP in the airspace above Malmö/ Sturup airport, M County, on the 22nd of August 2002

Case L-083/02

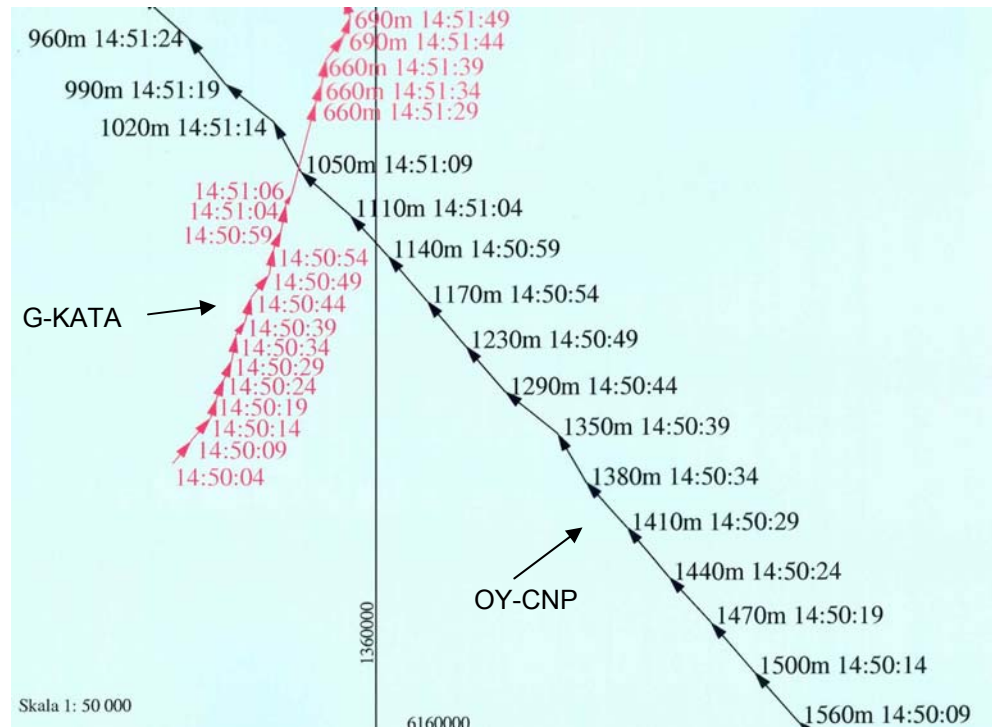
The flight paths of the two aircraft have been registered by MUST and are presented in the figure below. From the register, it has been calculated that the minimum distance between the two aircraft was approximately 130 meters horizontally and 420 meters vertically, which occurred at 14:51:09 hours (see next page).

Remark: The heights given are for the standard air pressure of 1013.2 hPa and are not adjusted for the actual air pressure at the time of the incident.

According to the MUST register, the aircraft came as close as approximately 130 meters horizontally and 420 meters vertically, which means that the infraction of minimum separation was serious from a flight safety point of view.
