Report RL 2005:13e

**Helicopter accident to SE-HSI
at Linetjåkke, NV Ammarnäs, AC County,
Sweden, on 4 August 2004**

Case L-28/04

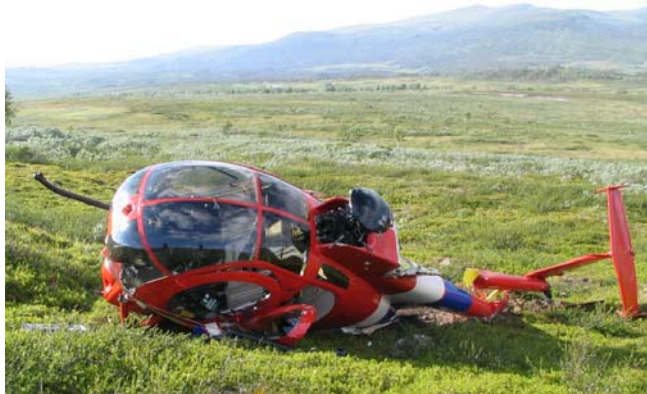
The helicopter ended up lying on its left side. The structure was damaged, the left undercarriage was broken and the tail boom broken off. All the rotor blades had been broken off near the rotor hub.

Accident site

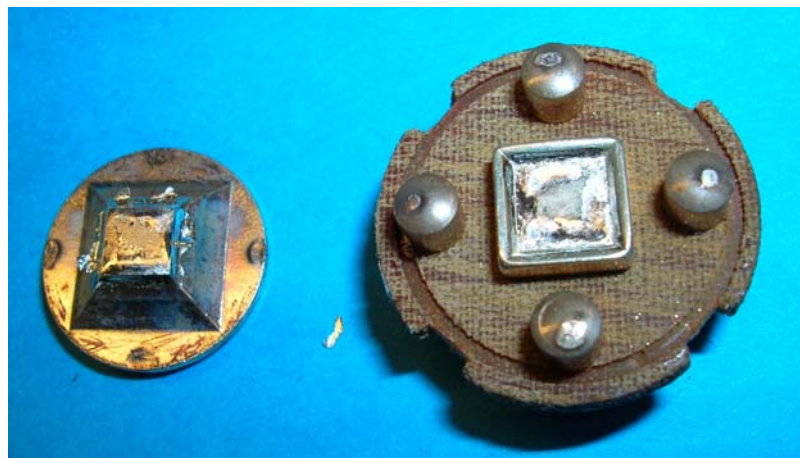
The four-way trim switch, which was of the latest version (see 1.18.2), was bench-tested for function without remark and without any tendency to binding or loose contacts. When the switch was disassembled a number of small metal chips of a material resembling silver were found in the space between the contact pins and the contact plate. On the plate, "smeared-out" filings of the same material were found. No clear sign of short-circuiting between the centre plate and any of the contact dubs was found (see photograph below).

Contact plate and contact pin in the four-way trim switch

The time the switch had been in operation was checked, and according to the helicopter's technical documentation it had accumulated 863 flying hours time before the accident.

In the four-way trim switch on the cyclic stick, loose metal chips were found which according to Service Bulletin DN-184 can cause electrical arcing between the contact plate and any of the contact dubs. If this happens, there can be undesirable trimming in one direction or another. However there was no burn mark or similar in the switch that could suggest that there had been arcing. Further, it appears unlikely that such arcing between contacts could have persisted so long in this case, particularly in view of the pilot's frequent use of the switch.

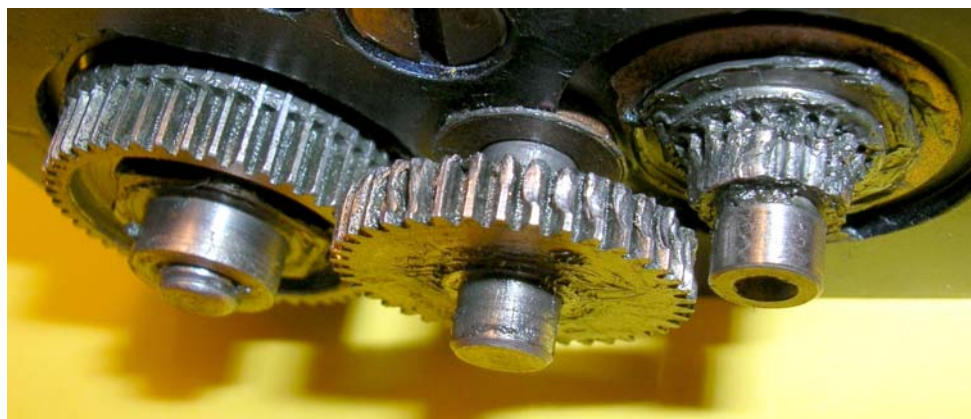
The trim actuator, which on the outside was physically undamaged, was function-tested unloaded before removal and initially functioned normally in both directions. After being shaken several times in both directions, it "stuck" sporadically in both directions even though the motor was running. When the actuator gearbox was disassembled, extensive damage to the gearwheels was found together with metal chips of different sizes. (See photo below.)

Gearwheels in the trim actuator gearbox

The teeth of the input pinion (the smallest gearwheel) were all largely worn down. The teeth of the intermediate gearwheel were partly worn down in certain sectors. The teeth of the output gearwheel (the largest) were worn but intact. The intermediate gearwheel is seated in the gearbox and its lid. Its axial position can be adjusted with spacers on the gearwheel axles. The damage to the input pinion teeth indicates that it had been axially displaced so that the teeth did not mesh along their full lengths.

It is therefore more probable that the faulty operation was caused by a malfunction in the trim actuator of the lateral trim system. When the actuator was examined it was found that two of the gearwheels in the gearbox were seriously worn. All the teeth of the drive pinion and certain teeth on the intermediate wheel were practically worn down.

The likelihood is therefore that at least the input drive pinion was already severely worn. This may have been because the intermediate gearwheel was not correctly adjusted axially, resulting in incorrect meshing and hence increased wear.

When the wear had grown sufficiently, the gears probably started to unmesh at first sporadically and the more often, which resulted in rapidly increasing wear.

There is therefore reason for the Civil Aviation Authority to promulgate, for the helicopter type in question and other types in which the trim system can cause a risk to flight safety, suitable restrictions on operating hours for constituent components, together with the requirement that functional controls be carried out with the system loaded.
