## **Report RL 2005:08e**

**Helicopter accident to SE-HLK  
at Joesjö, Tärnafjällen, AC county, Sweden,  
on 7 July 2004**

Case L-22/04

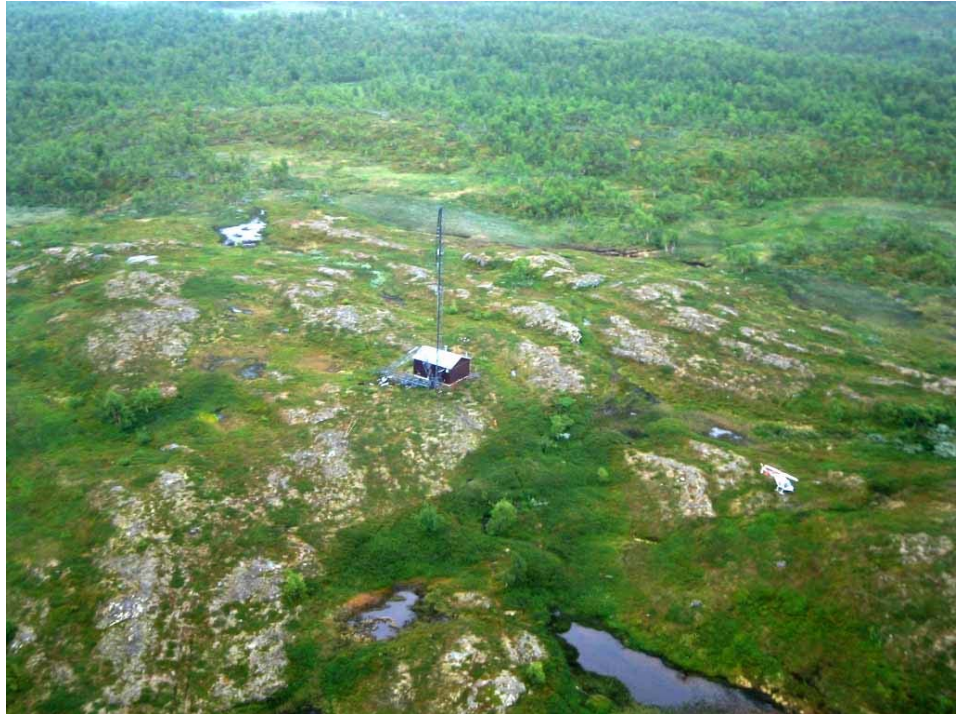
The accident took place on bare mountain in a relatively flat area. The surface consists of rock and stone at the time clad with low grass and bushy undergrowth.

*The site of the accident*

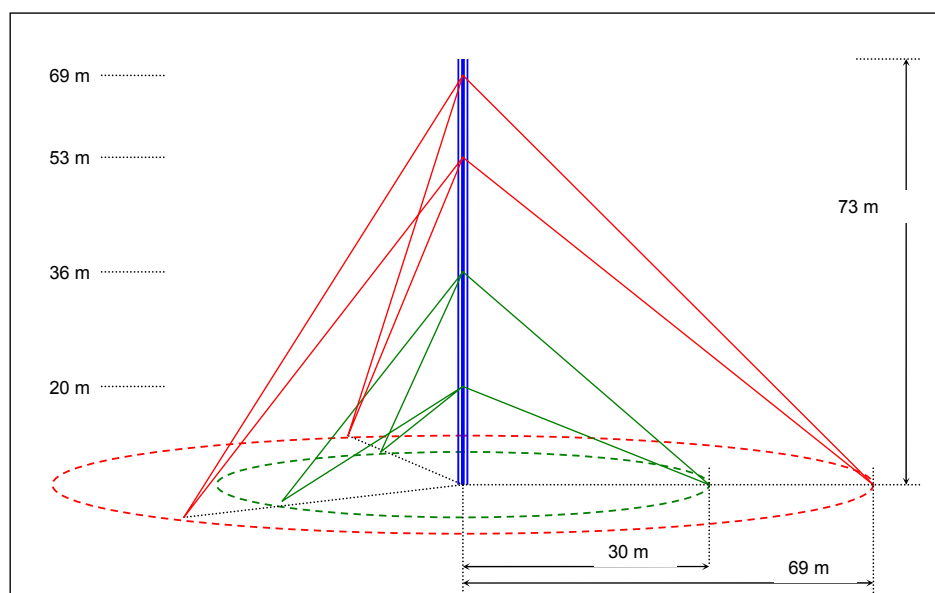
One of the mast's pairs of stay wires in the outer circle (se 1.12.3) was severed by a rotor blade just over 10 metres above the ground. As a consequence of this damage the upper portion of the mast collapsed.

The radio station consists of a fairly small wooden station building with associated radio mast. The building contains technical radio and communications equipment and some space for service personnel. The radio mast is a 70-m-tall triangular latticework construction in galvanised steel. The mast is supported with three stay wires at each of four 'support levels' at 20 m, 36 m, 53 m and 69 m above ground level. The diameter of the stay wires is approximately 13 mm.

The stay wires from the two lower levels are coupled in three pairs symmetrically anchored on a circle with a radius of 30 m. The stay wires from the two upper levels are coupled in three pairs anchored in the ground around the mast in a circle with a radius of 69 m and in the same vertical plane as the lower pairs. (See sketch on following page.)

*Arrangement of mast stay wires*

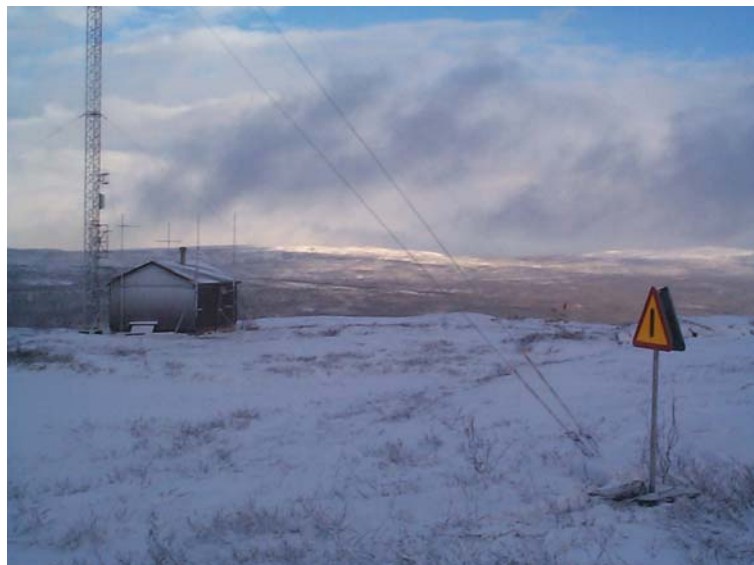
Following the accident the mast operators have decided, on their own initiative and on a trial basis to mark the anchor points in the outer circle of the mast in question with "road sign" type warning signs (see below).

The possibility of increasing flight safety in this type of activity by marking the anchor points of the outer stay wires was discussed at the Board's accident meeting. Even the trial marking on the mast in question was judged by the helicopter operator to be a significant improvement.

*Marking of mast stays*

In addition, the anchor points that are sited furthest out from the centre of the mast should be marked in a suitable manner. Helicopter pilots would then get both a reminder of the spread of the mast stay wires and clear reference points when manoeuvring at low altitude near masts. Even the trial marking set up by the mast operators on their own initiative appears to represent a substantial improvement in this respect.
