Statens haverikommission
Swedish Accident Investigation Board

Report RL 2003:29e

***Accident involving aircraft SE-GSS
at Örebro airport, T County, Sweden,
on the 5th of June 2002***

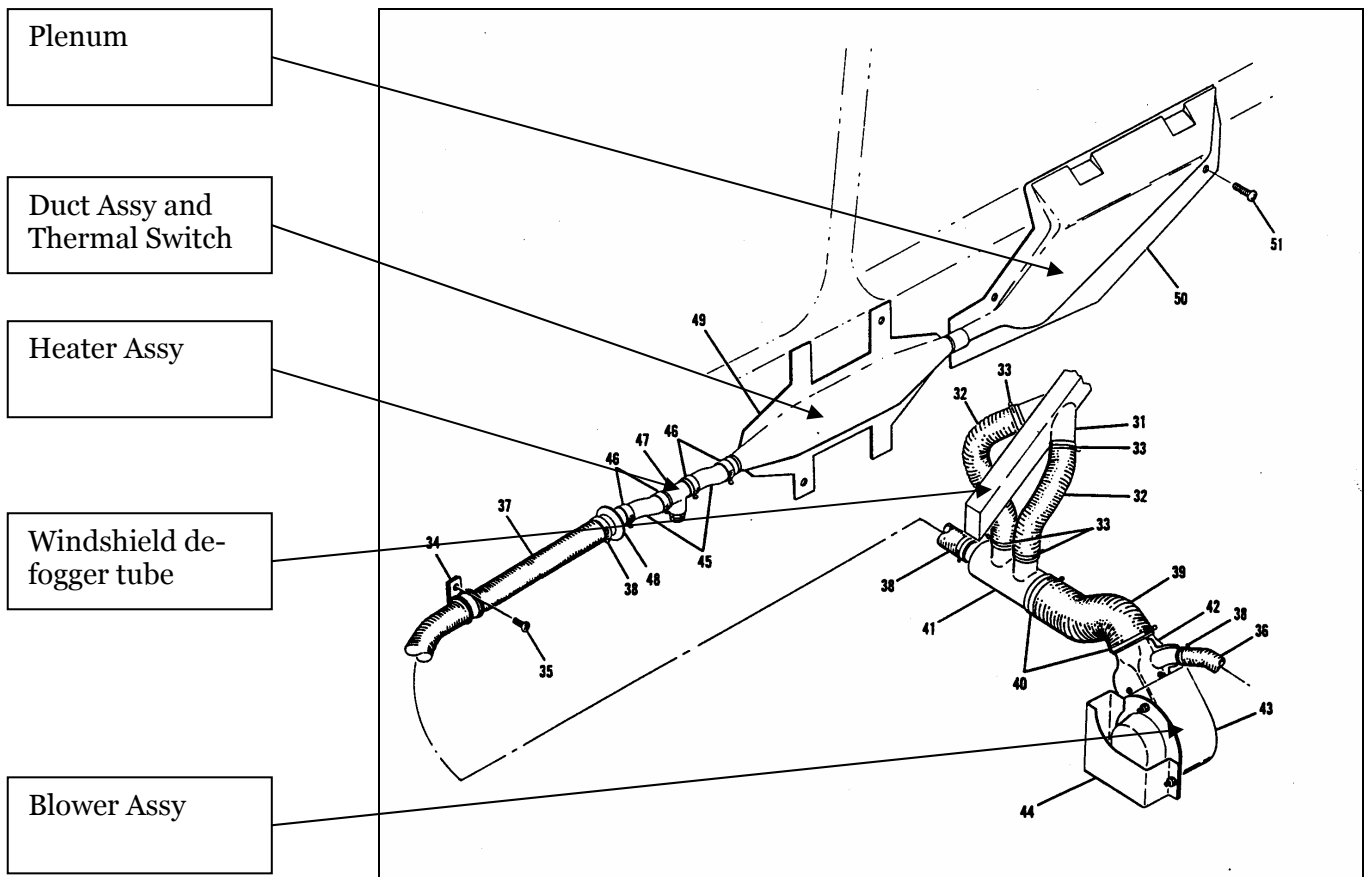
There is no system to warn the pilot or to automatically turn-off the heaters, should the fan fail to start or stop during operation.

Side window defogger system, right side.

Everything would indicate that the heaters became over-heated when the airflow stopped or was absent due to the fan having stopped. The thermostats, which are mounted in an air duct (Duct Assy) between the heater and the discharge nozzle (Plenum) were not affected by the increase in temperature, partially due to the distance to the heater and partly due to the cessation of the airflow. Consequently, the thermostats did not function as over-heat protection.

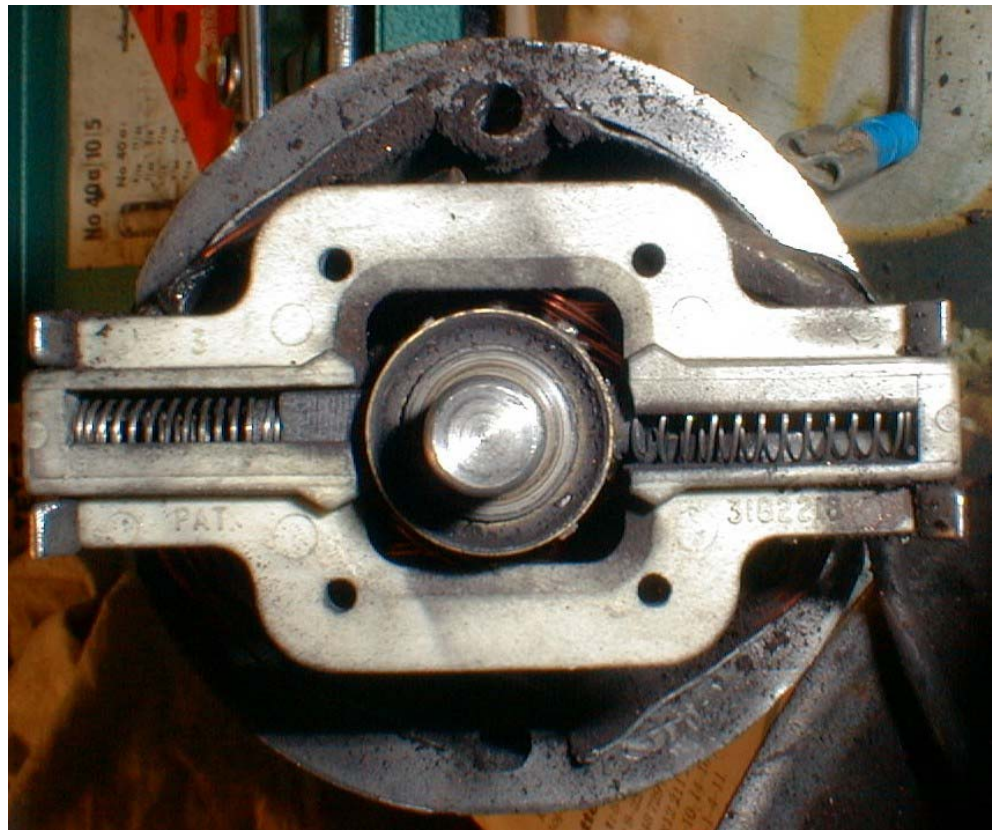
One of the motor brushes in the fan motor was completely worn-out and the motor did not run when supplied with electricity.

The fan motor collector with motor brushes and brush holders. The brush on the right in the picture is worn-out.

SHK finds it remarkable that the maintenance program does not require any periodical service on the fan or its motor. The functional check which is to be accomplished every 100th flying hour appears to be insufficient to prevent fan failure and therewith the accompanying over-heating of the side window defogger heaters.

The Swedish Civil Aviation Administration is recommended to work for that the aircraft type's design and maintenance program are revised; on the one hand so that a risk of fire does not arise if the fan stops, and on the other hand so that the probability of the fan stopping is diminished to an acceptable level. (*RL 2003:29e R1*).

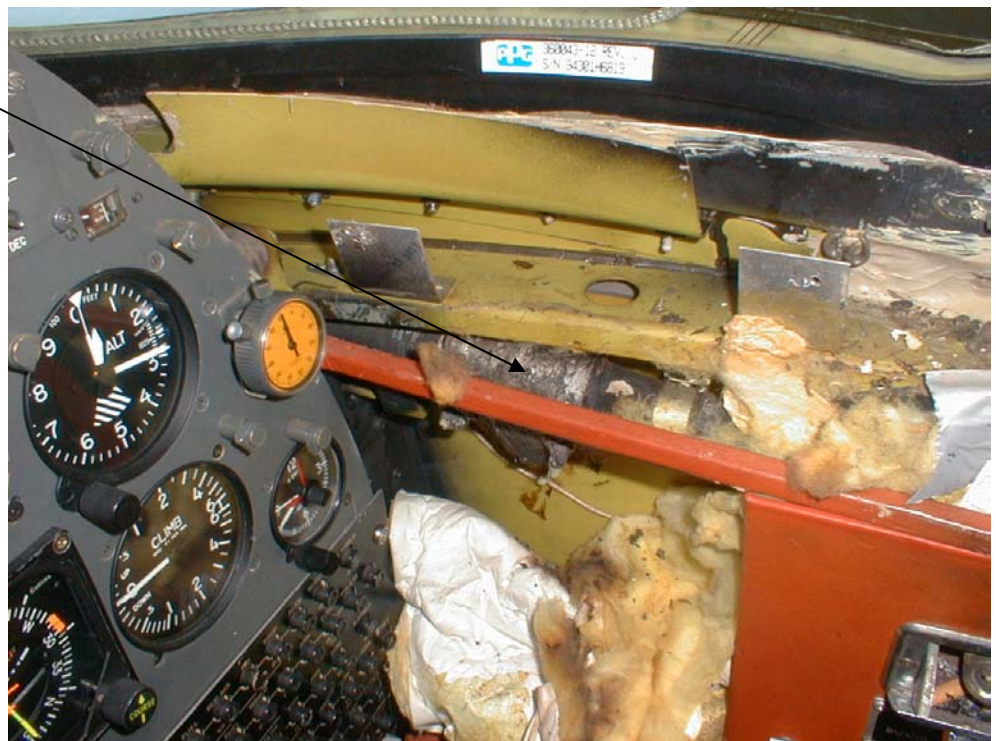
Side Window Defogger Heater

The left and right heat shrouds were severely heat damaged while the internal heating elements were fully operational.

Right-hand side window defogger.

As the heaters became too hot, they over-heated and charred the adjacent insulation and partially melted the instrument panel glareshield, which in turn caused the generation of smoke. The crew's use of the halon fire extinguisher may have prevented a fire from breaking-out in nearby material.
