**Statens haverikommission**  
Swedish Accident Investigation Board

## ***Report RL 2009:14e***

**Incident involving aircraft OE-LRW  
at Åre/Östersund airport, Z län  
(Jämtland county),  
Sweden on 9 September 2007**

Case L-27/07

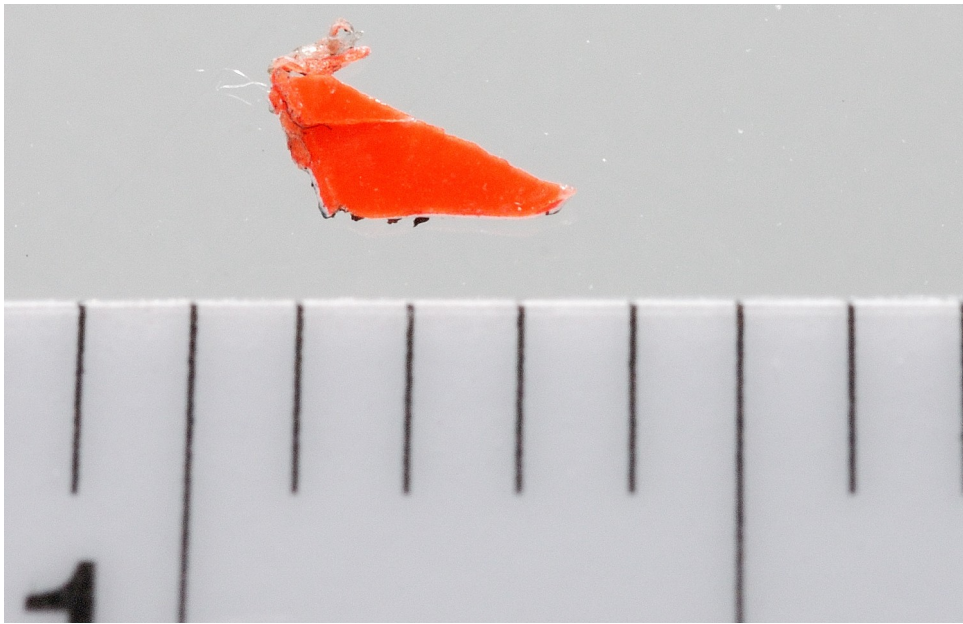
Fig.1. Particle found at the landing gear.

This foreign object consisted of an unknown piece of plastic material coloured orange, measuring about 2.8 x 1.5 mm. The particle was retrieved and sent, together with one of the damaged reflective poles from the airport to SKL<sup>5</sup> for examination and analysis (see Section 1.16.1)

No damage was found to the aircraft. The only evidence that could be found was the paint particle discovered in the landing gear and that could be identified as part of the reflective tape from the snow poles next to the approach lights.

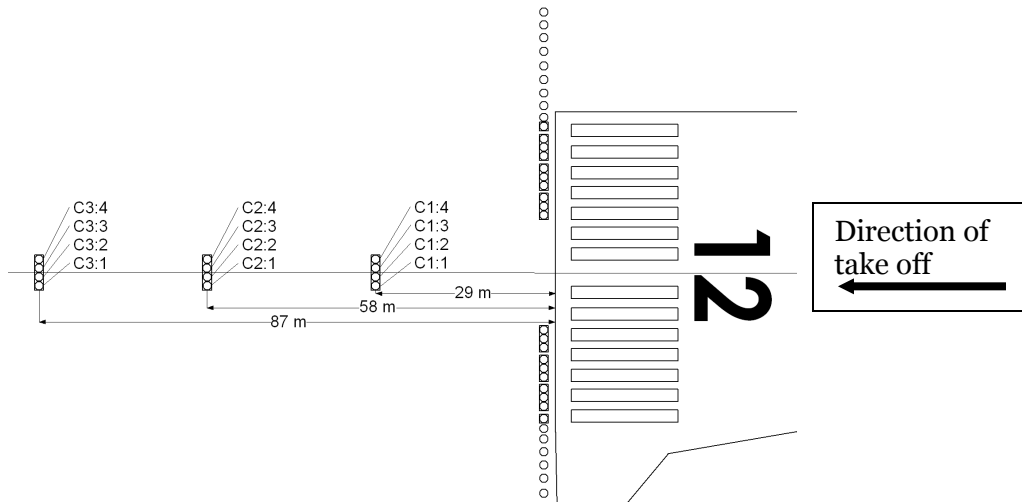
During inspection of the runway on 10 September damage was discovered to the approach lights for runway 12. This lighting was of the Barrette CL Cat I international standard type, and consisted of a 720 m long centreline with the approach lights located at right angles to the runway. There was also a long horizontal transverse light bar located further from the runway end. Damage had occurred to the three approach light bars nearest to the runway, C1, C2 and C3.

Fig.2. Part of the approach lighting to runway 12 at Åre/Östersund airport

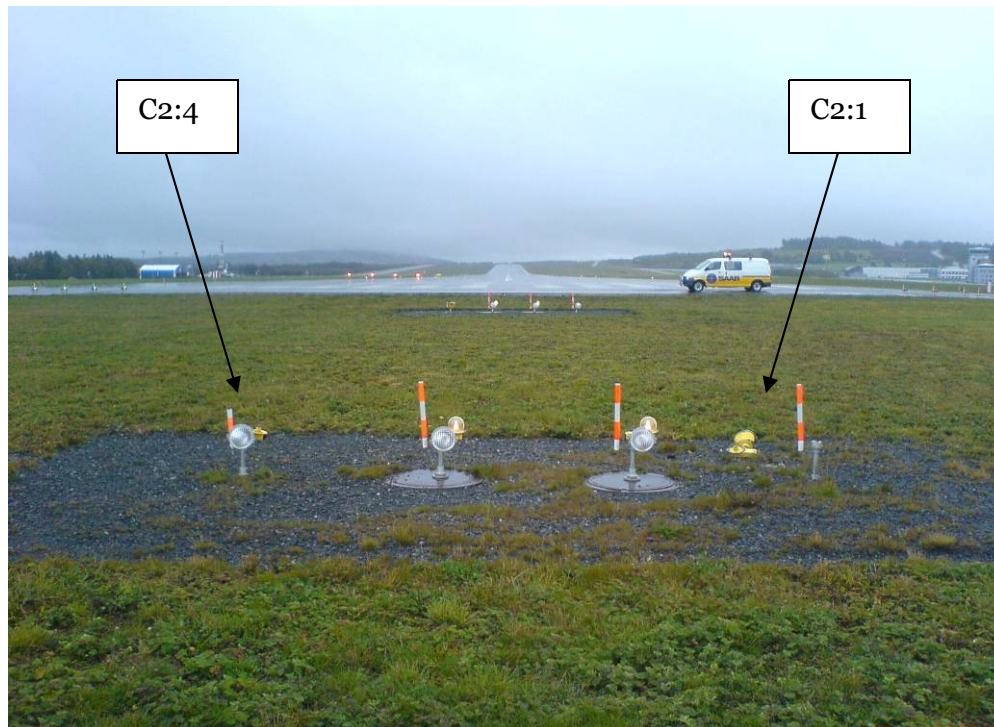
- C1:1: glass housing for low intensity lighting broken, and high intensity light fitting twisted,
- C1:4: lamp housing for high intensity lighting deformed, with two longitudinal scores, broken lens in the high intensity light fitting, reflective snow pole broken off, glass housing for low intensity lighting broken and light fitting direction twisted,
- C2:1: High and low intensity light fittings detached from the upright, lamp housing for high intensity lighting deformed with longitudinal scoring and broken lens, glass housing for low intensity lighting broken,
- C2:4: glass housing for low intensity lighting broken, light fitting twisted, reflective snow pole broken off and connection box cracked,
- C3:1: reflective snow pole bent, low intensity lighting broken, reflective snow pole detached from upright.

Fig.3. Second row of approach lights.

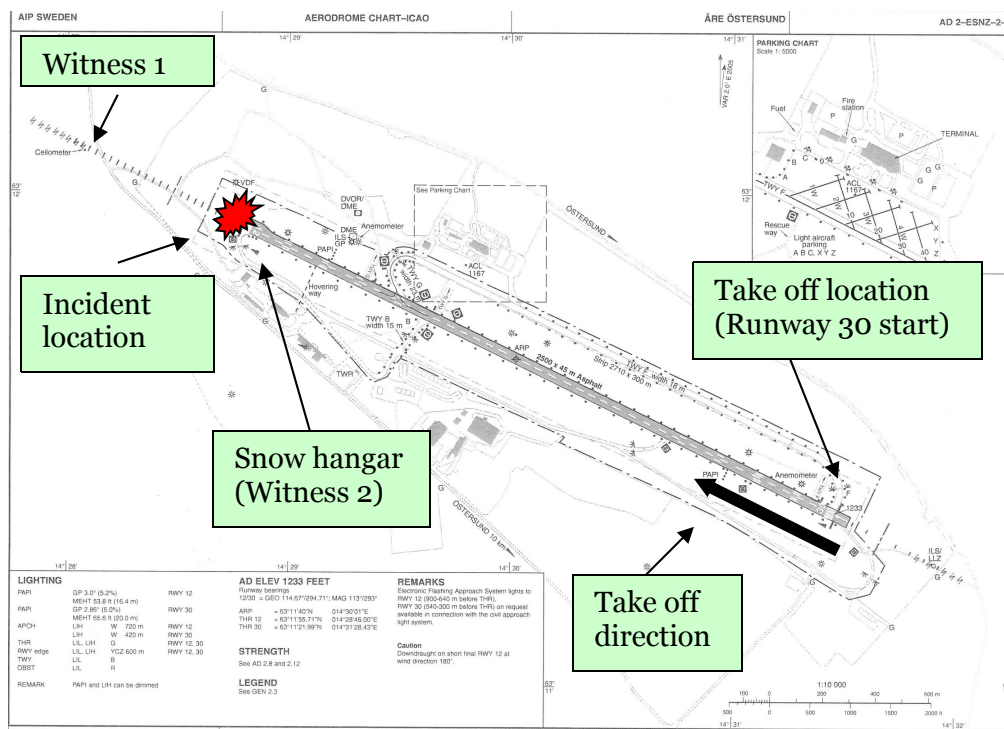
The incident occurred at Åre/Östersund airport, ESNZ, in connection with a take off to the north-west on runway 30. The incident, during which the aircraft landing gear struck the opposite runway's approach lighting, took place at the gravel surface beyond the end of the asphalted runway.

Fig. 6. Map extracted from AIP-Sweden showing Åre/Östersund airport with annotations for the incident sequence.

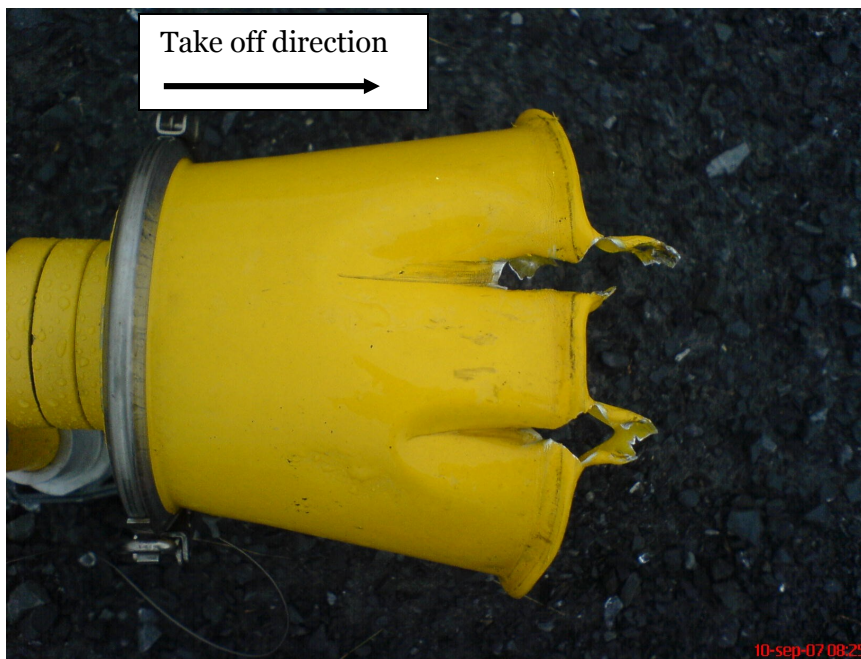
Figure 7 shows the damage to lighting fixture C 1:4. The lamp housing has two longitudinal parallel dents and tears. The sheet metal material at the front edge of the lamp housing has been torn out in the direction of the runway where the aircraft took off.

Fig.7. Lamp housing C1:4.

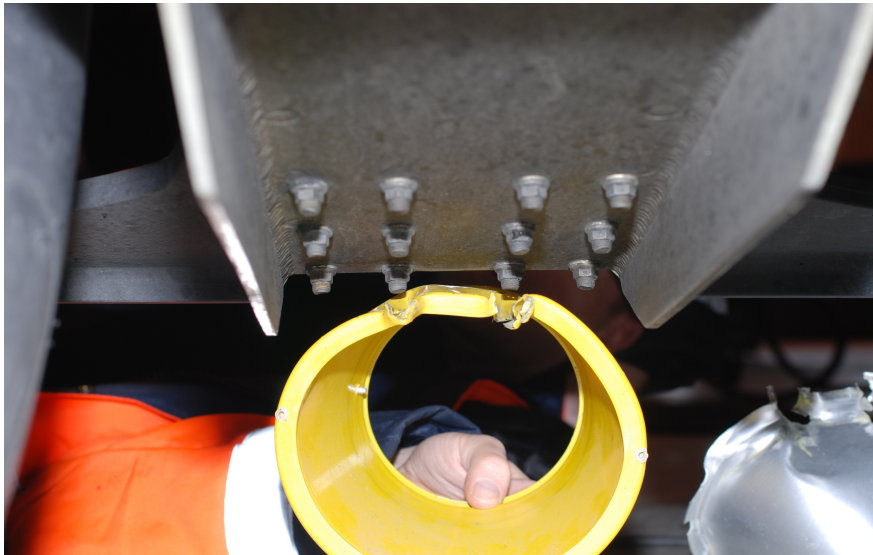
Figure 8 shows a detail view of part of the MD-83 landing gear. The distance between the inner pair of rows of the projecting bolts matches the damage to the lamp housing very well.

Fig.7. Detail view of part of the MD-83 landing gear and lamp housing C1:4.

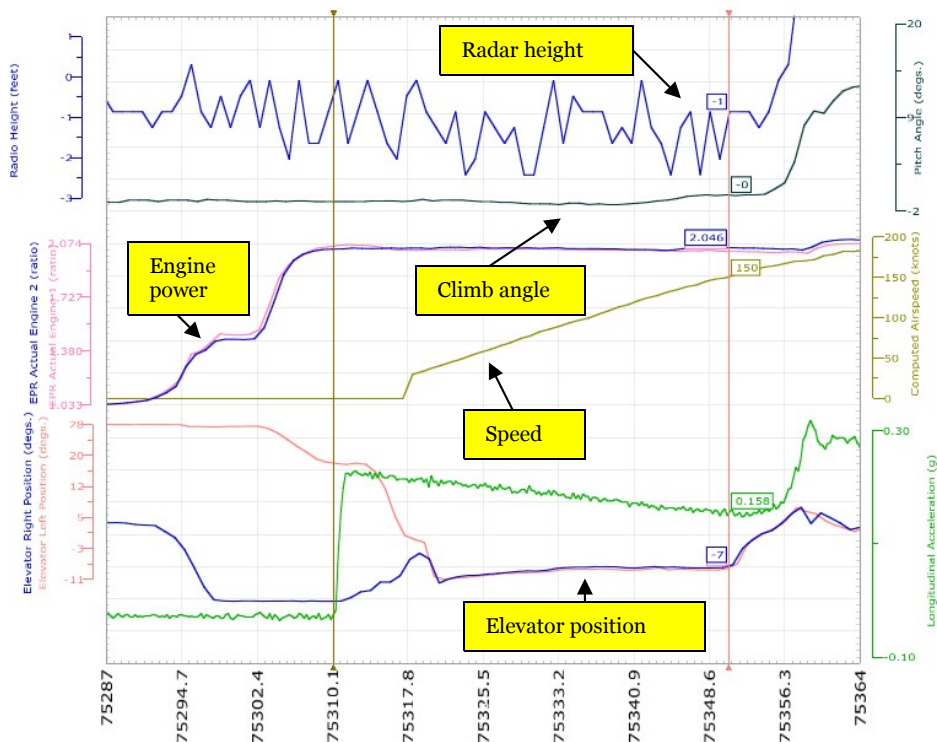
Fig.8. Extract from the flight data recorder during the take off sequence. The horizontal axis shows the time in seconds.

Figure 8 shows certain parameters taken from the flight data recorder during the take off sequence. The horizontal axis shows the time in seconds. The beginning of the take off sequence is indicated by a vertical line at 75 310.1, and the moment when rotation began is at 75350.6, i.e. when the elevators were moved to lift off the runway, with the speed at that time being 151 knots Computed Airspeed, CA. The difference between CA and the speed that the pilots could see on the instruments, the indicated air speed (IAS) is negligible. According to the flight data recorder rotation took place at about  $2^{\circ}$  per second, up to about  $+14^{\circ}$  pitch angle.

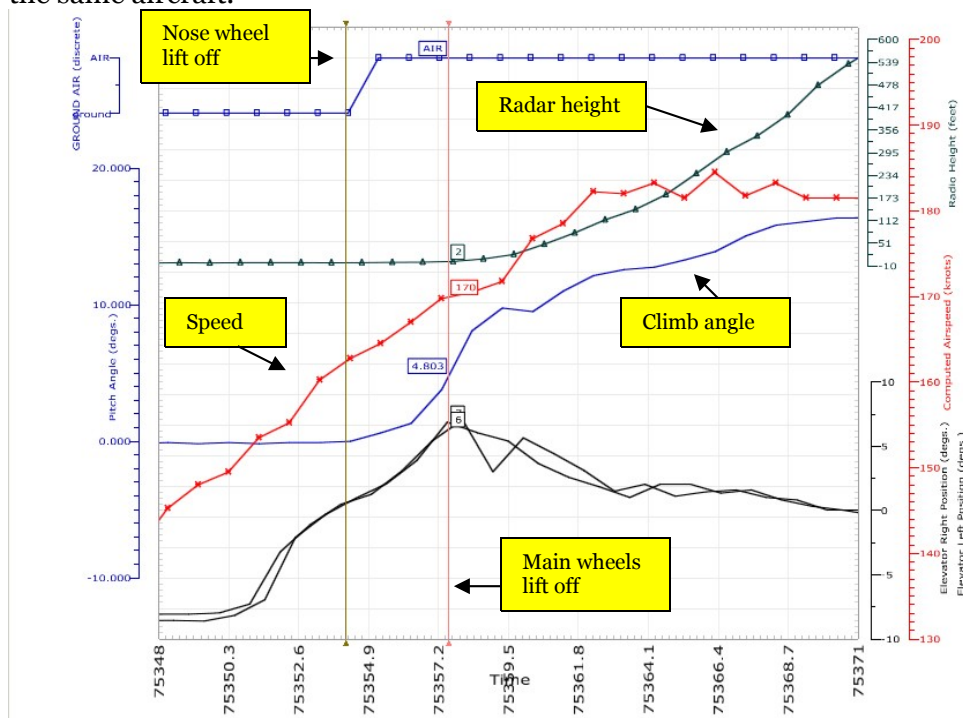
Figure 9 shows the relevant parameters during the time the aircraft lifted off the ground. The instant the nose wheel lifted off the runway is indicated by a vertical line at 75 354.1 at a speed according to the diagram of 164 knots, while the aircraft main wheels lifted off the runway at 172 knots at time 75 357.6. The different lift off instants, for the nose wheel and the main landing gear, were calculated from the flight data recorder values from the “weight on wheels”<sup>8</sup> switch at the nose wheel, and the radar height indications respectively.

SHK has compared the data from the aircraft flight data recorder during this particular take off with other comparable take offs for this aircraft. The comparison showed that engine and other relevant parameters for the aircraft during this event did not in principle show any difference from earlier flights with the same aircraft.

Fig. 9. Extract from the flight data recorder during the later part of the take off sequence. The horizontal axis shows the time in seconds.
